GRL37410. #1. SE-30-82-2-6. Log fill crossing along access trail.

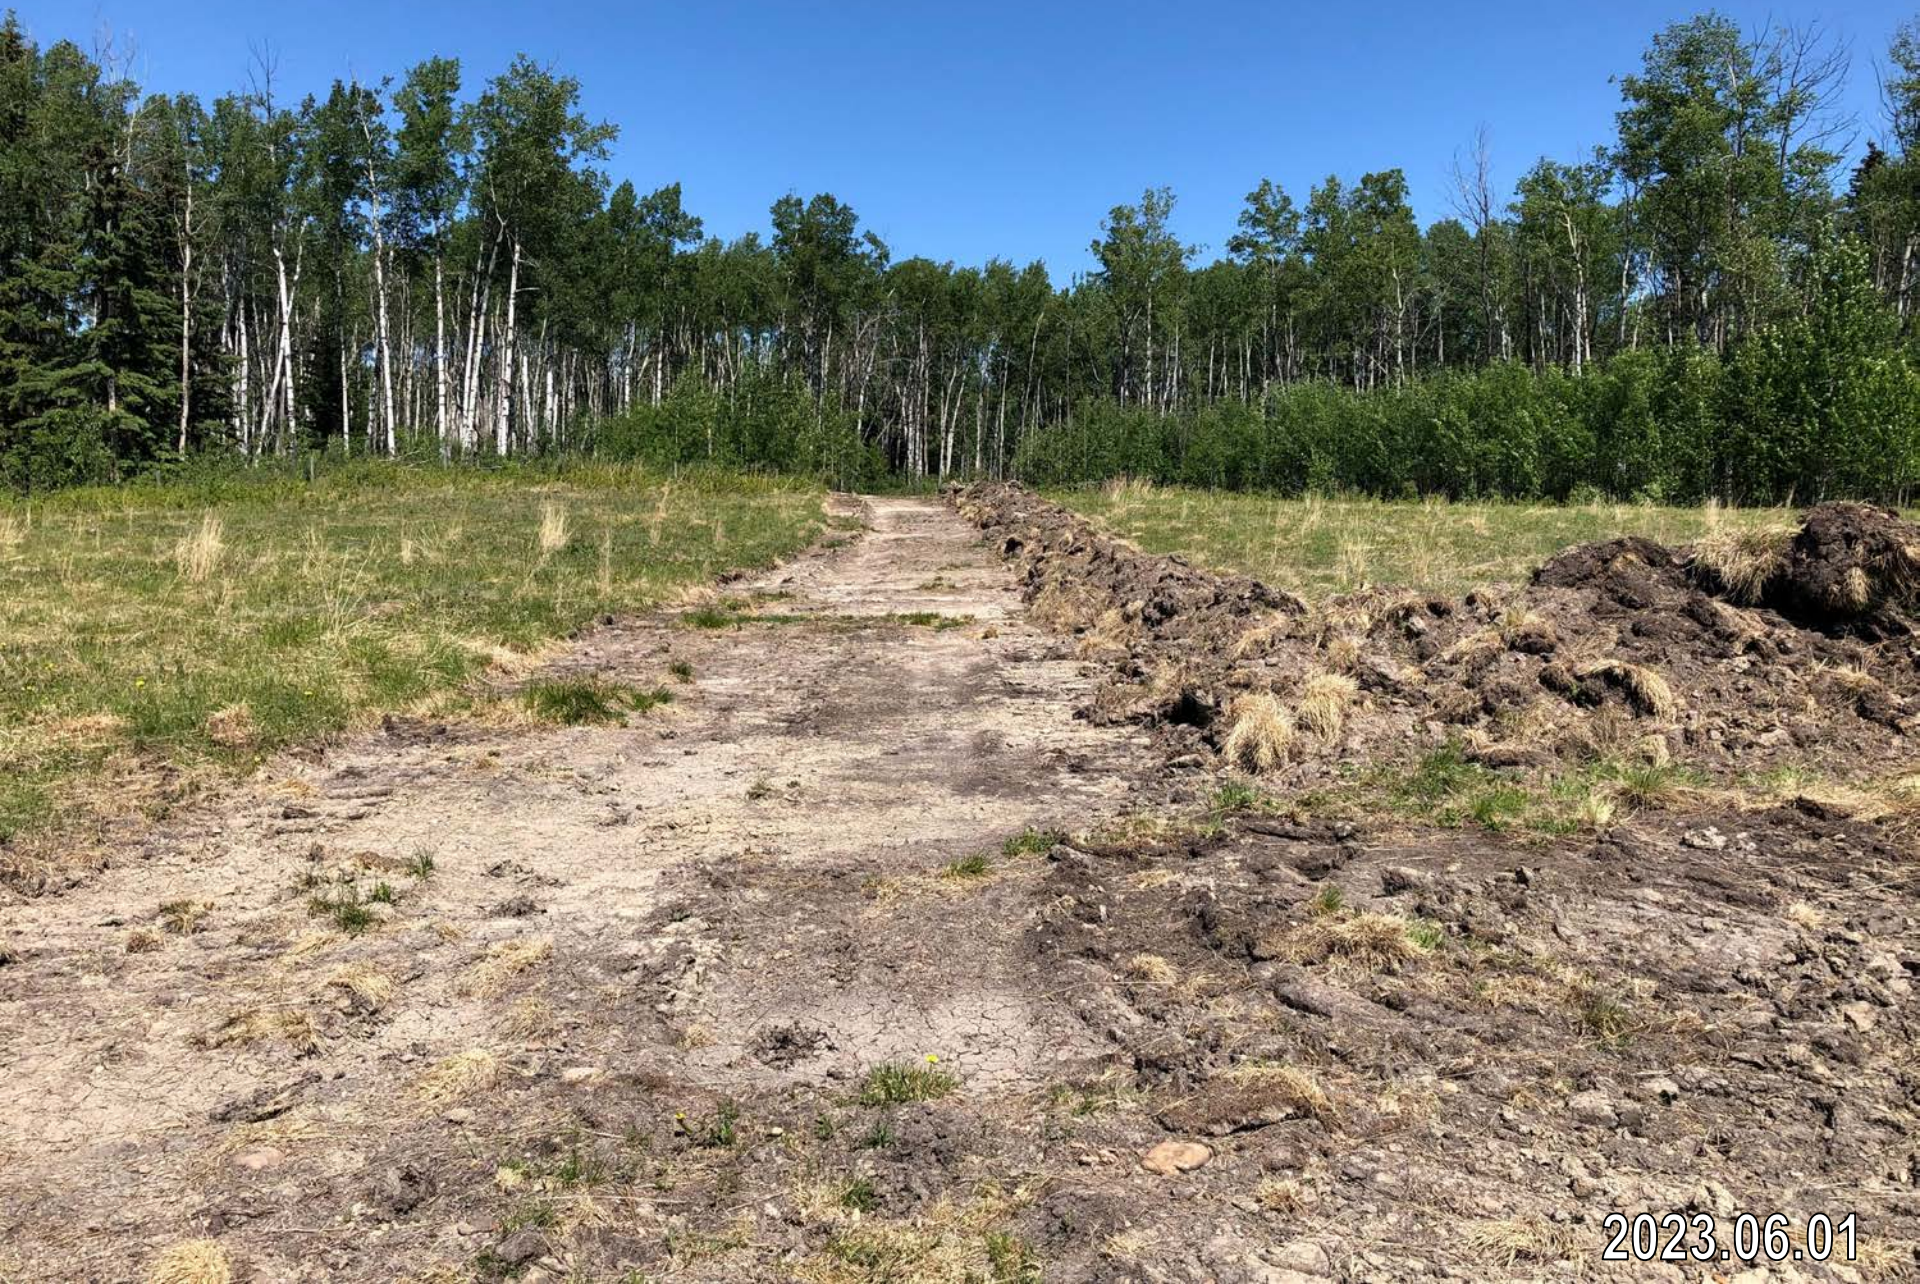
**GRL37410. #2. NE-30-82-2-6. 3-5 m wide access trail through old MSL.**

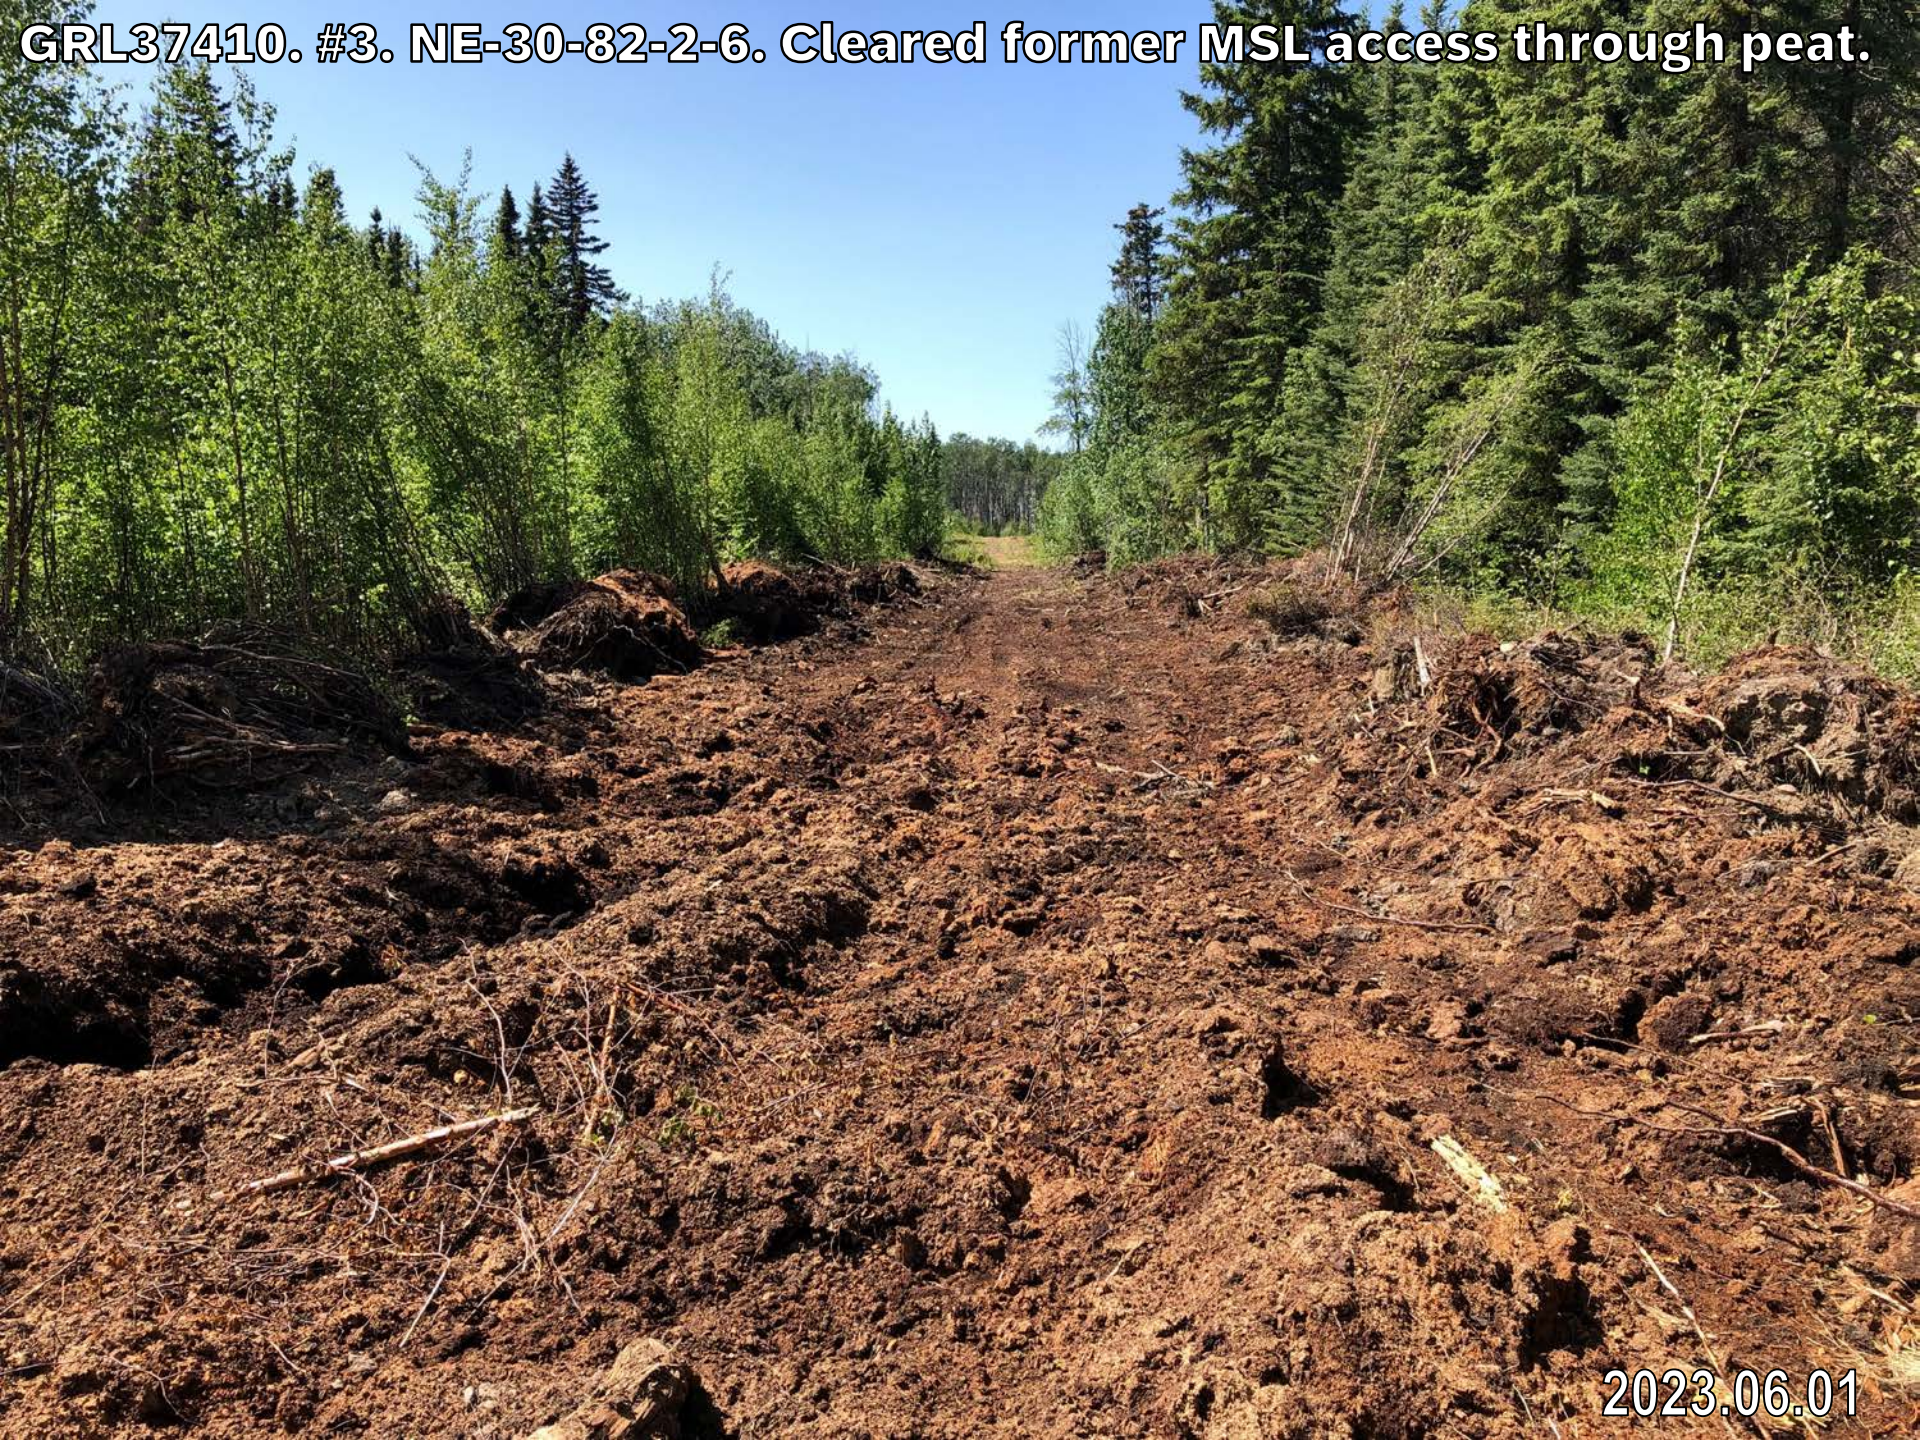
**GRL37410. #3. NE-30-82-2-6. Cleared former MSL access through peat.**

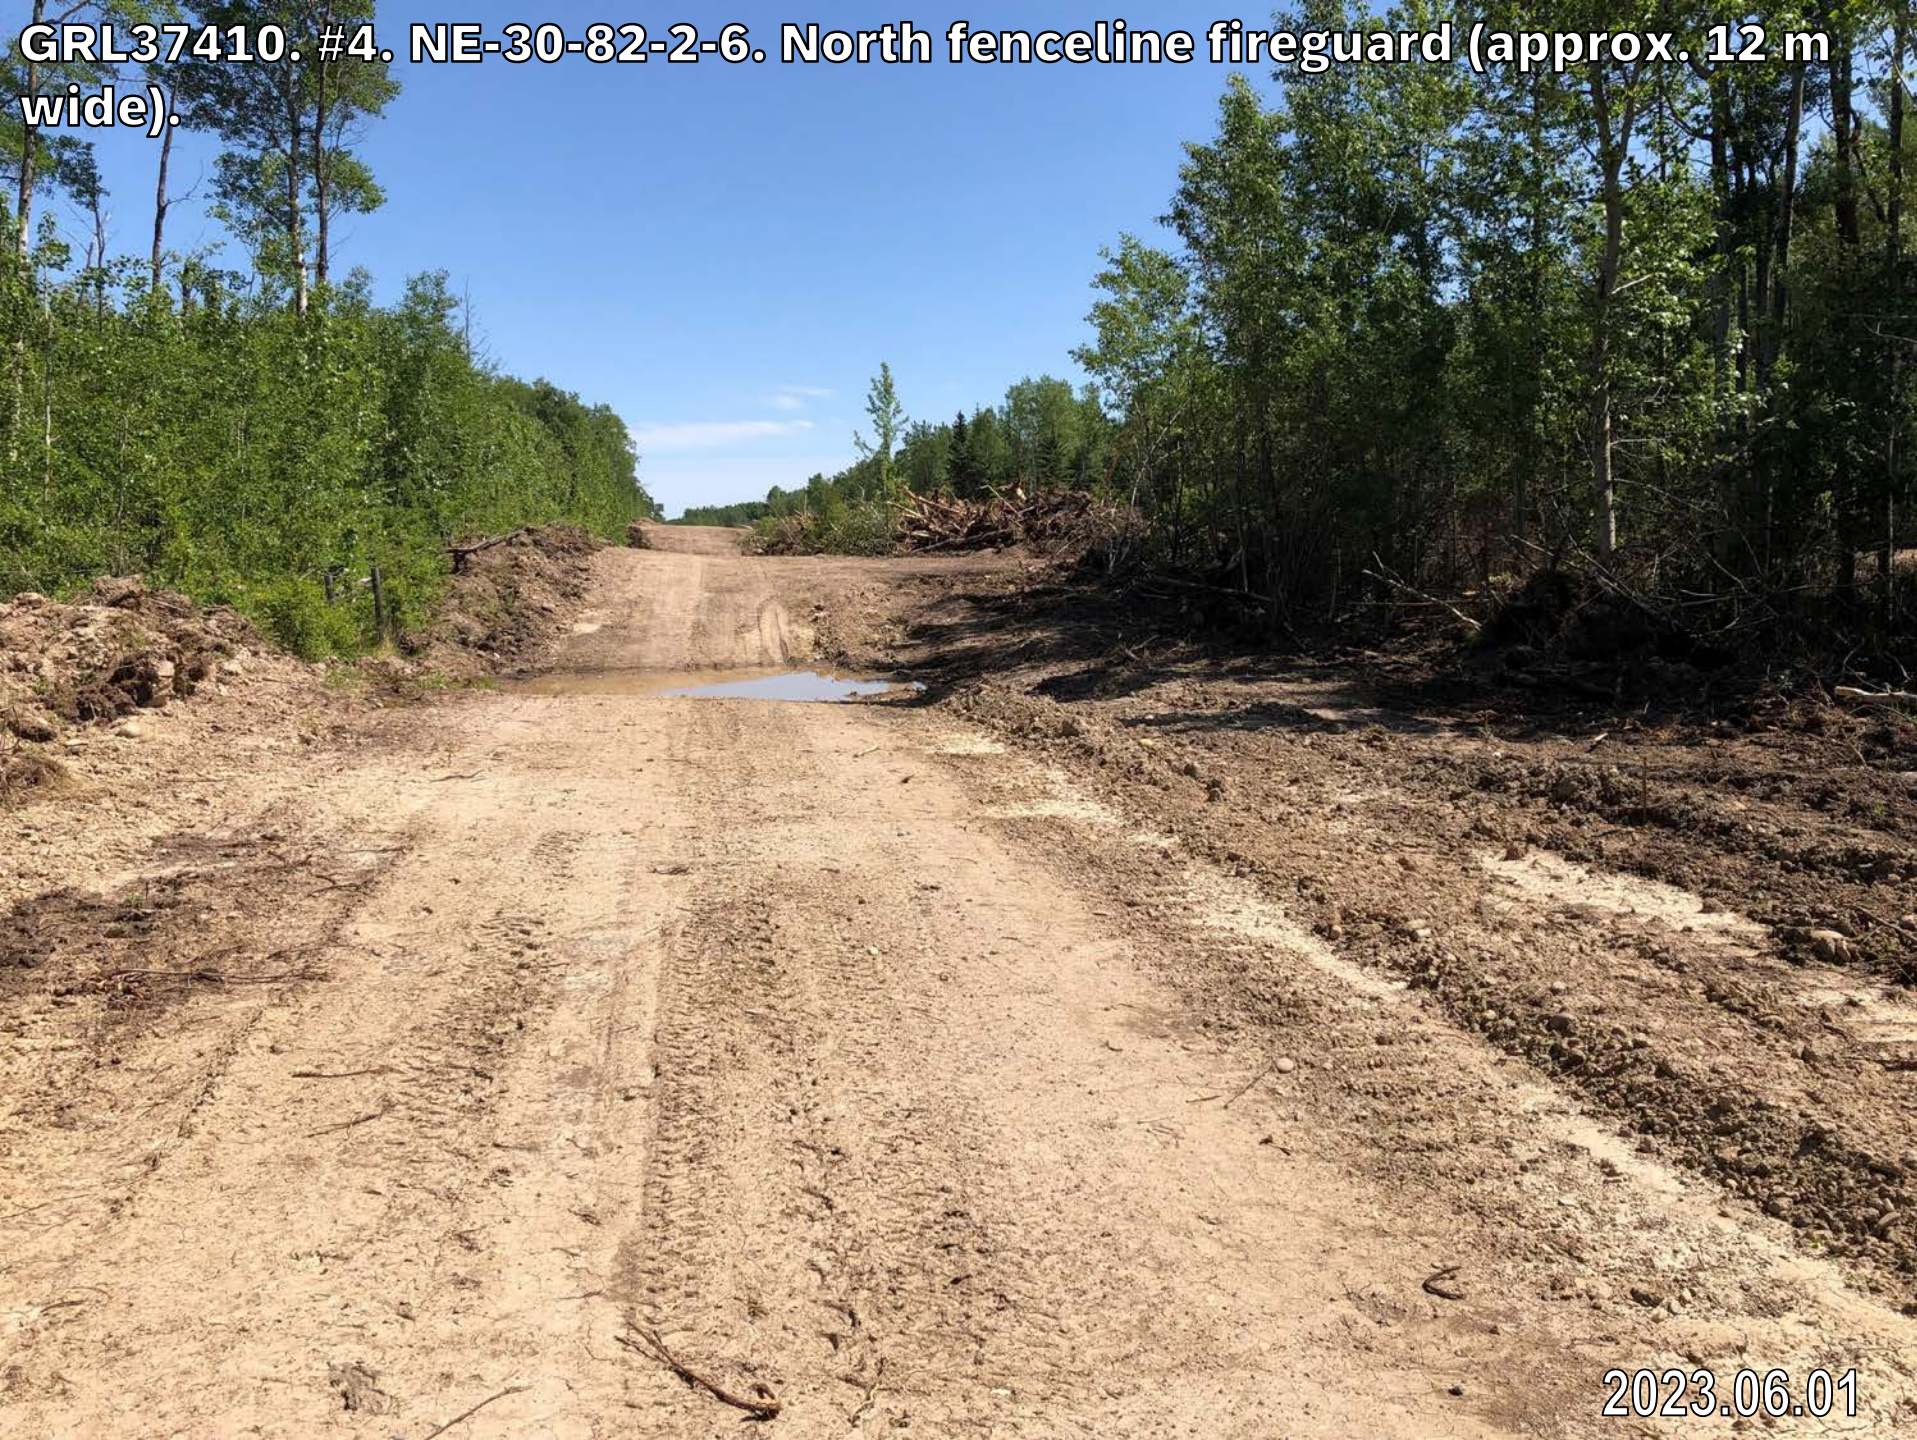
**GRL37410. #4. NE-30-82-2-6. North fenceline fireguard (approx. 12 m wide).**

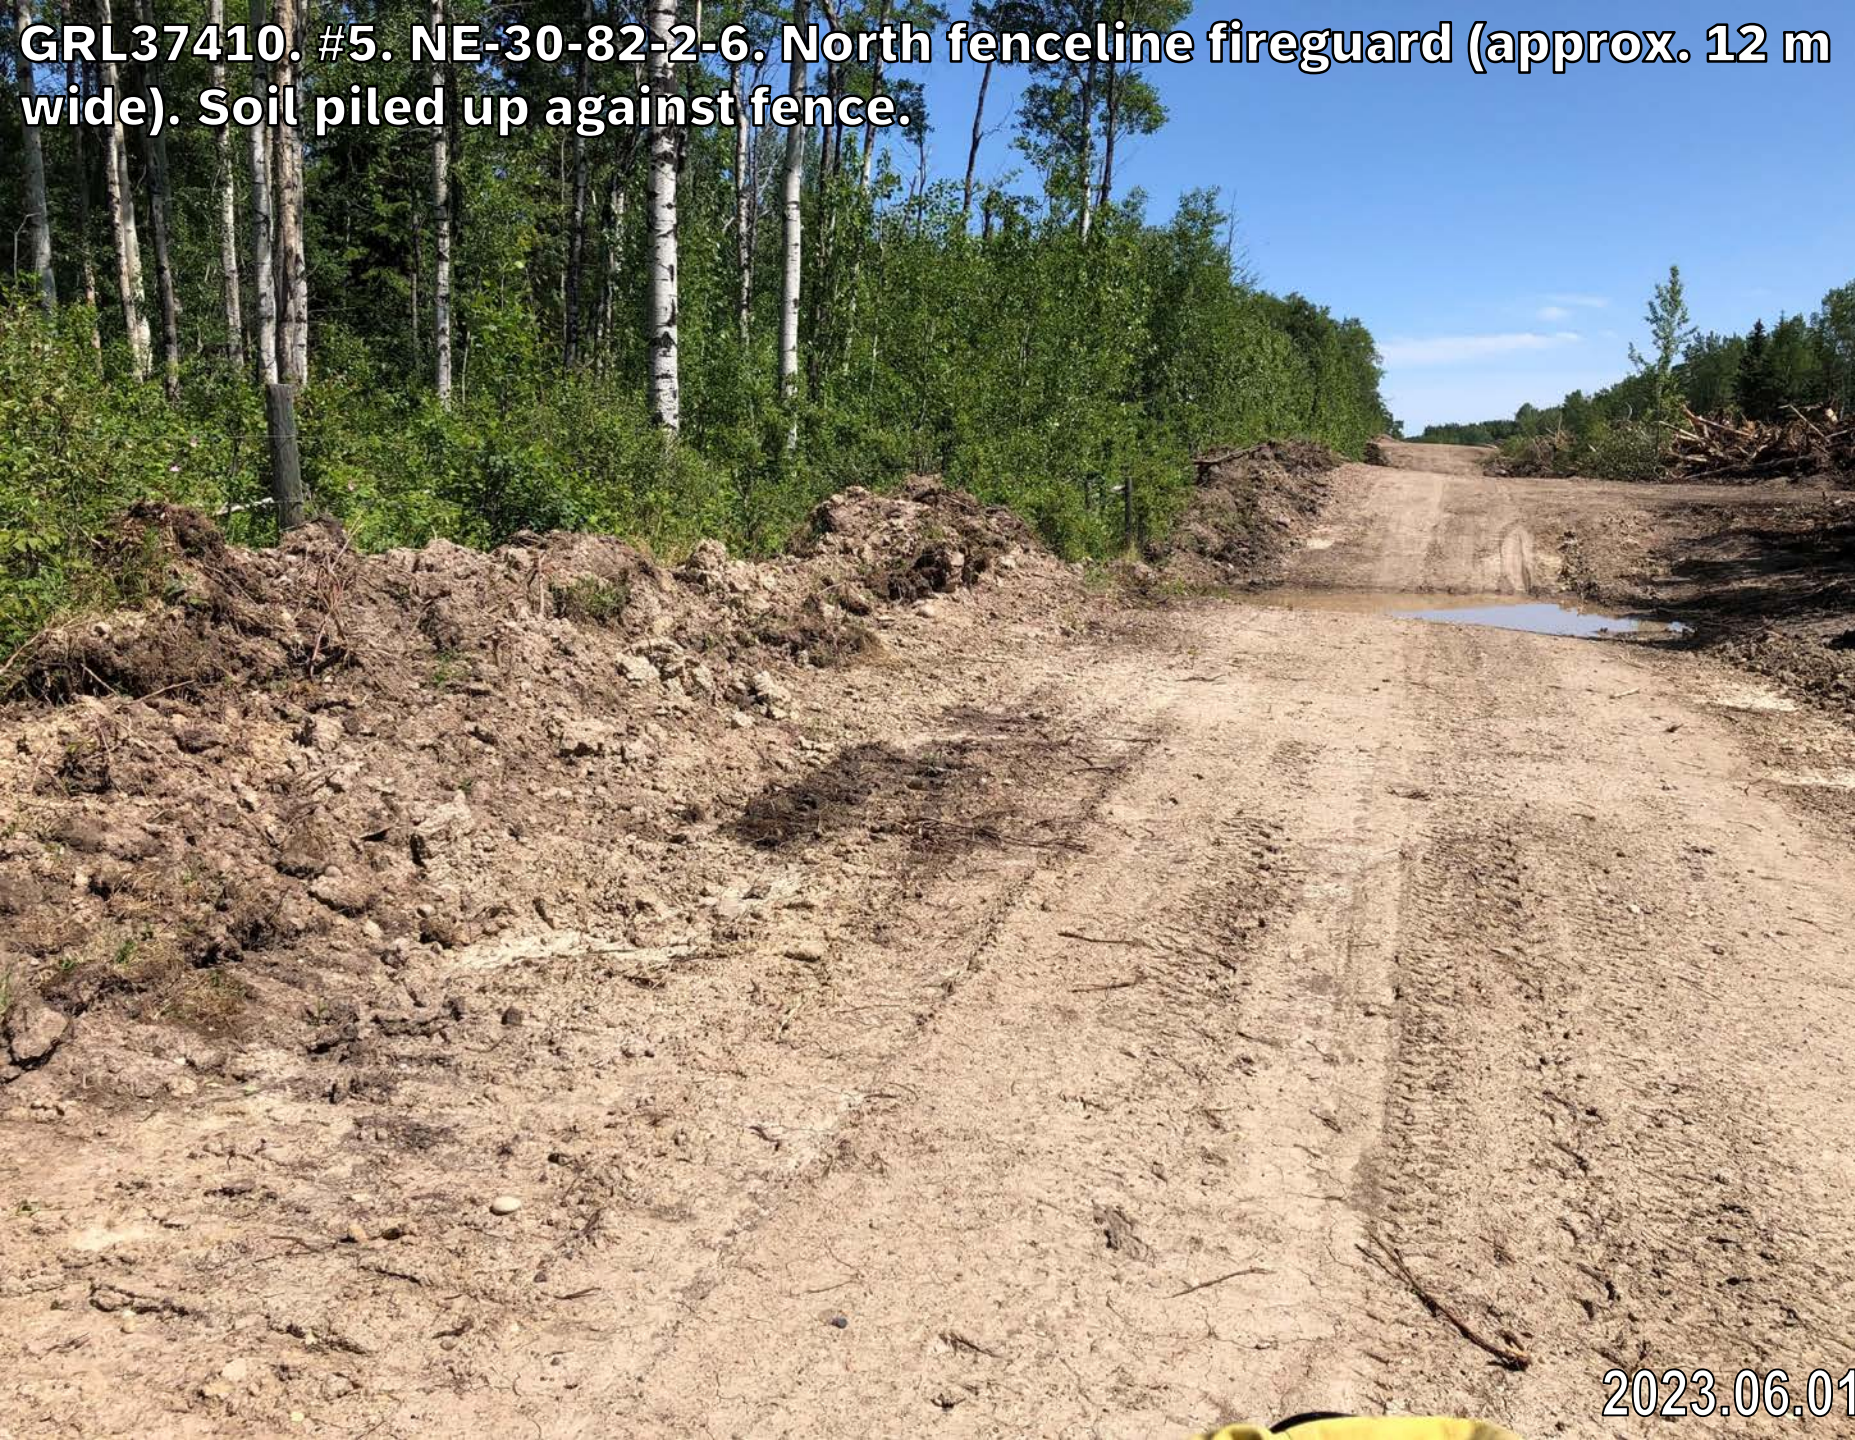
**GRL37410. #5. NE-30-82-2-6. North fenceline fireguard (approx. 12 m wide). Soil piled up against fence.**

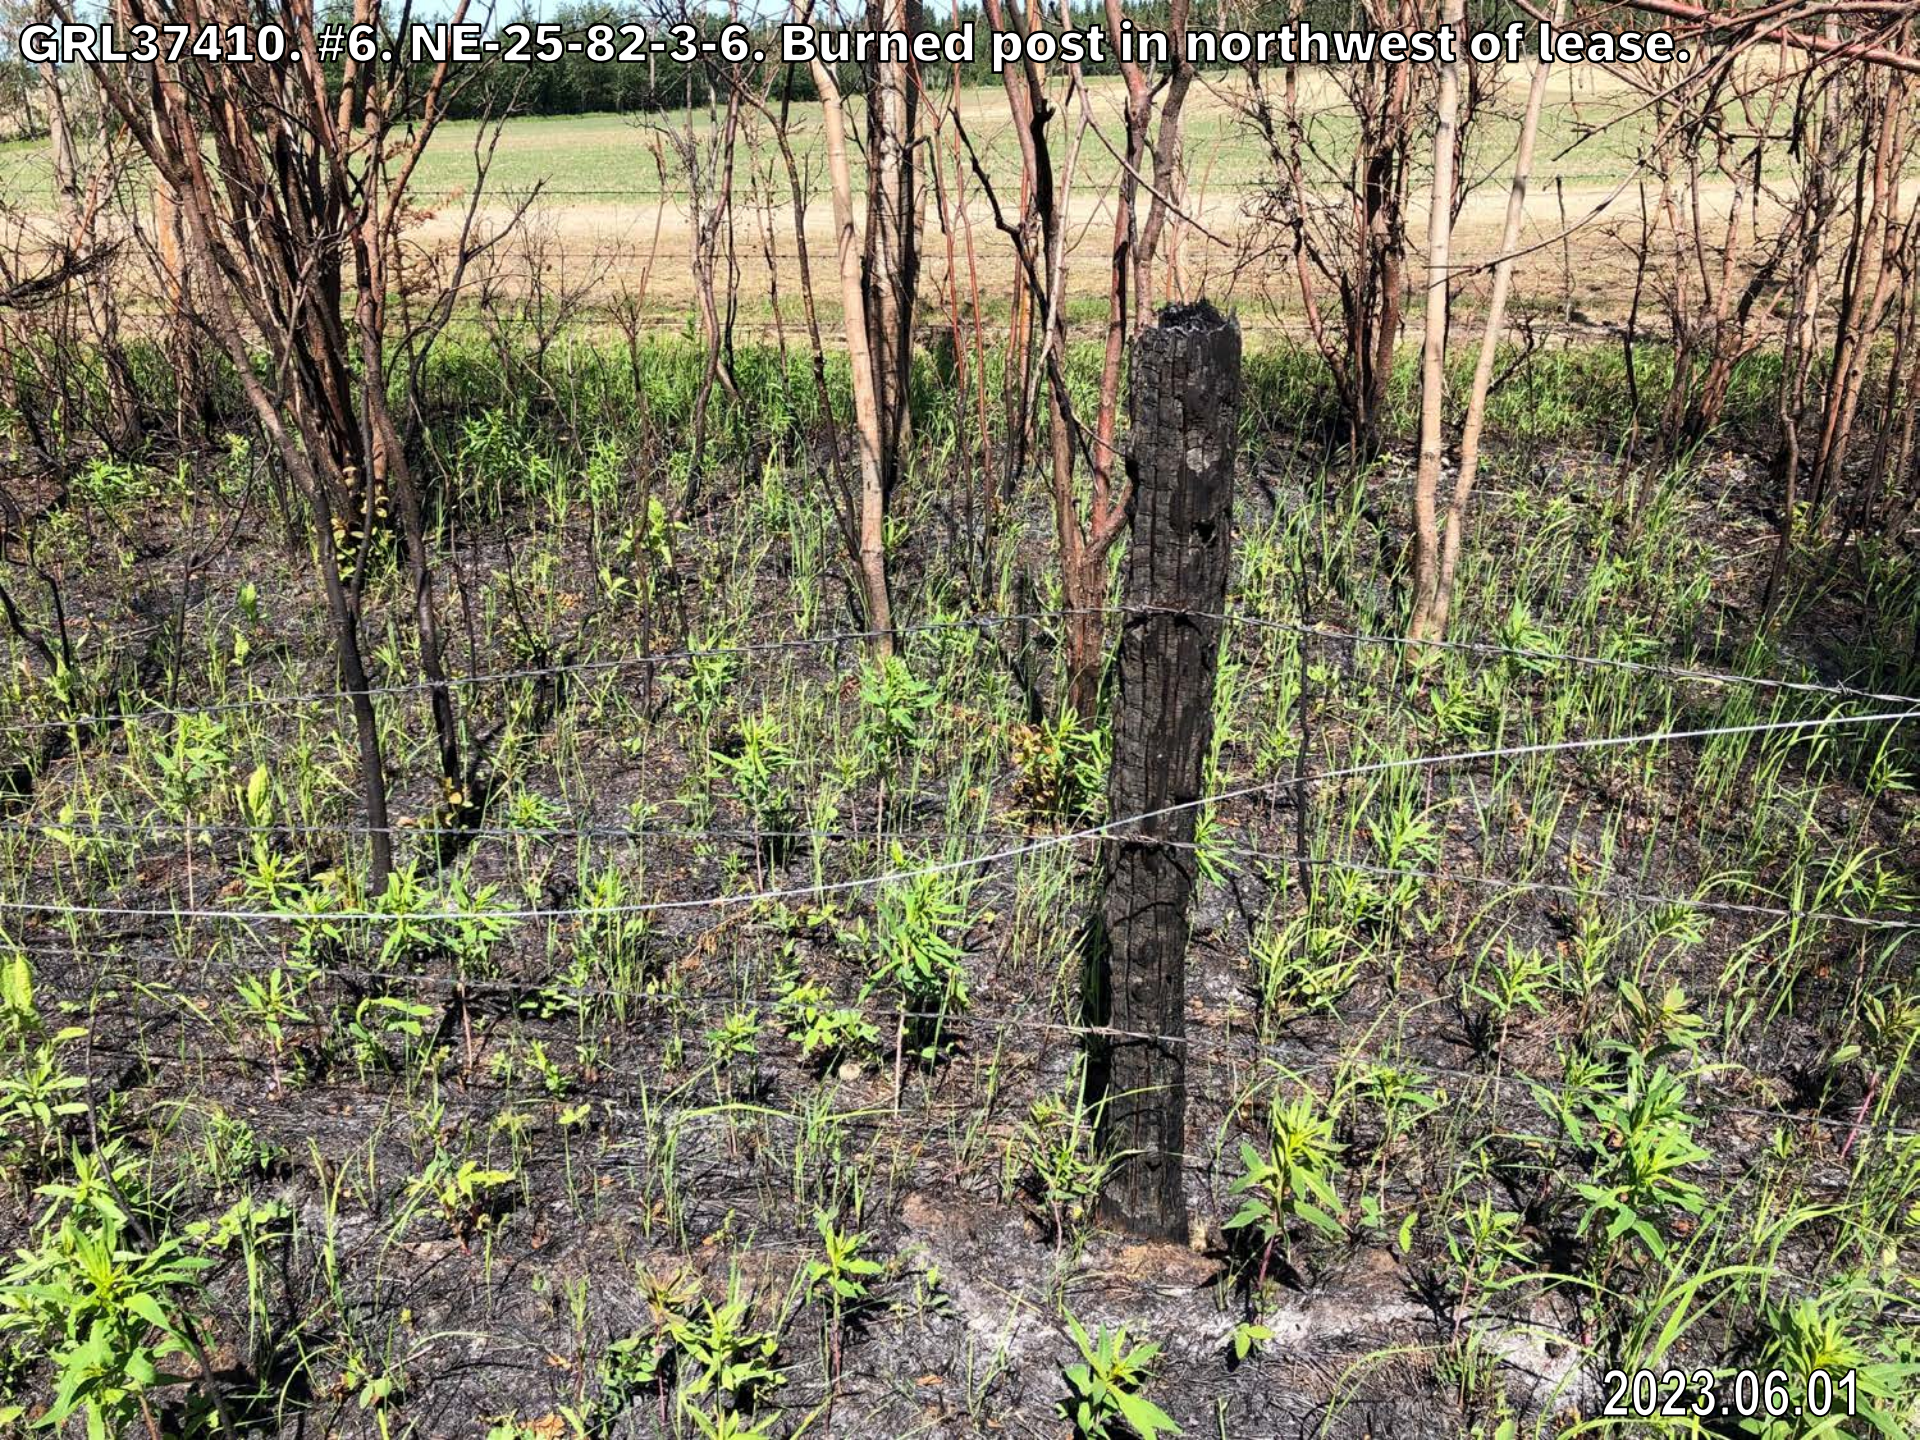
GRL37410. #6. NE-25-82-3-6. Burned post in northwest of lease.

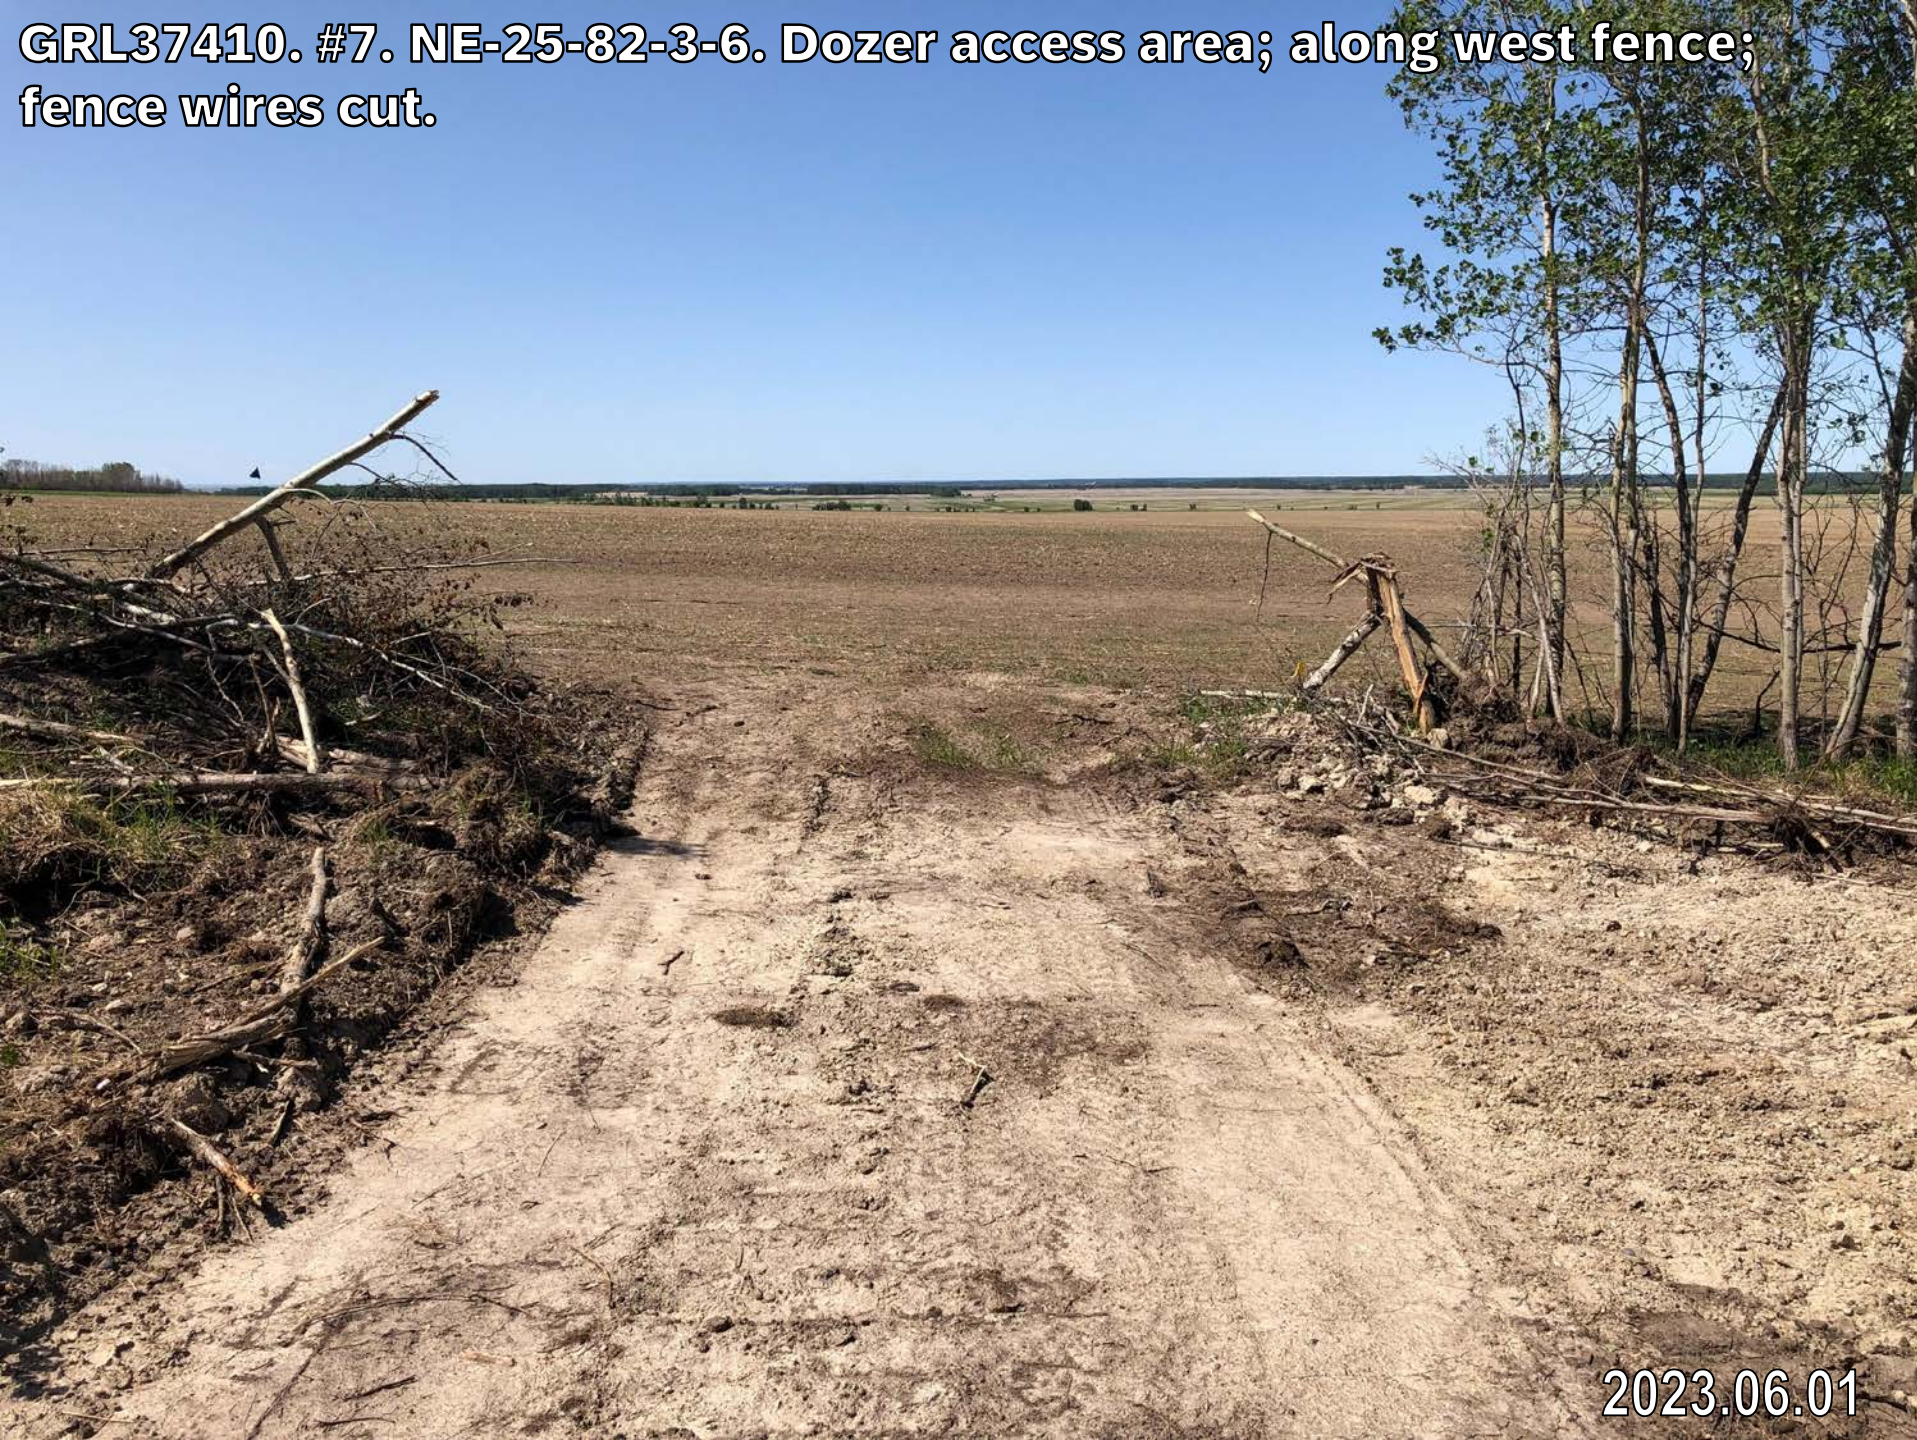
GRL37410. #7. NE-25-82-3-6. Dozer access area; along west fence; fence wires cut.

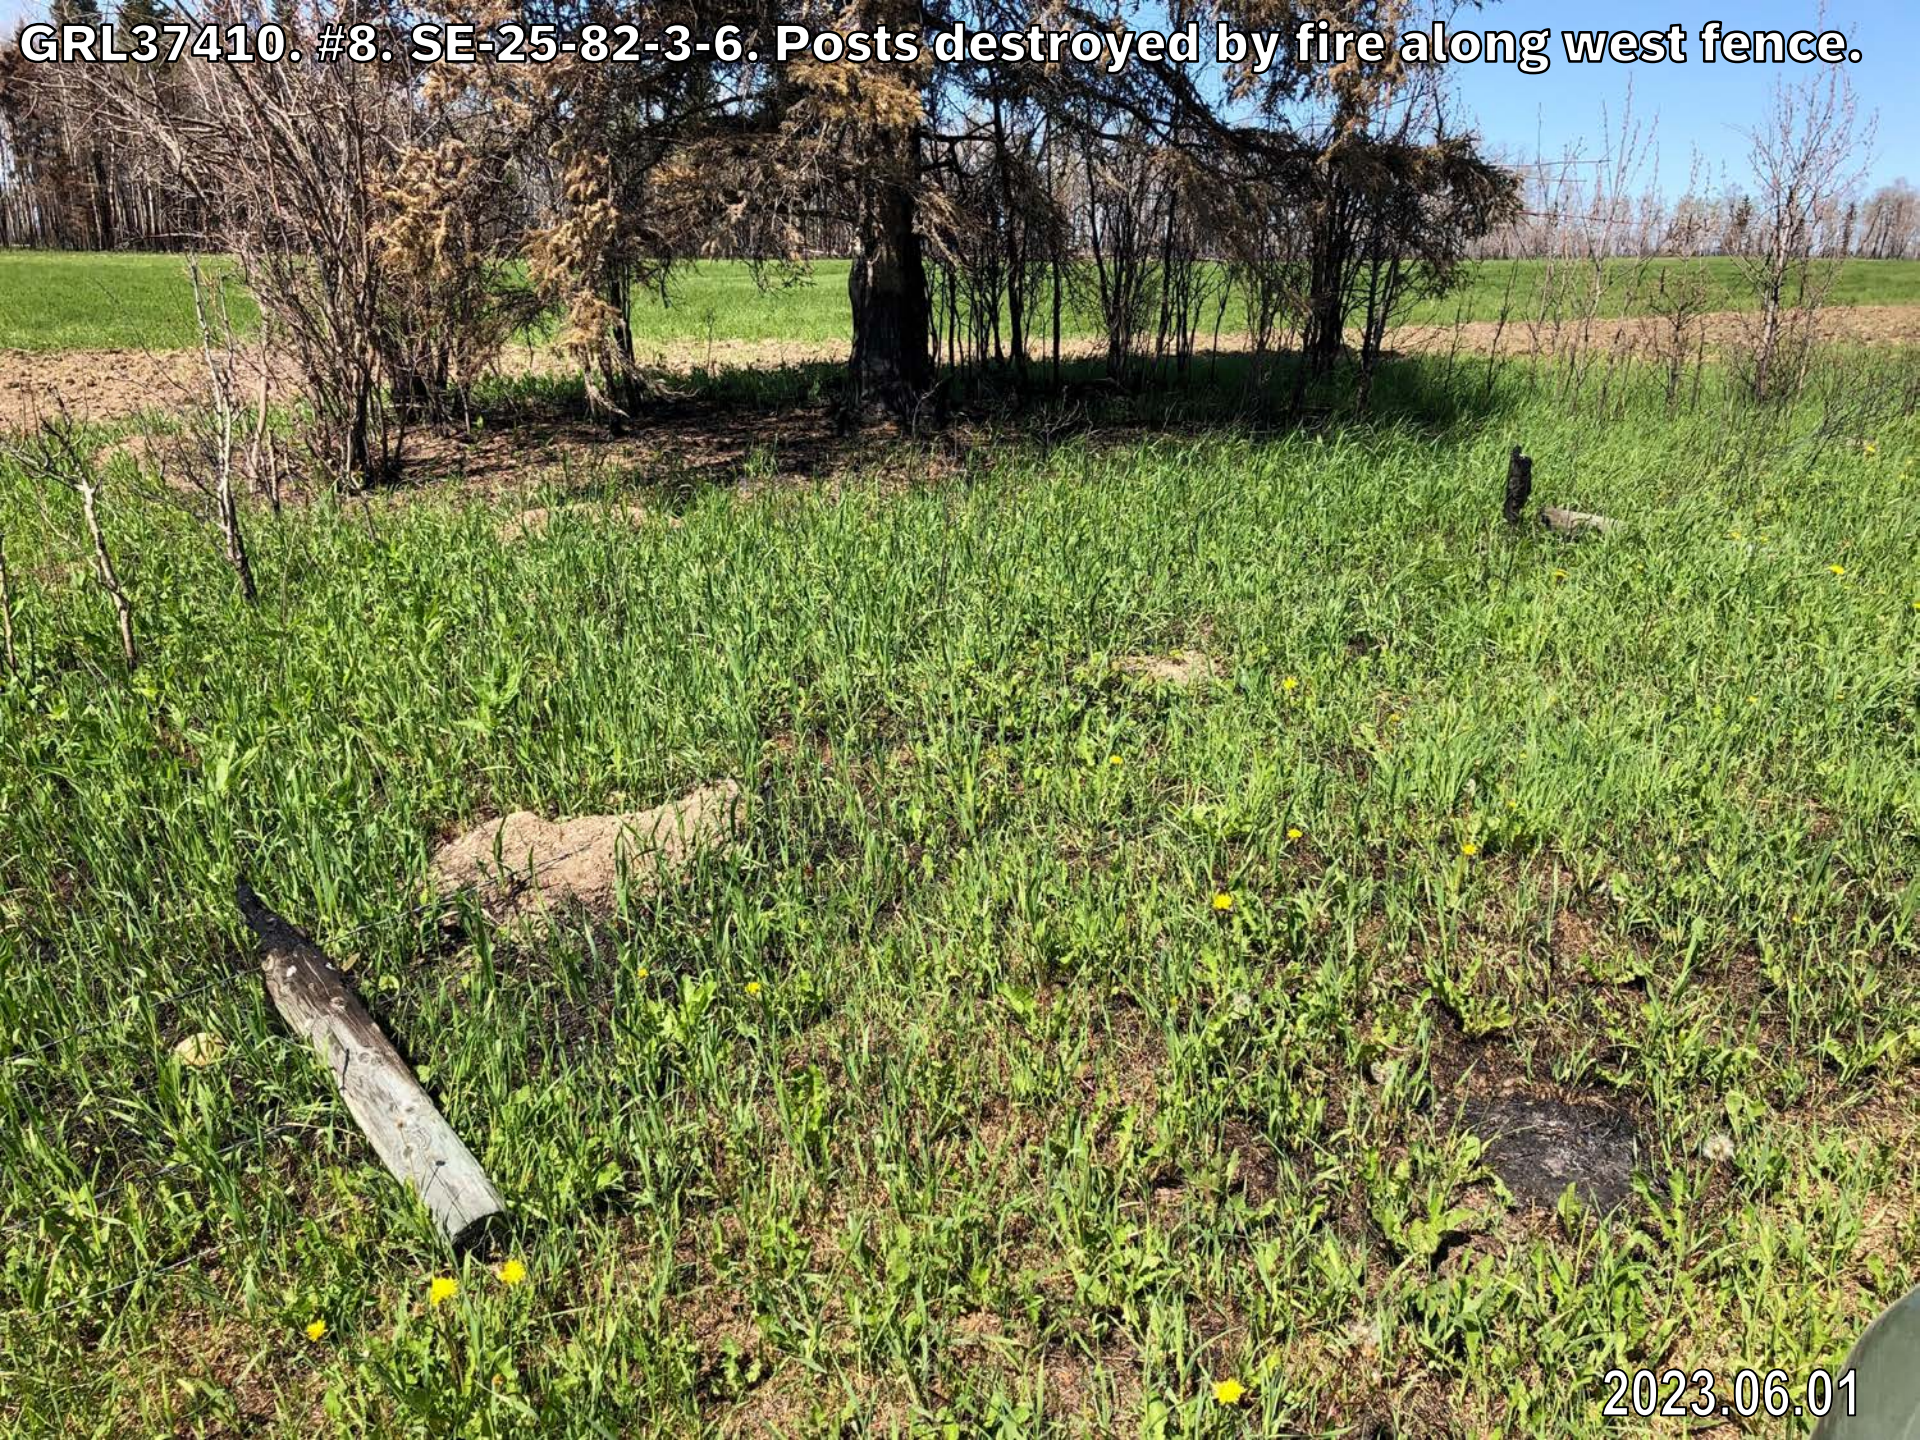
**GRL37410. #8. SE-25-82-3-6. Posts destroyed by fire along west fence.**

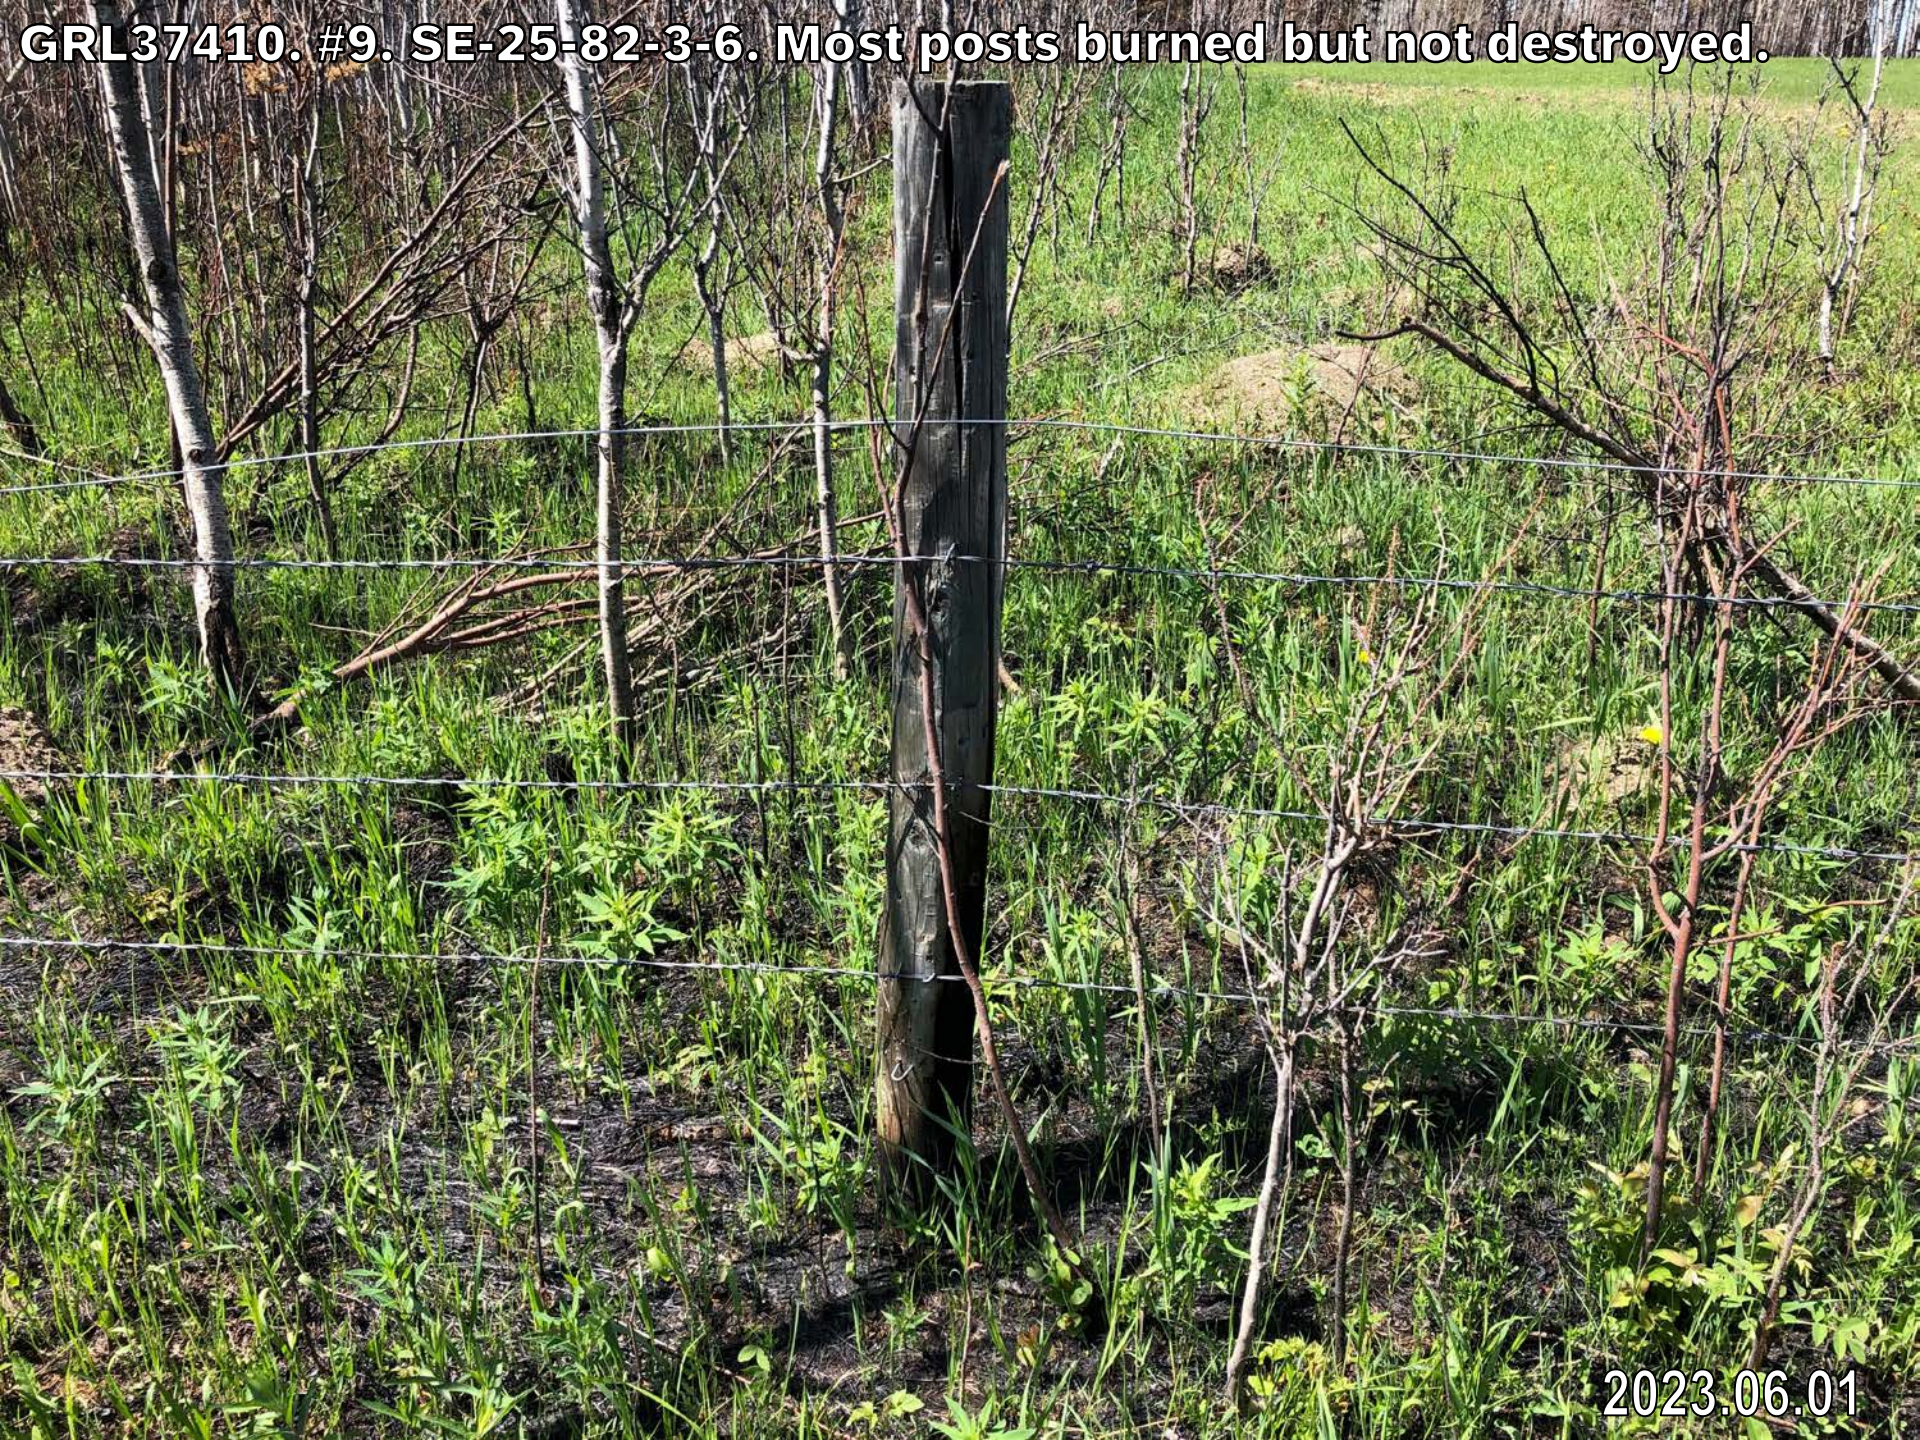
**GRL37410. #9. SE-25-82-3-6. Most posts burned but not destroyed.**
