GRL37410. #1. SE-30-82-2-6. Log fill crossing along access trail.

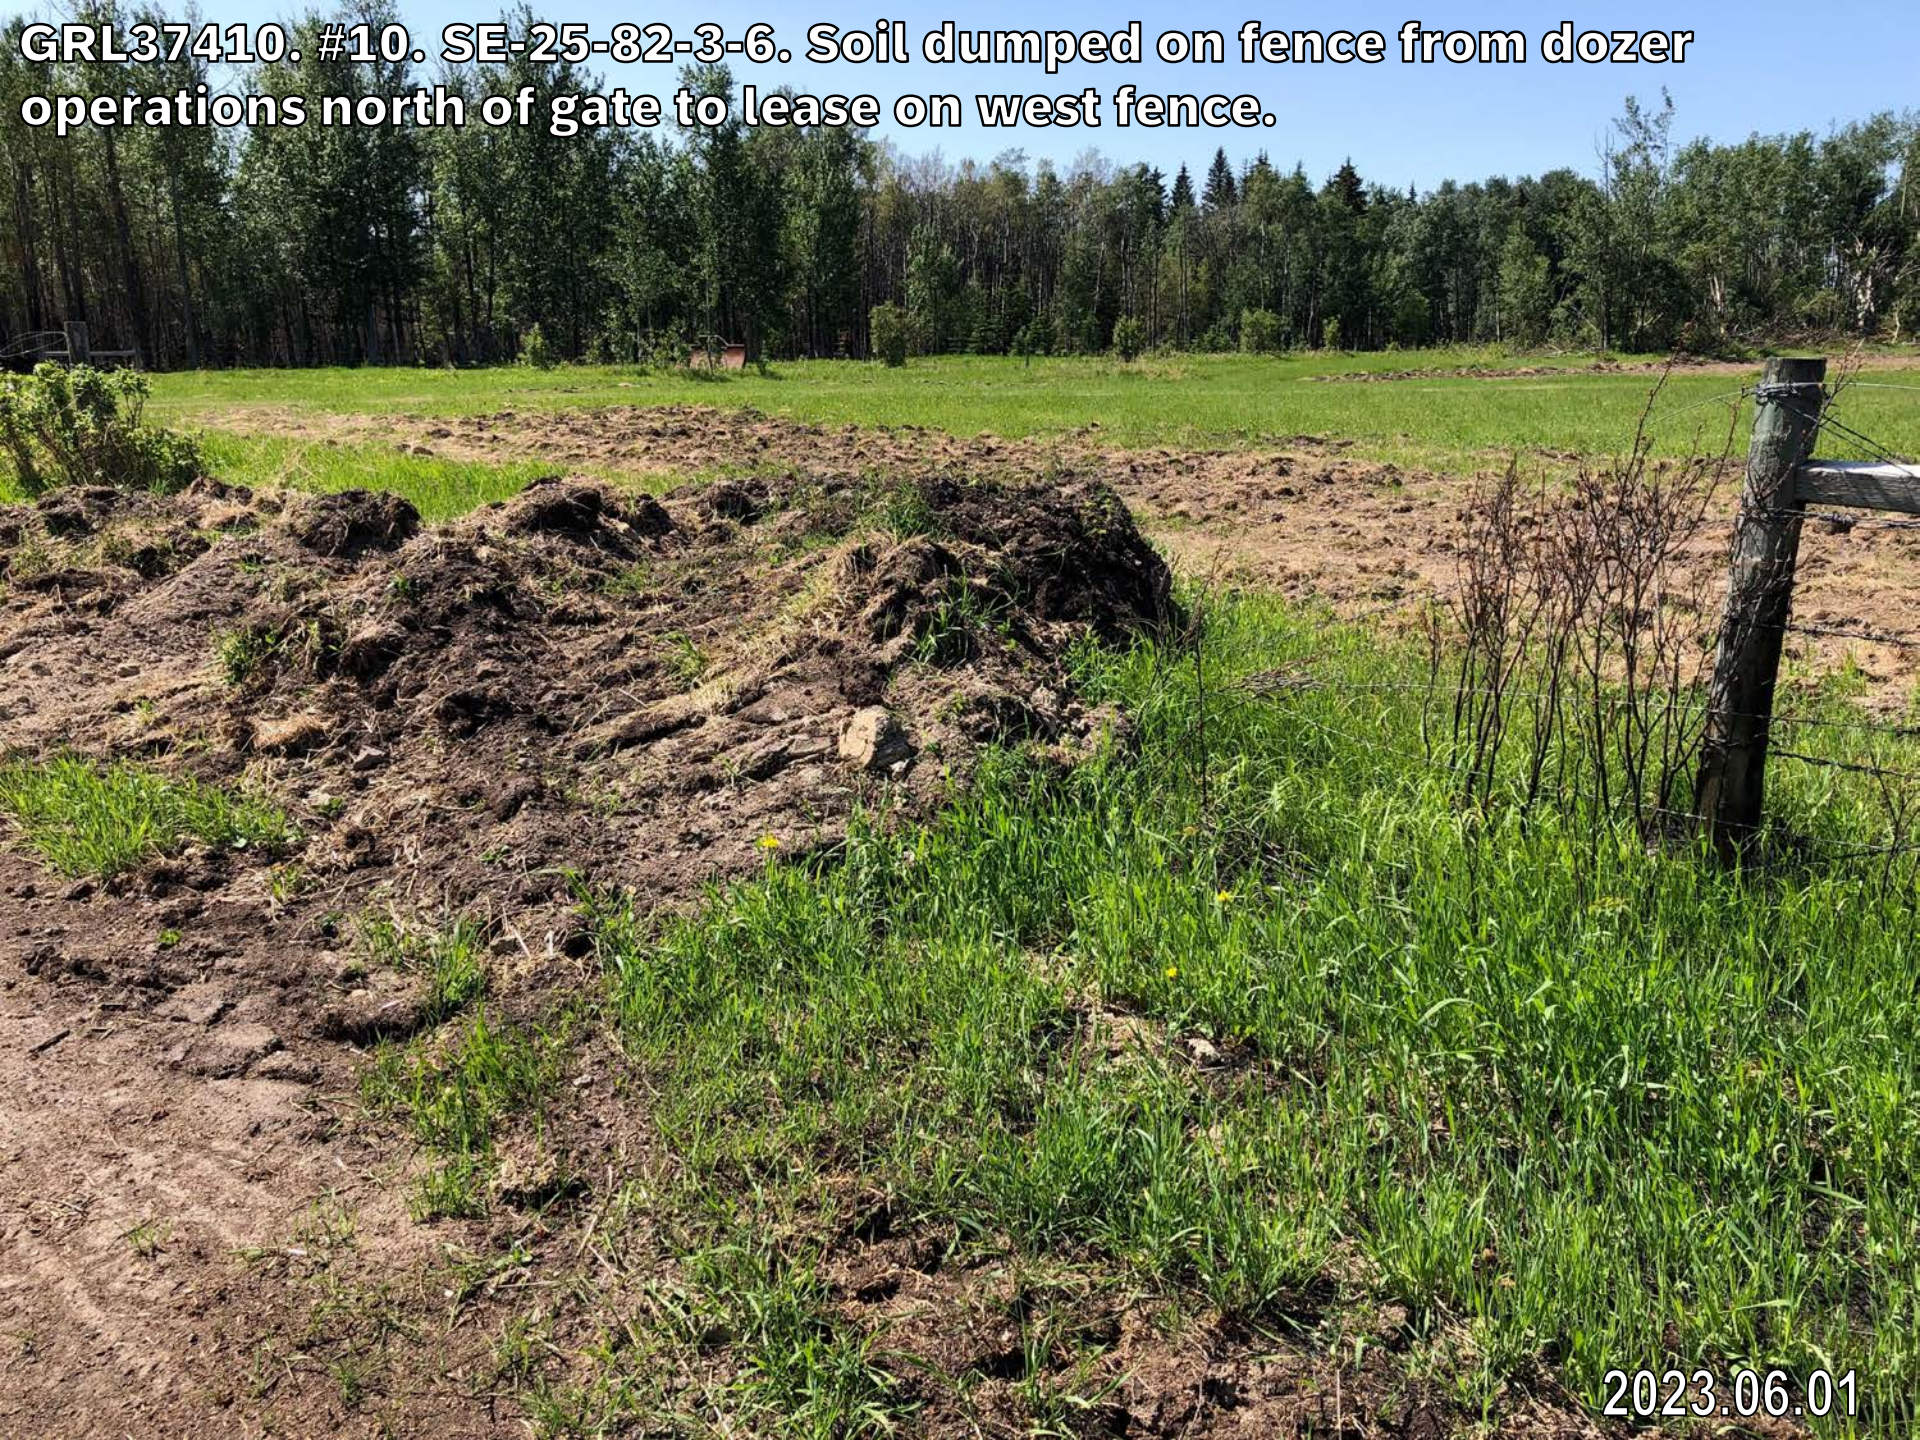
**GRL37410. #10. SE-25-82-3-6. Soil dumped on fence from dozer operations north of gate to lease on west fence.**

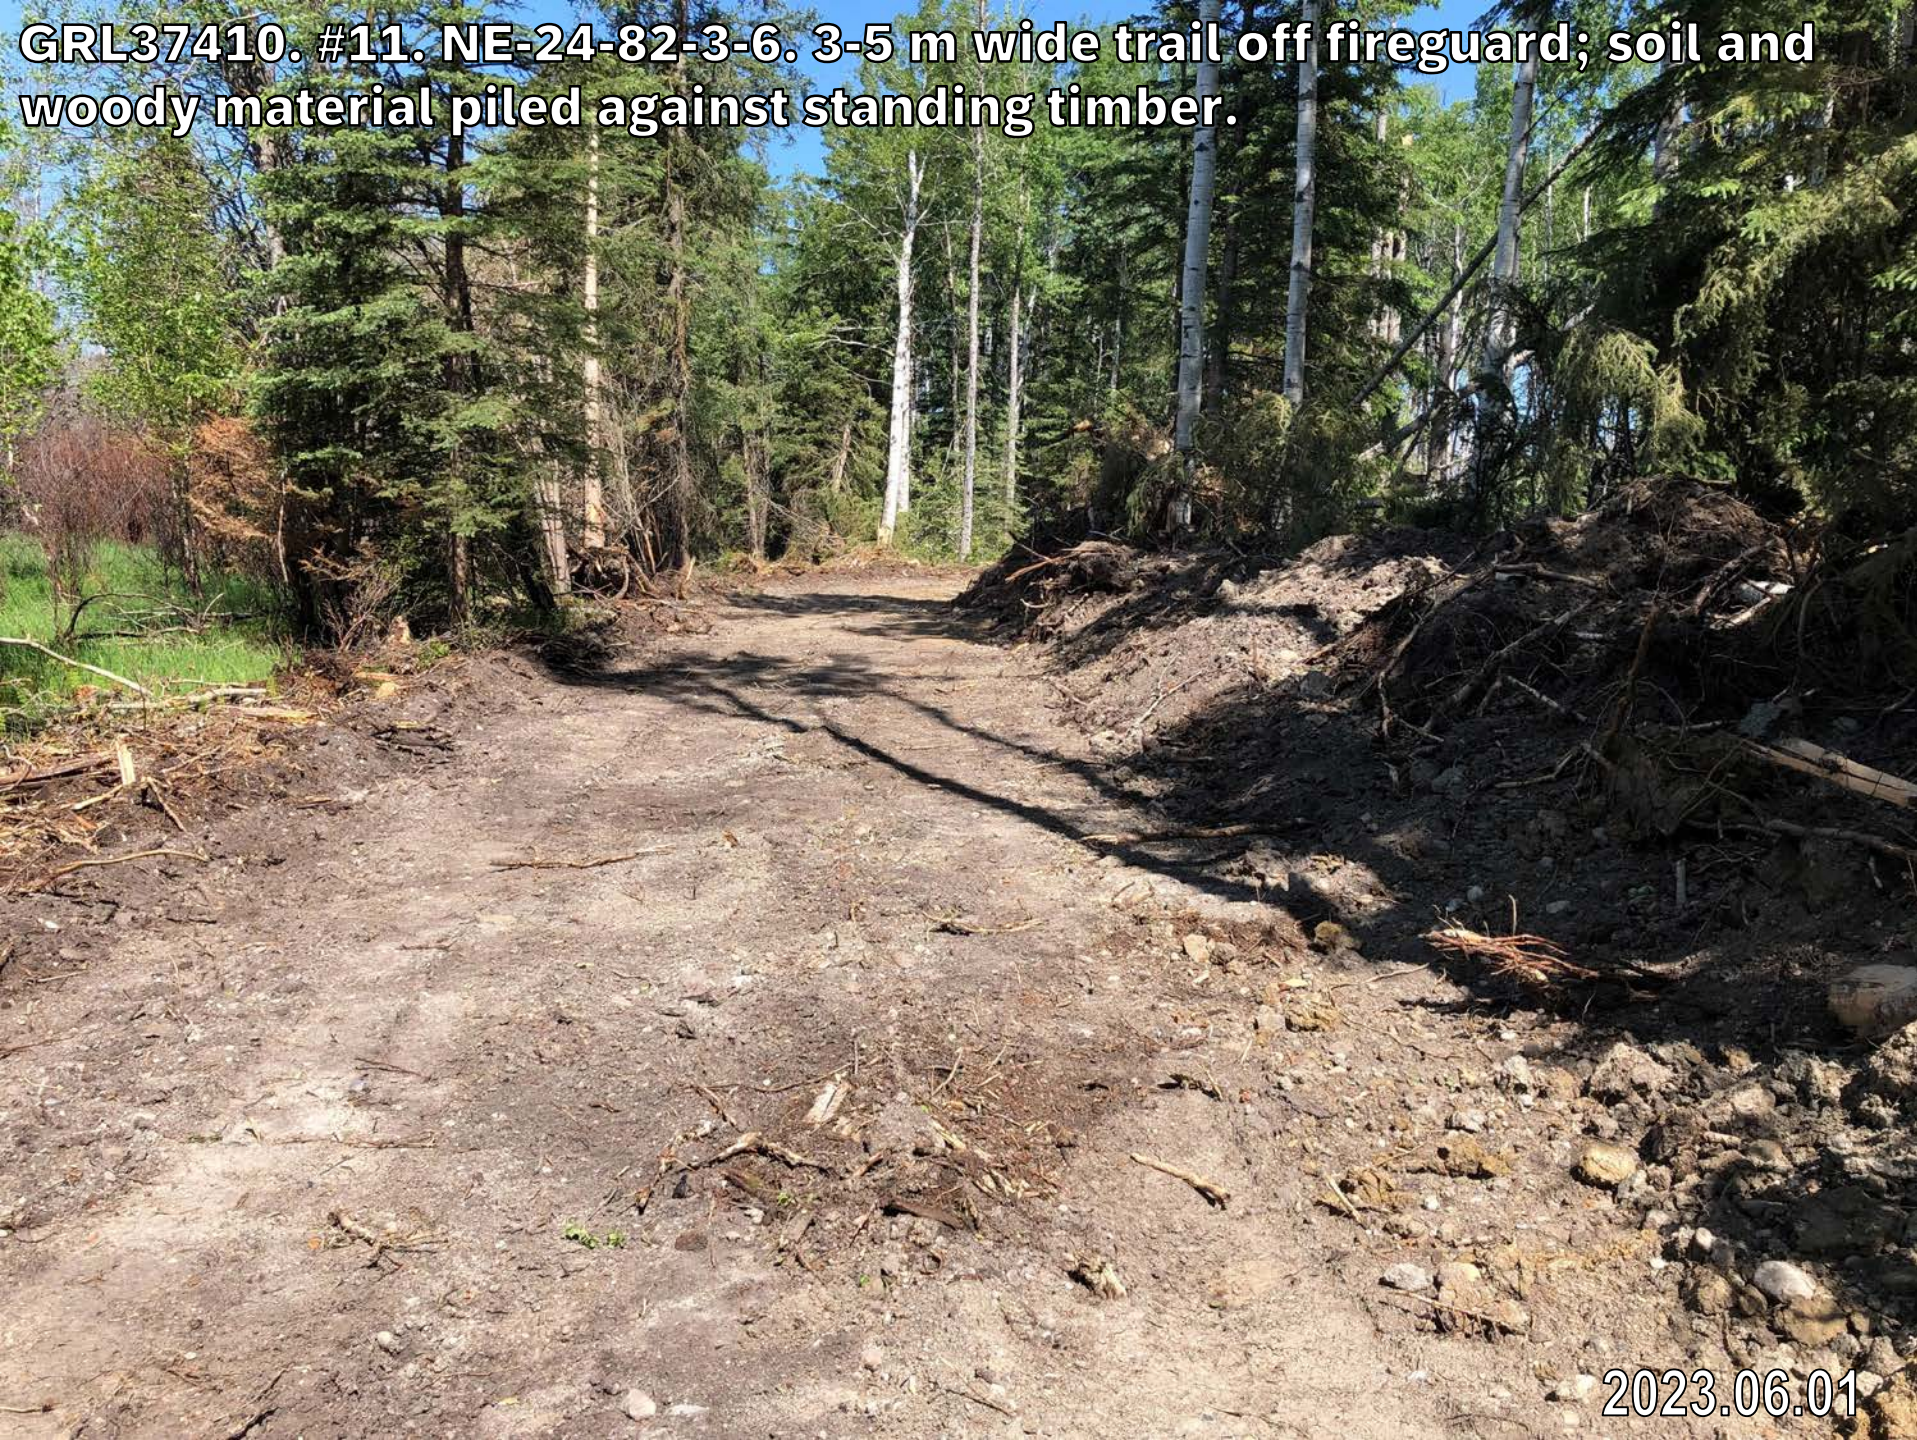
**GRL37410. #11. NE-24-82-3-6. 3-5 m wide trail off fireguard; soil and woody material piled against standing timber.**

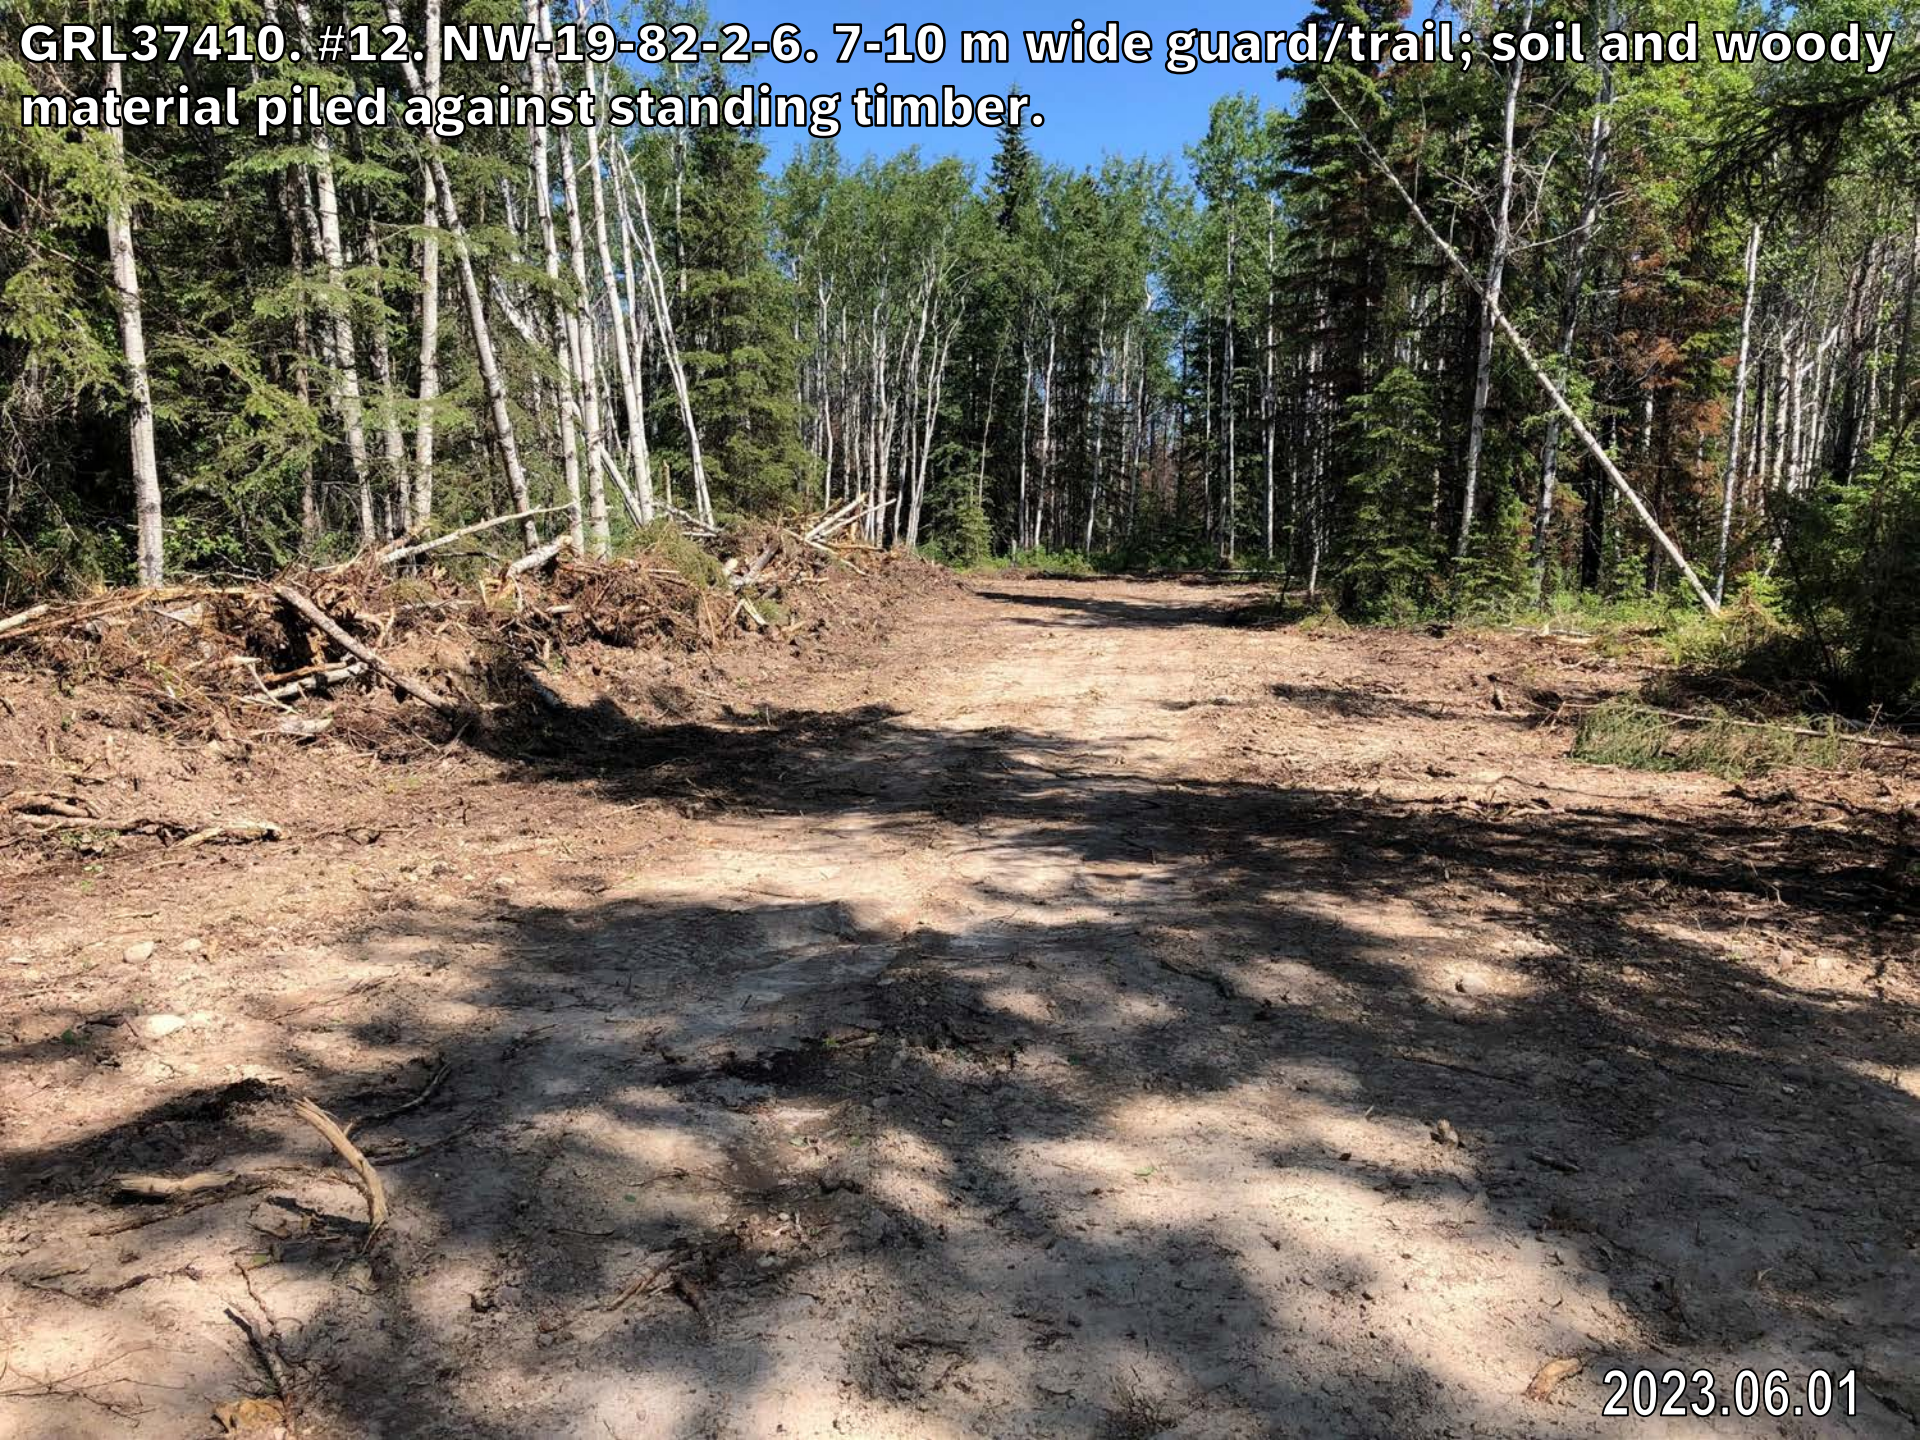
**GRL37410. #12. NW-19-82-2-6. 7-10 m wide guard/trail; soil and woody material piled against standing timber.**

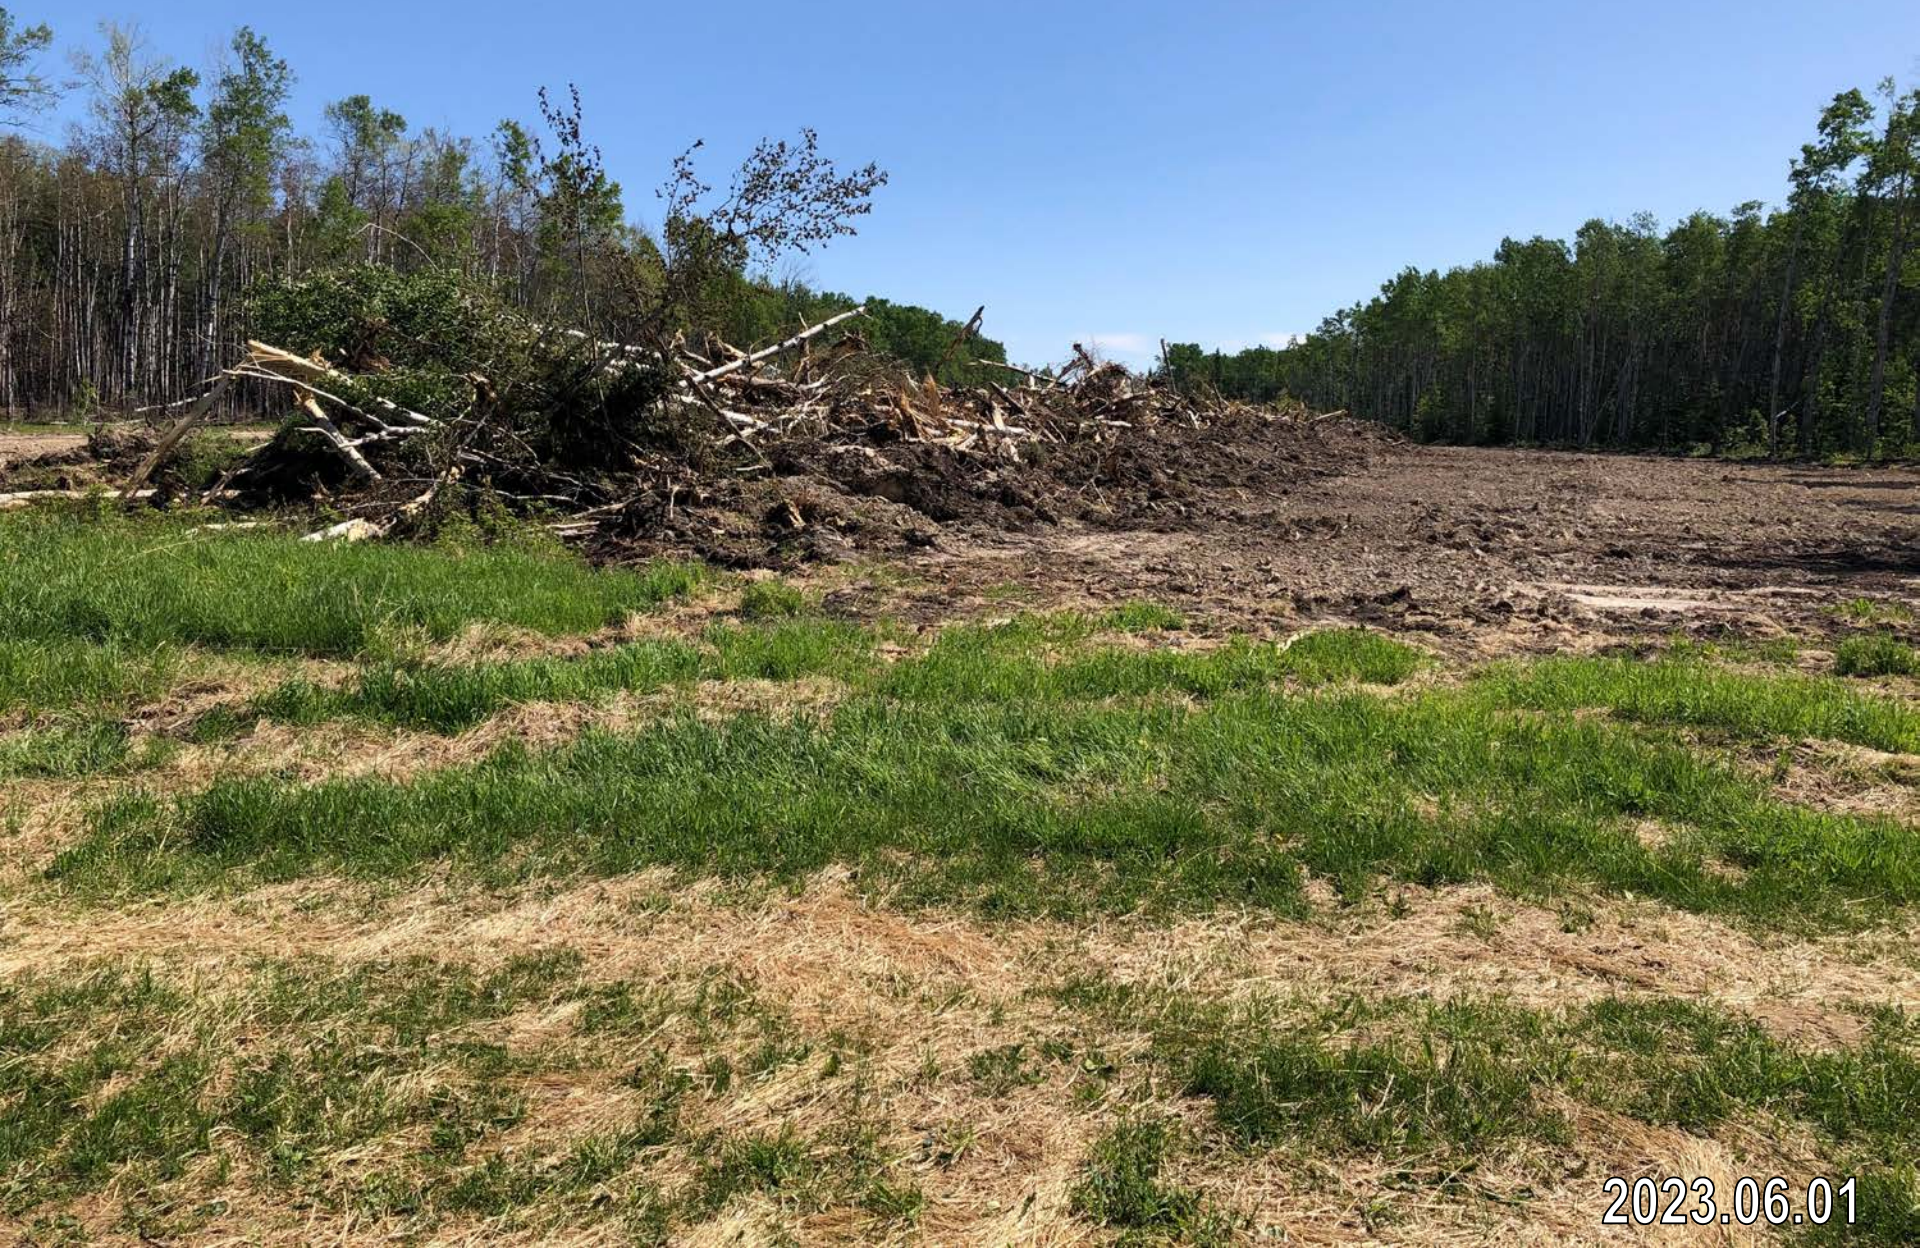
**GRL37410. #13. NE-24-82-3-6. Western terminus of 35-60 m wide fireguard; soil and woody material piled in middle of line.**

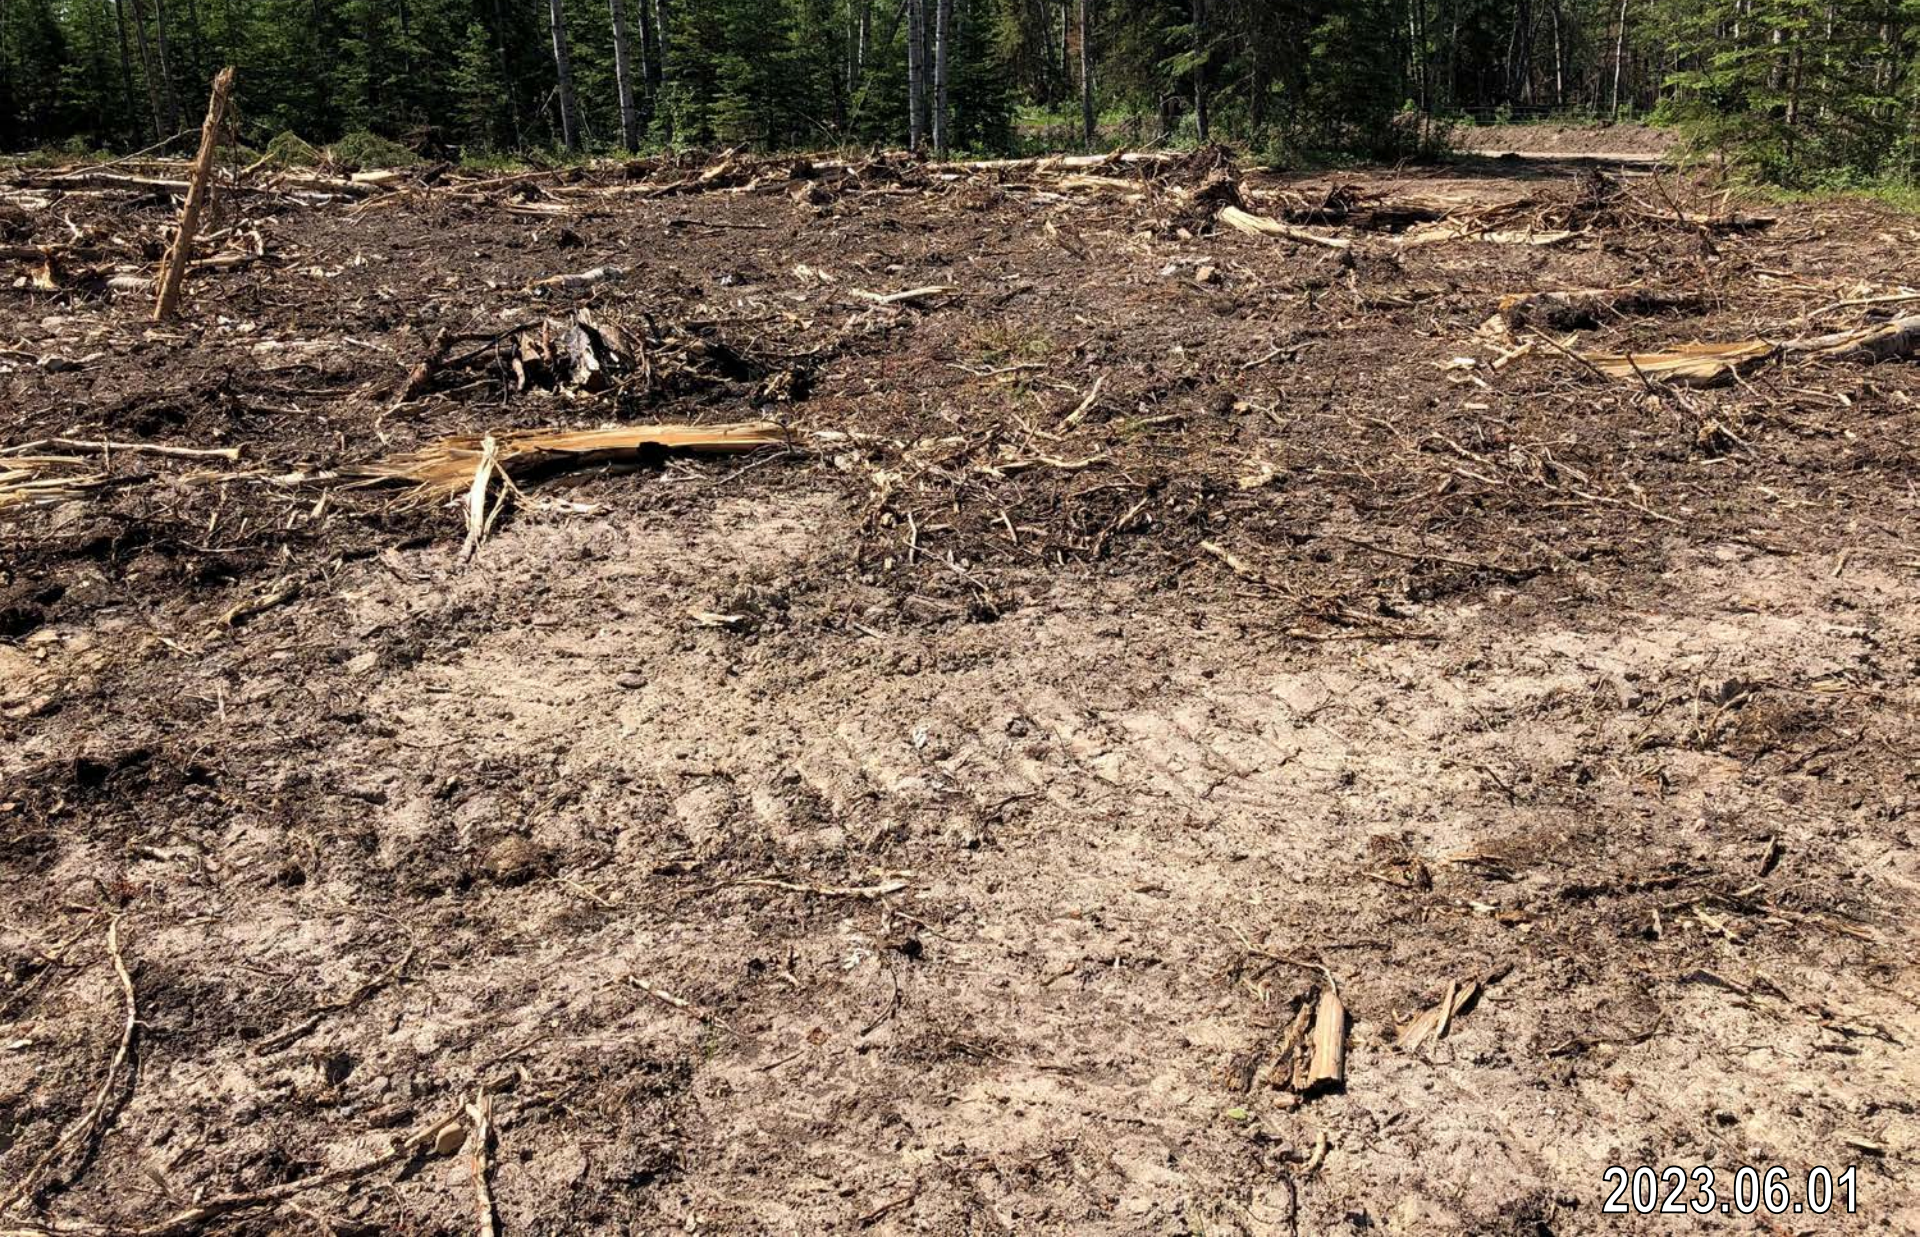
**GRL37410. #14. NE-24-82-3-6. Two small clearings (not more than a few acres) on west fenceline. A few areas on bare mineral soil; but most woody material and topsoil spread over area.**

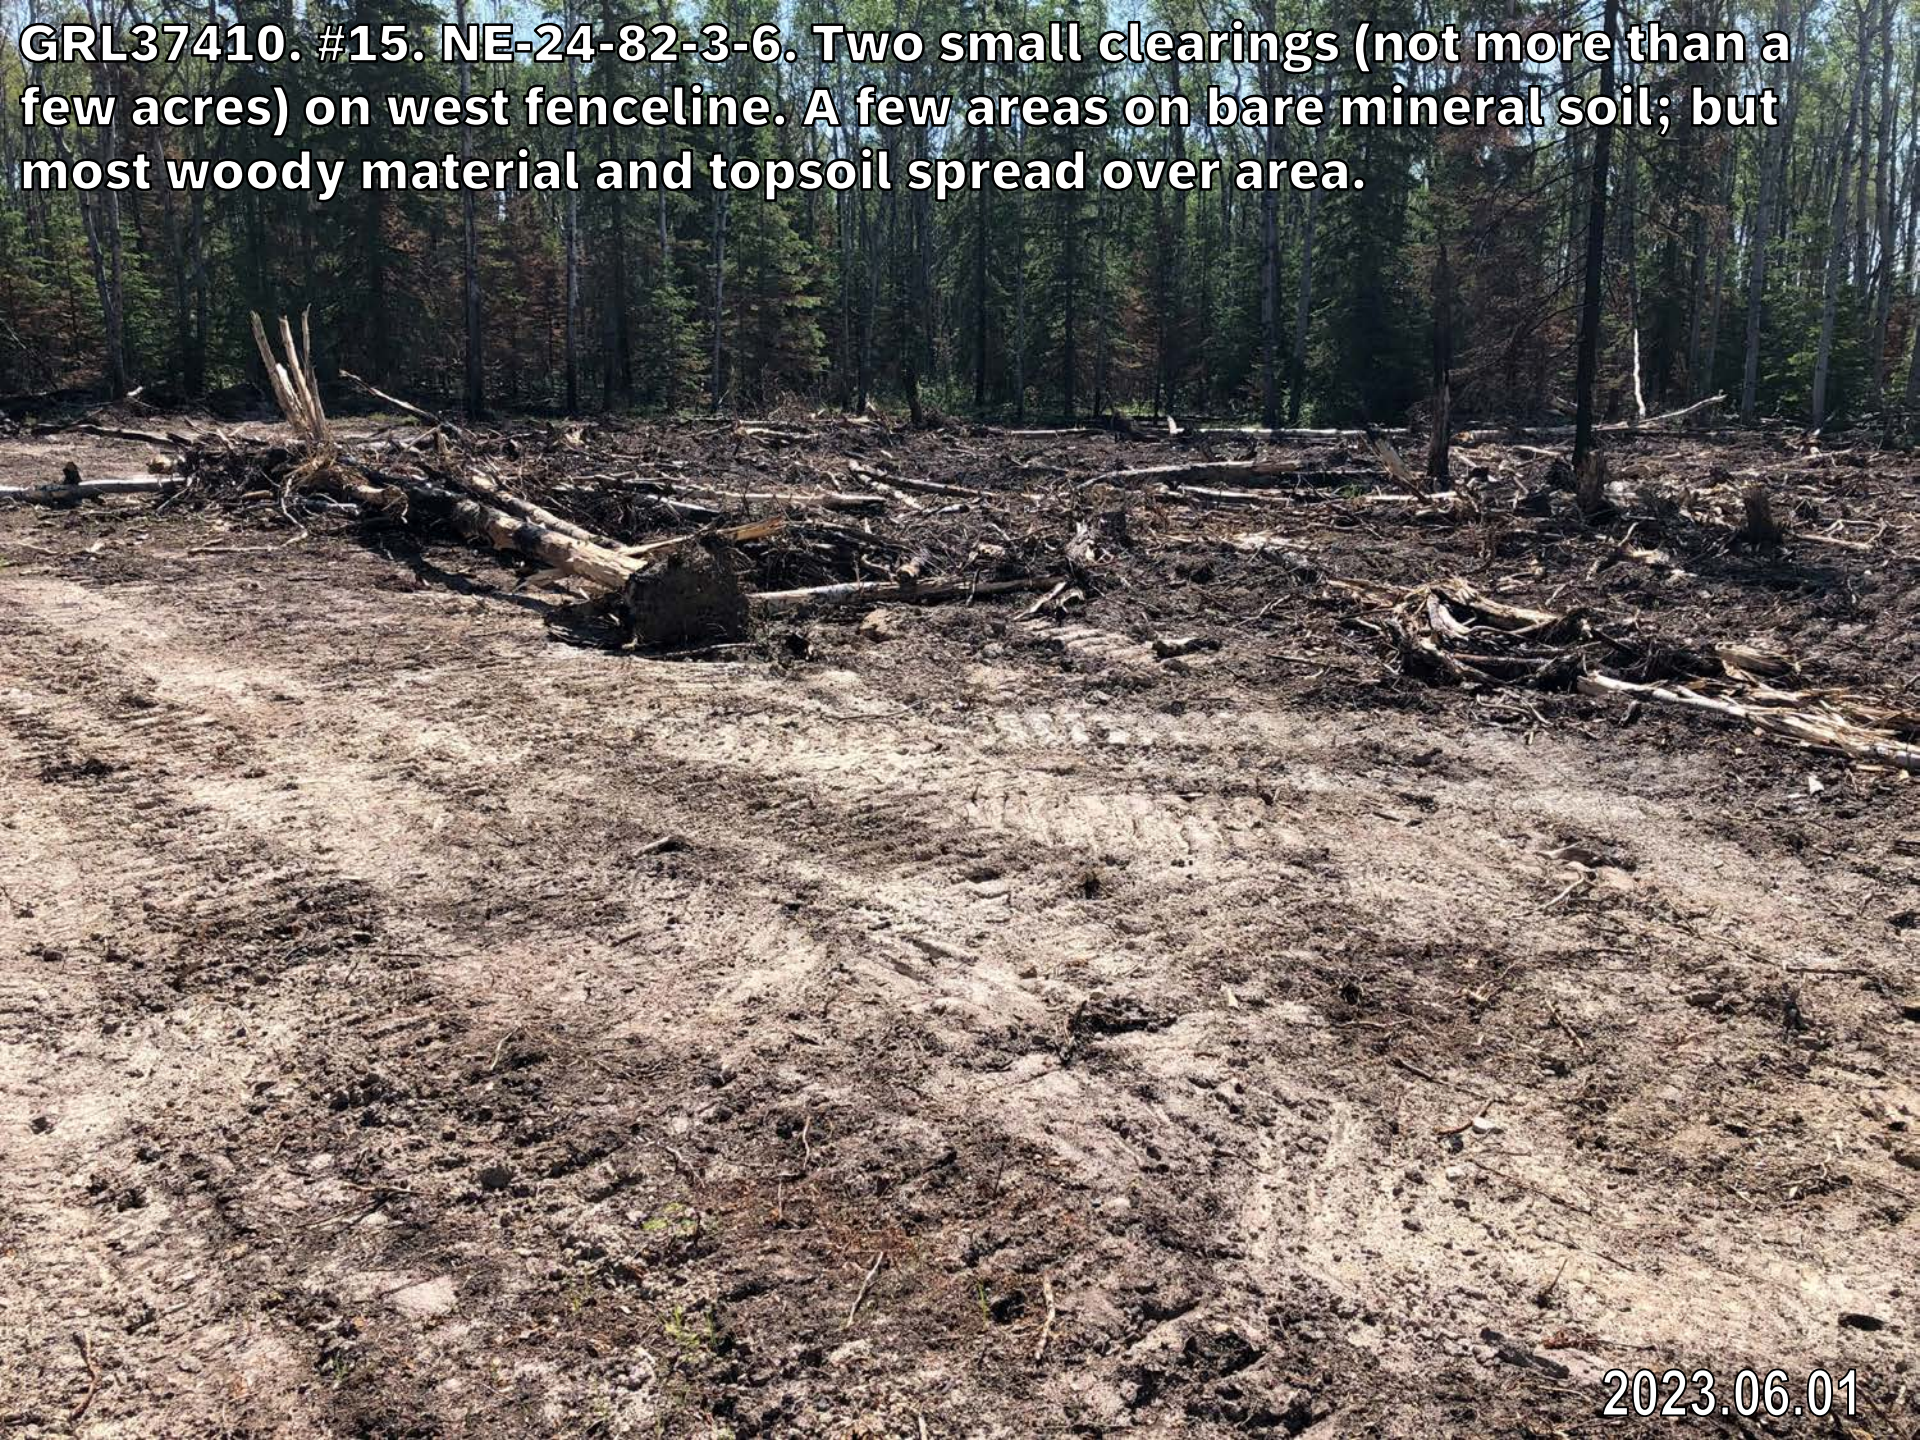
**GRL37410. #15. NE-24-82-3-6. Two small clearings (not more than a few acres) on west fenceline. A few areas on bare mineral soil; but most woody material and topsoil spread over area.**

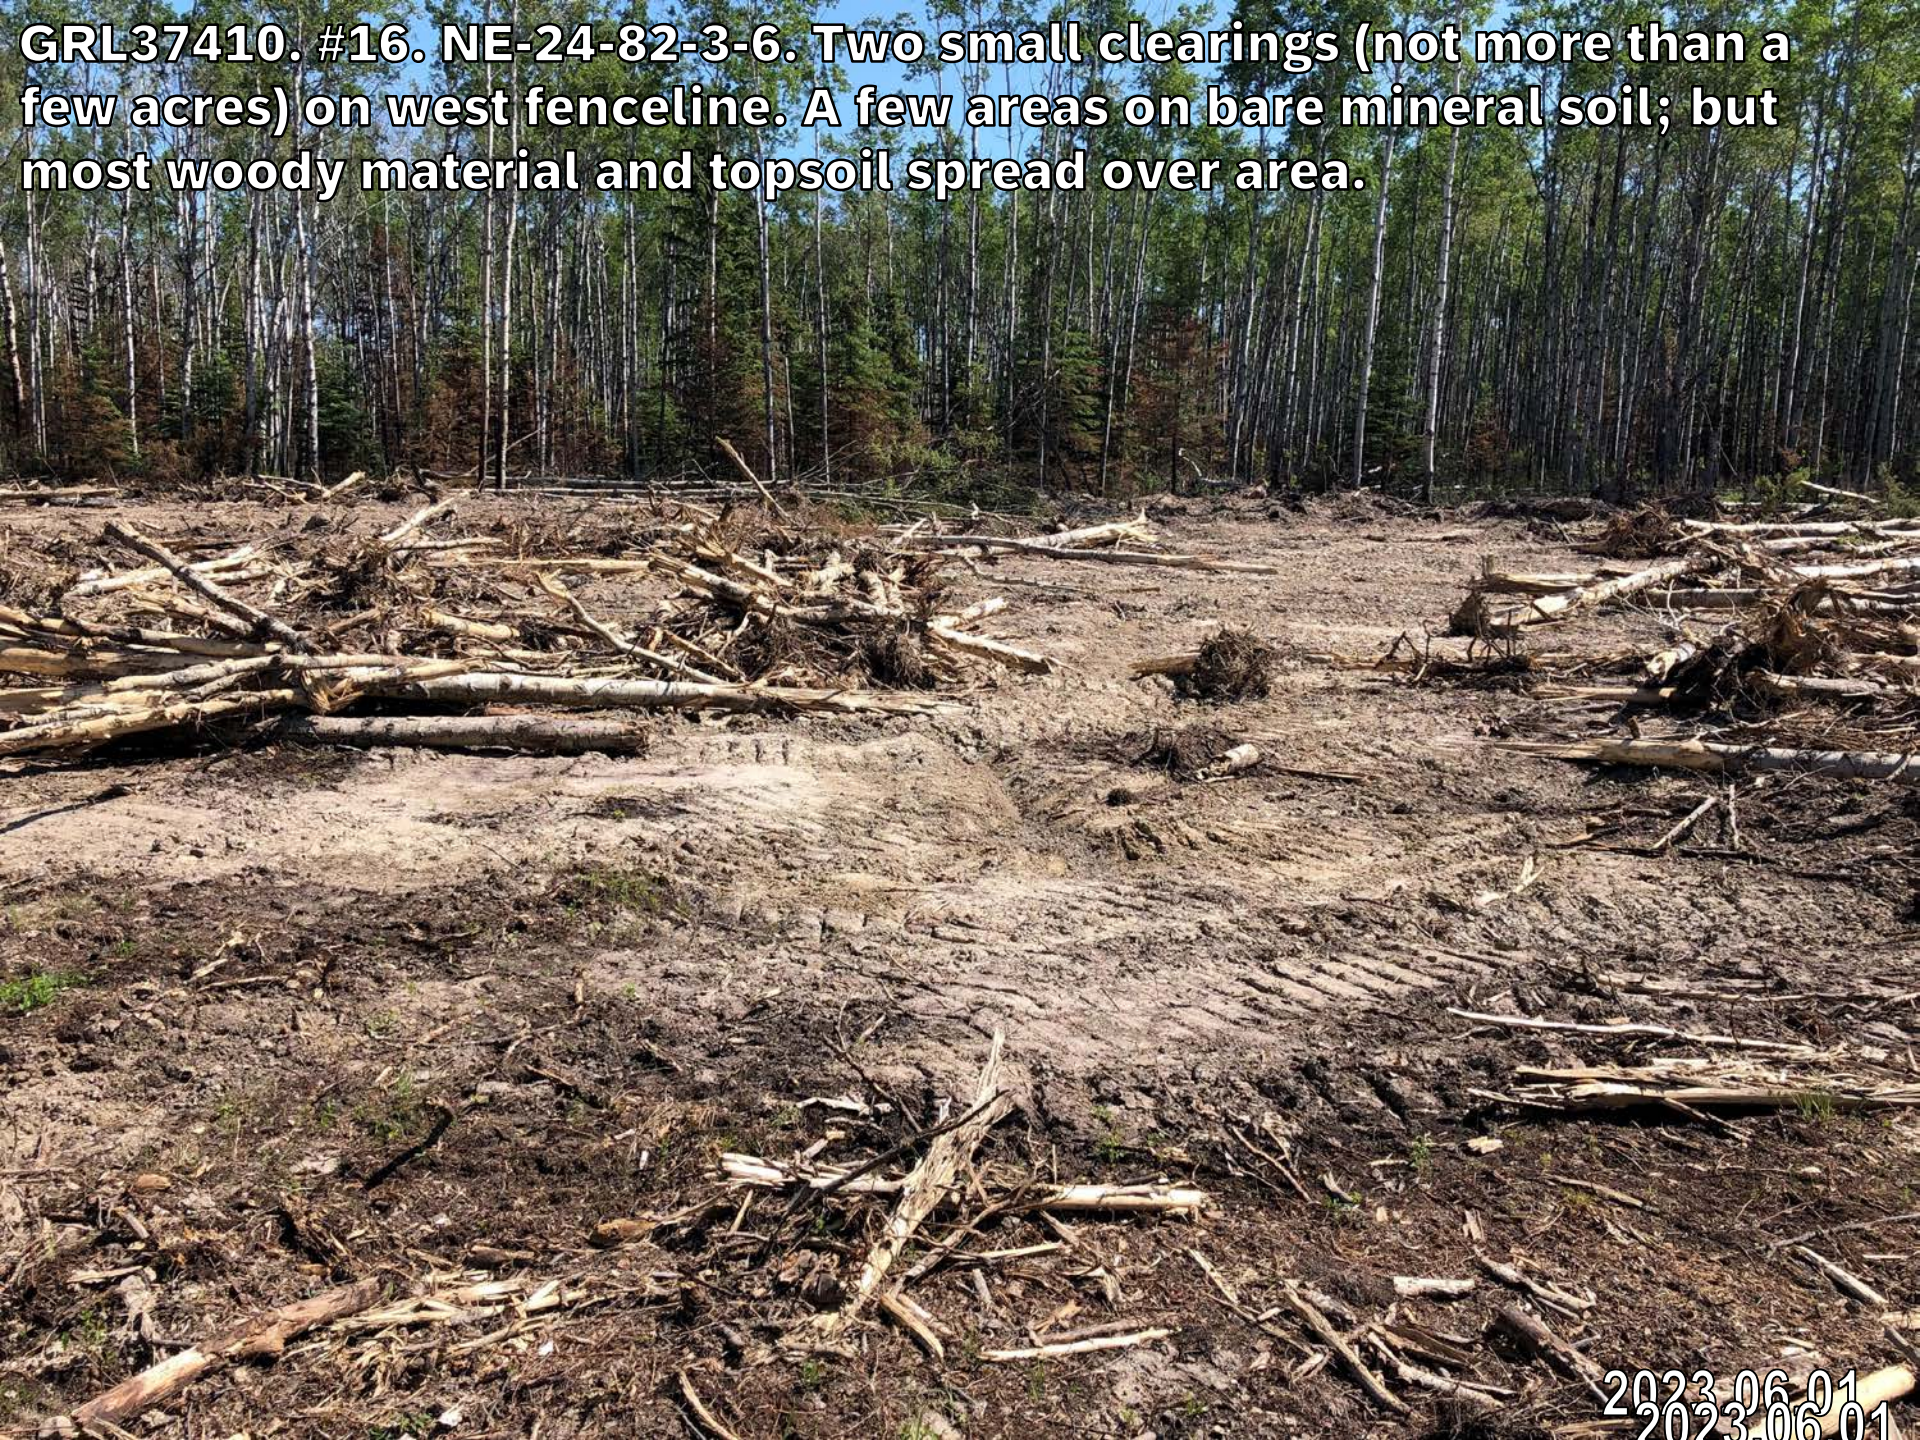
**GRL37410. #16. NE-24-82-3-6. Two small clearings (not more than a few acres) on west fenceline. A few areas on bare mineral soil; but most woody material and topsoil spread over area.**

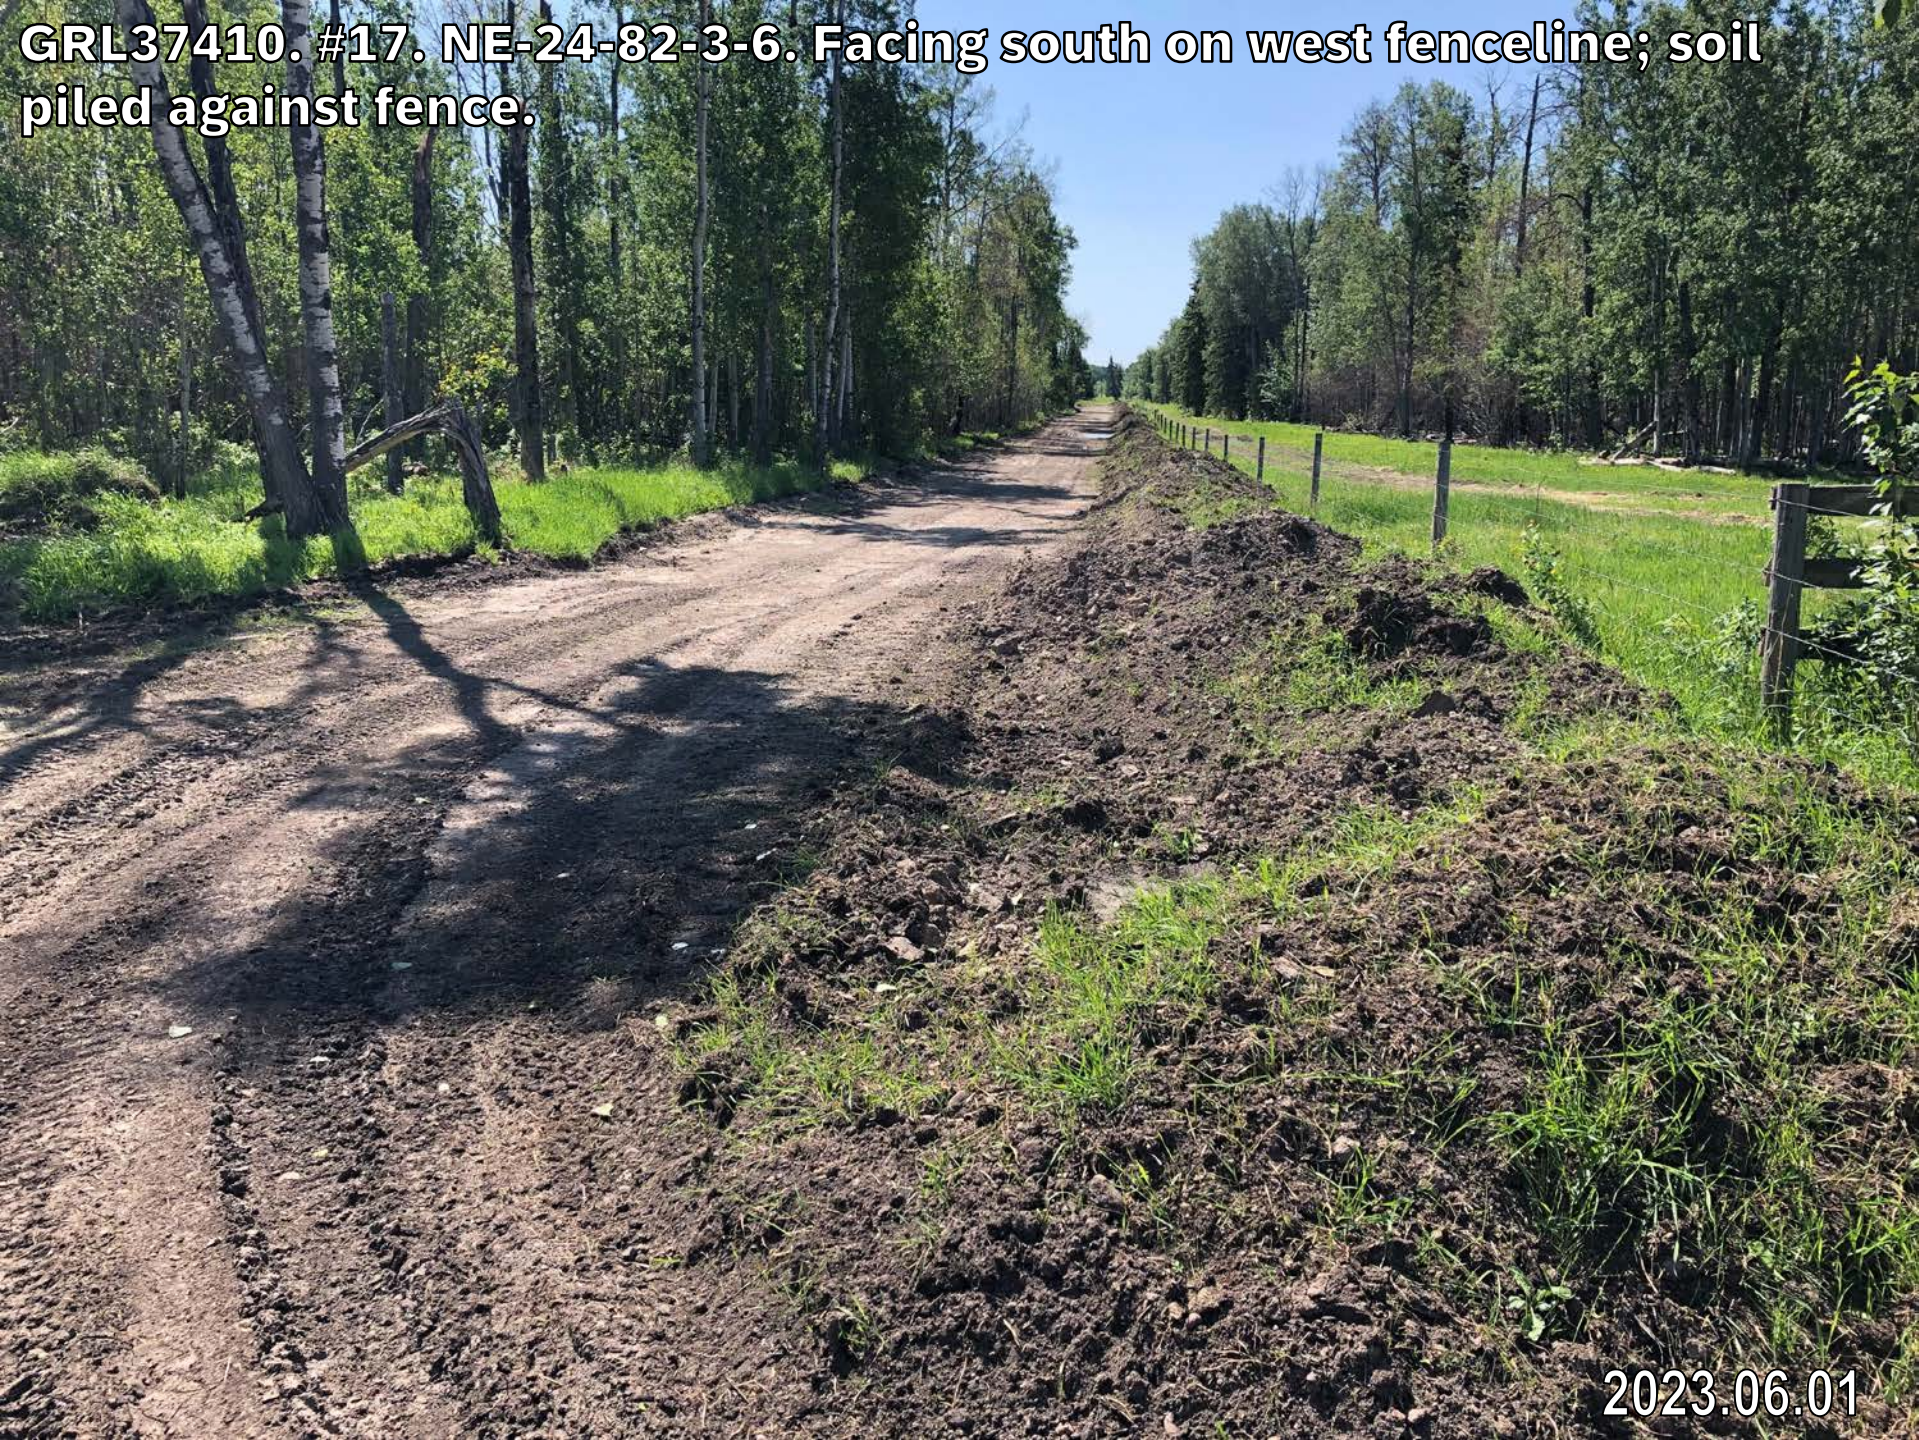
GRL37410. #17. NE-24-82-3-6. Facing south on west fenceline; soil piled against fence.
