GRL37410. #1. SE-30-82-2-6. Log fill crossing along access trail.

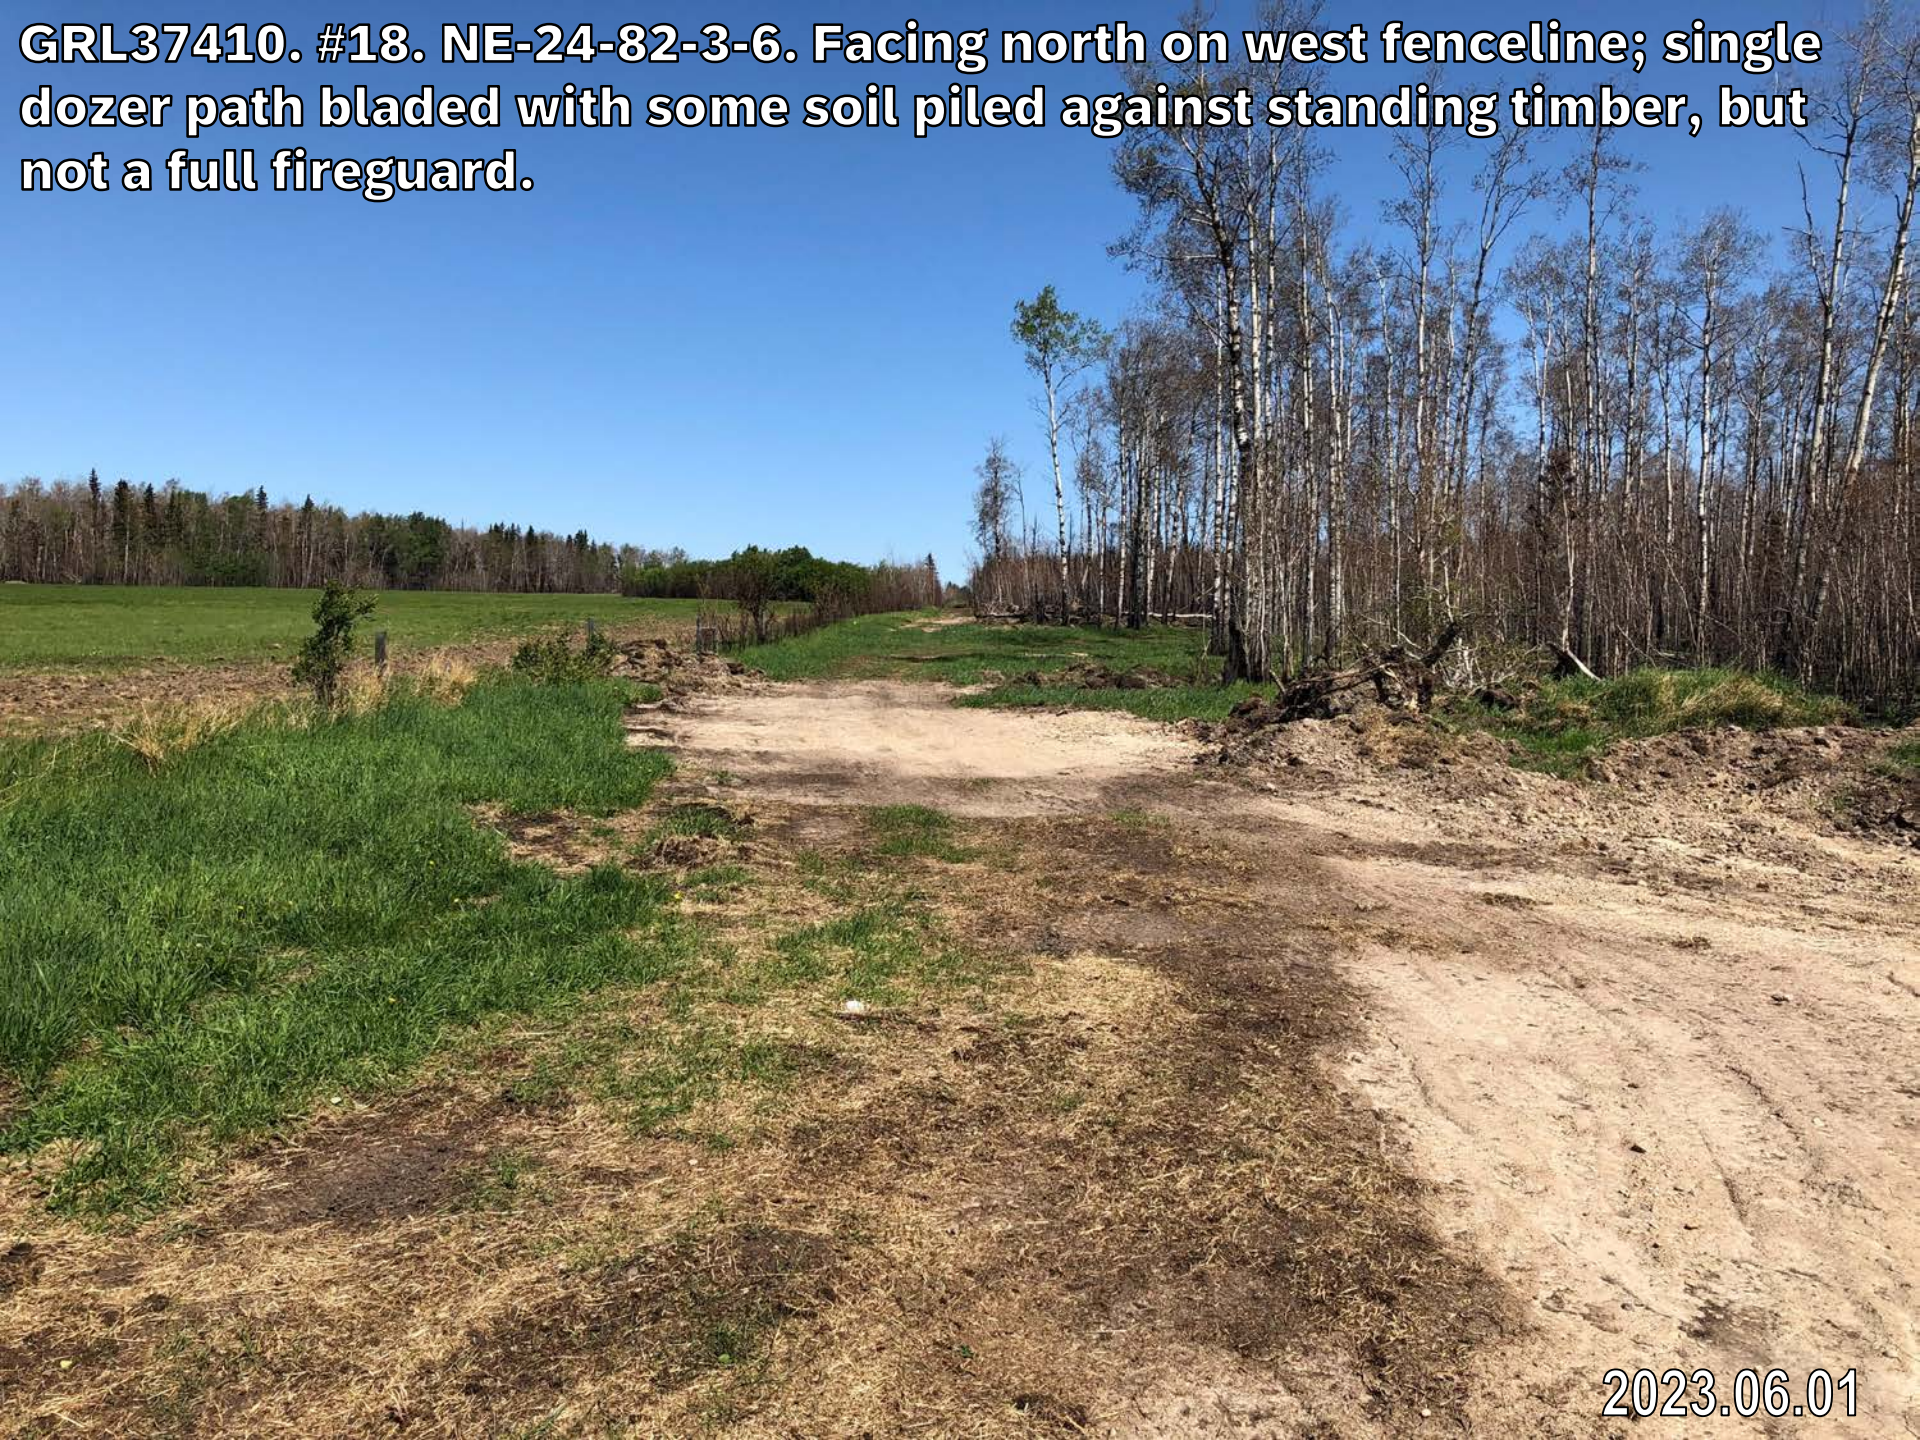
**GRL37410. #18. NE-24-82-3-6. Facing north on west fenceline; single dozer path bladed with some soil piled against standing timber, but not a full fireguard.**

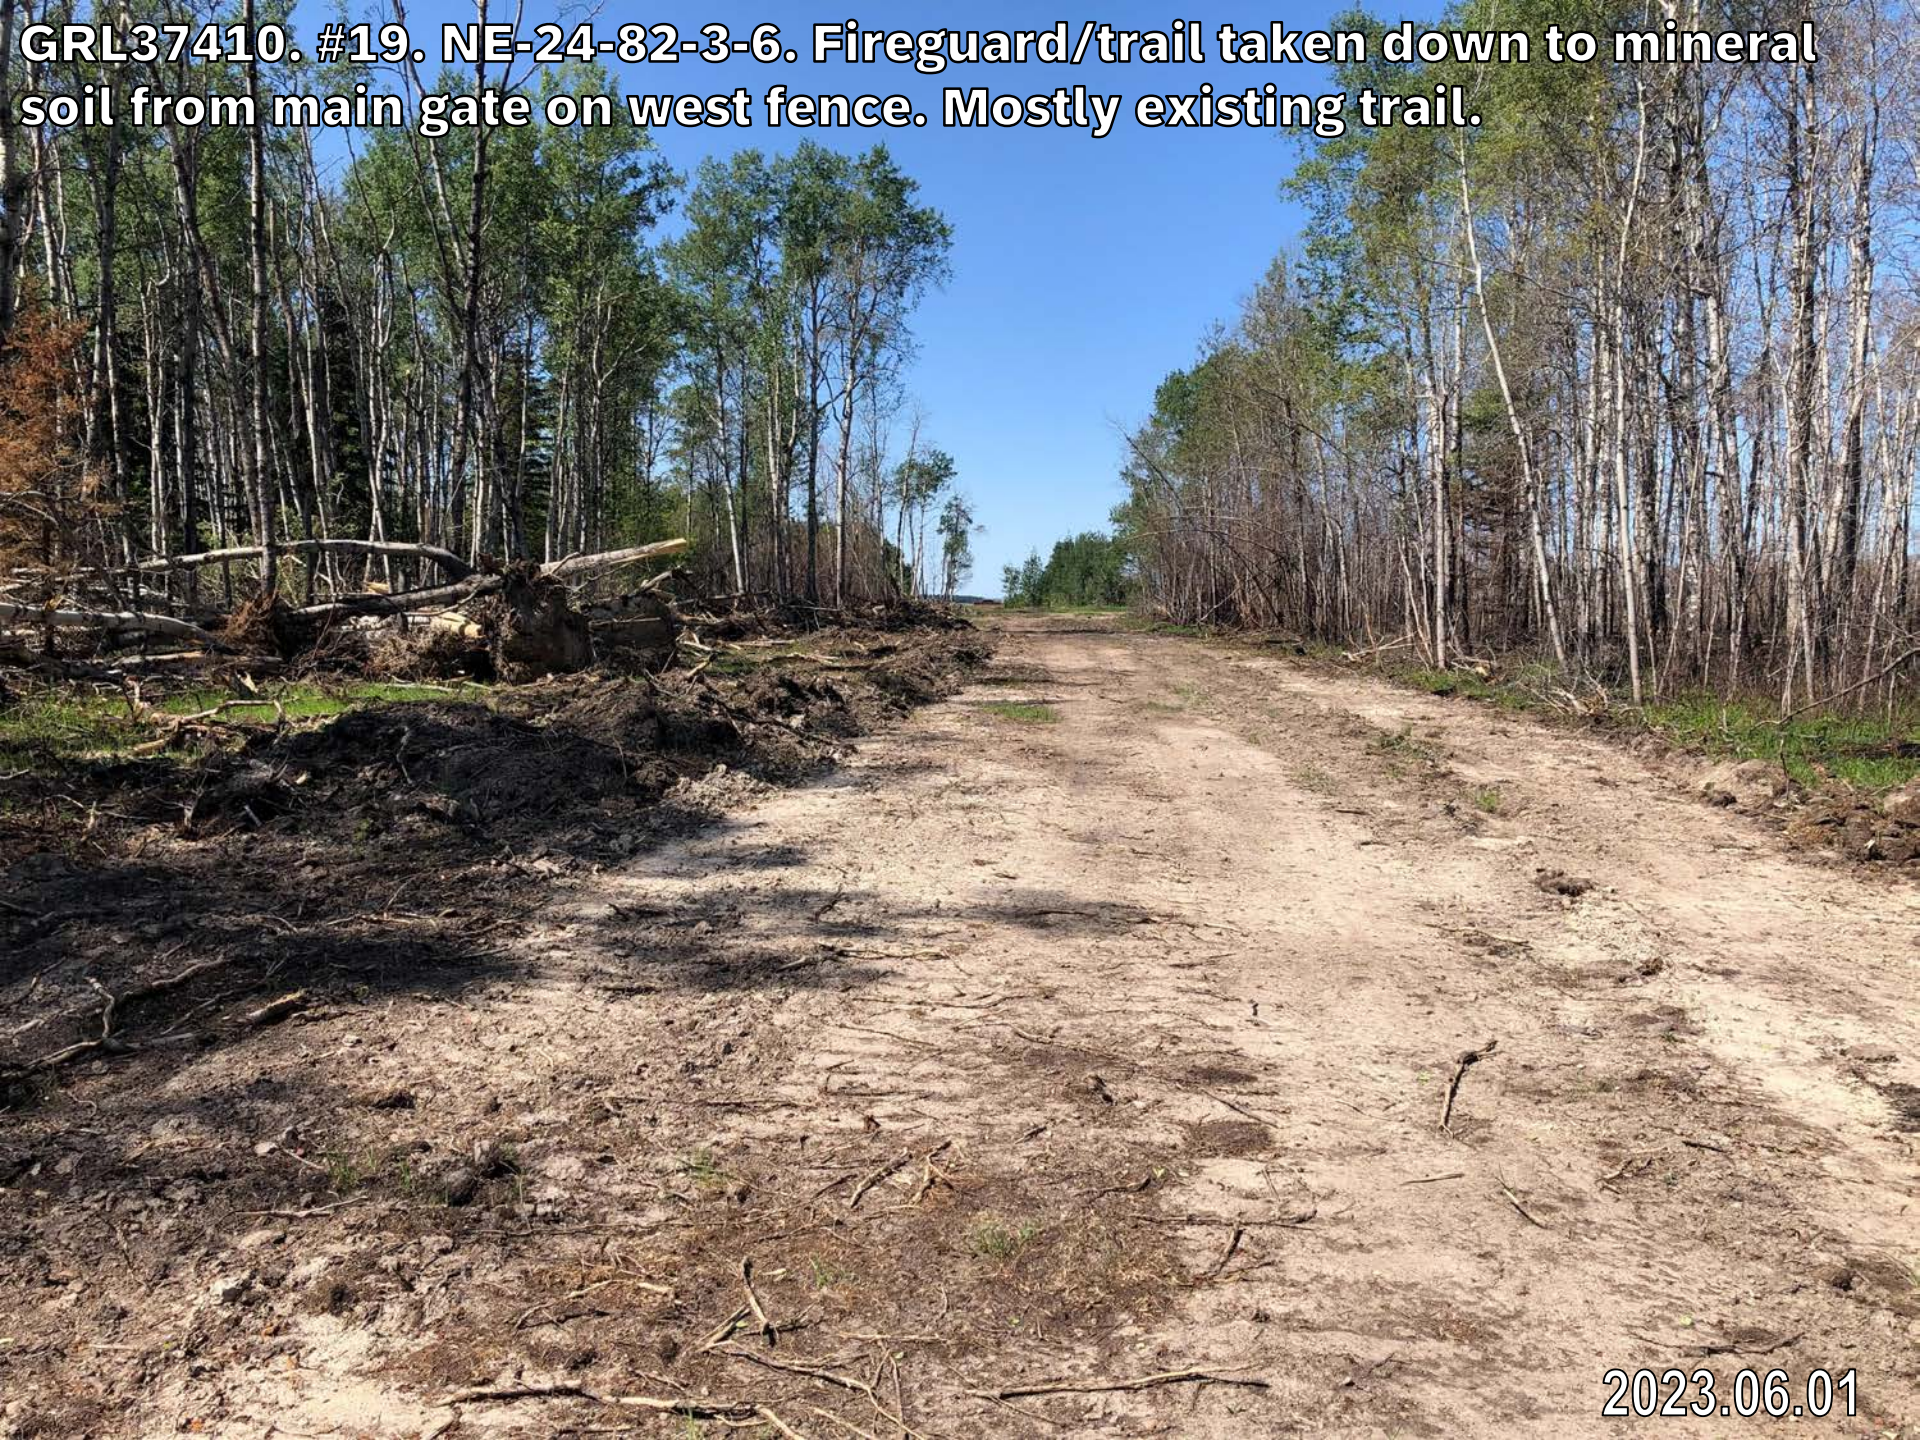
**GRL37410. #19. NE-24-82-3-6. Fireguard/trail taken down to mineral soil from main gate on west fence. Mostly existing trail.**

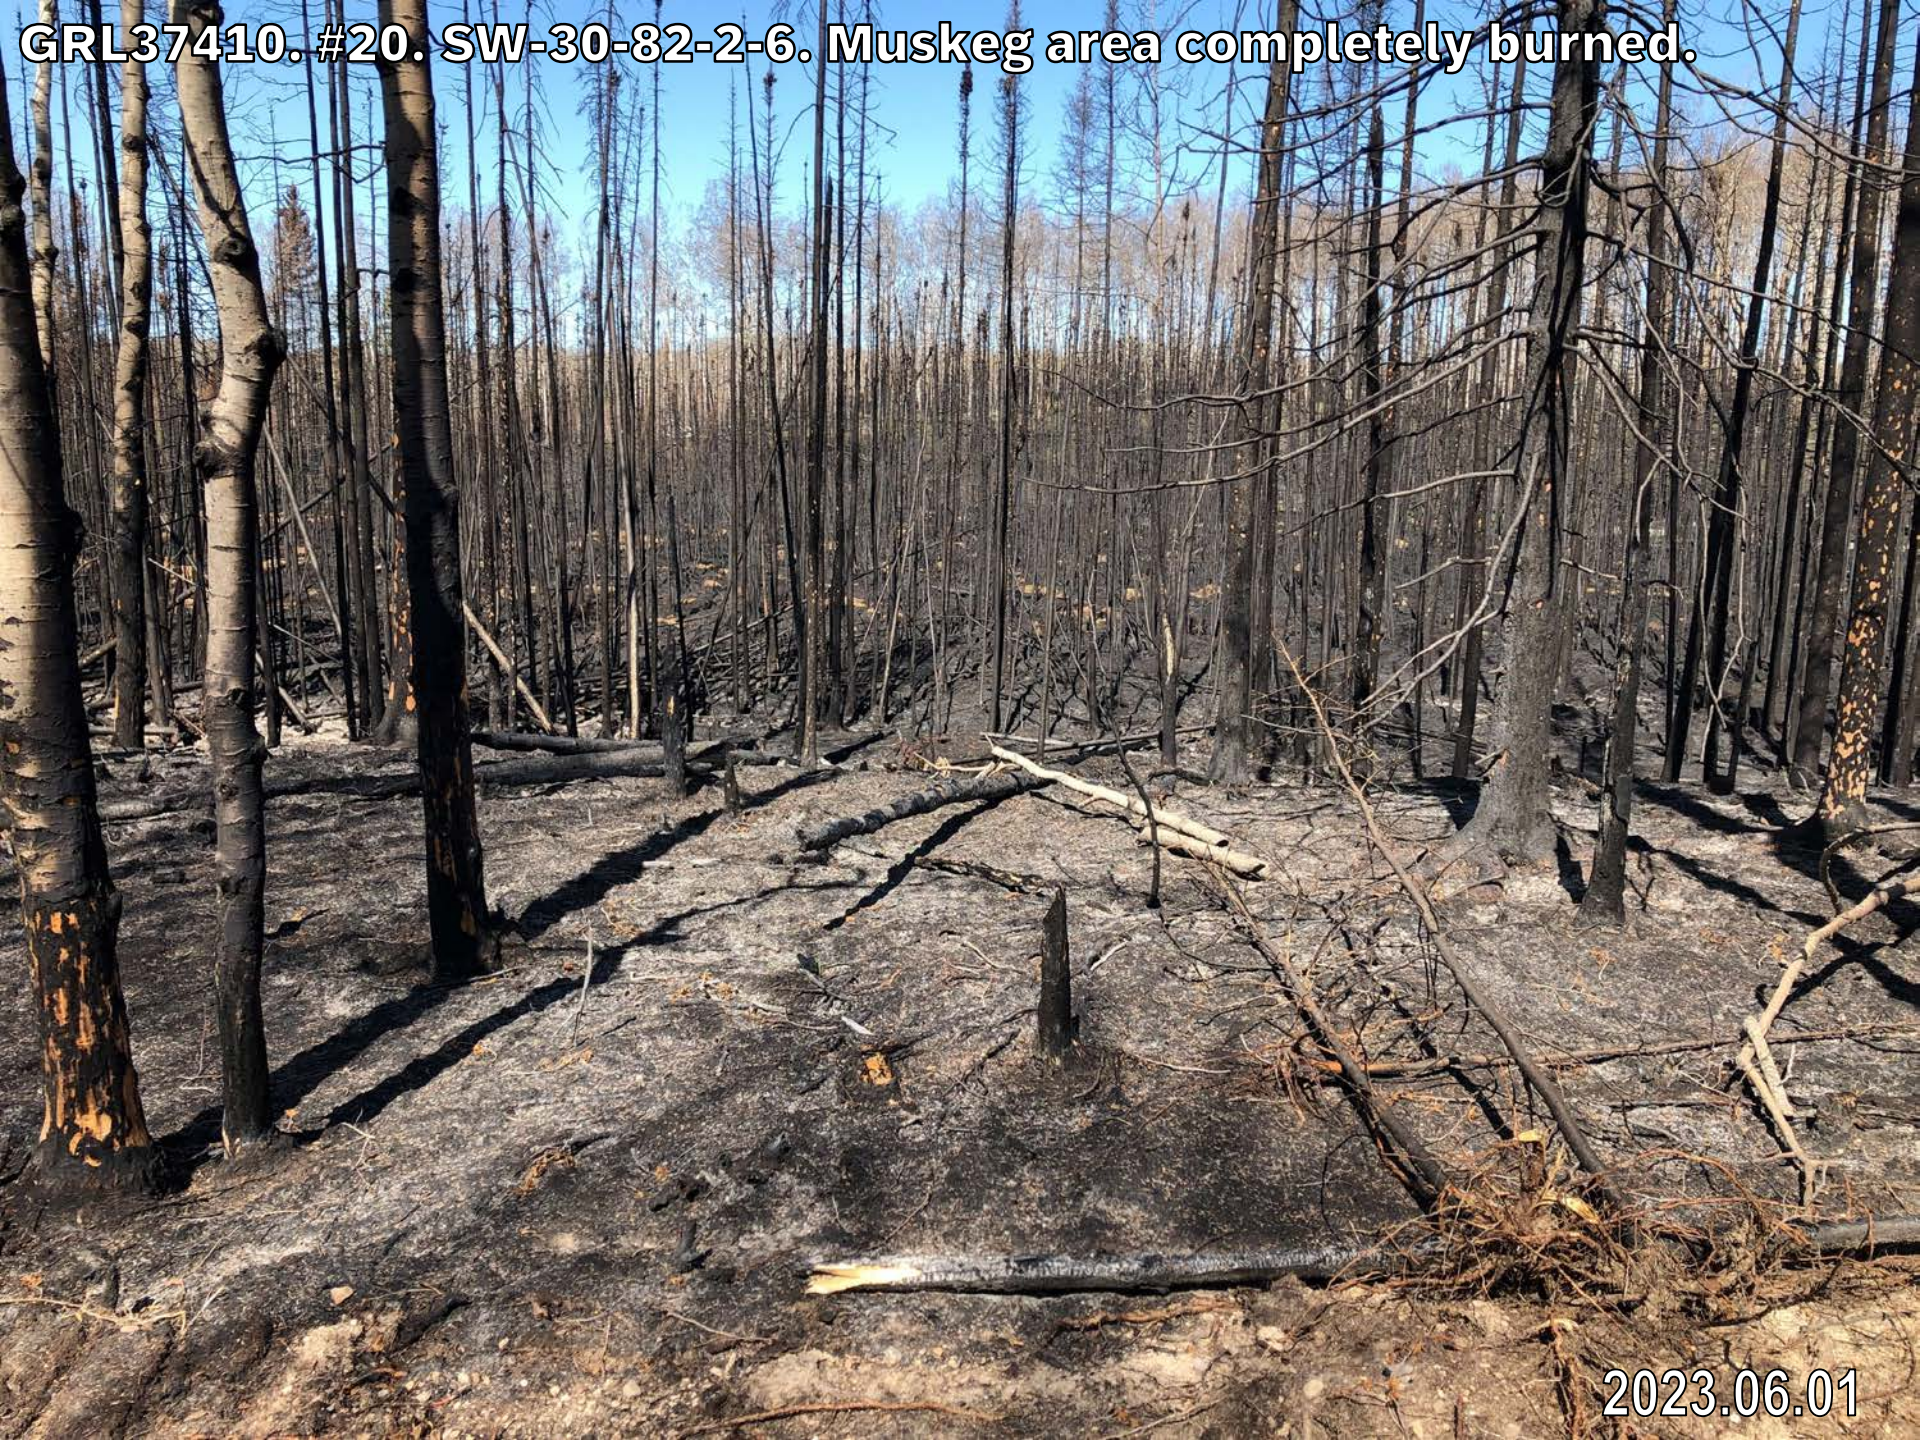
GRL37410. #20. SW-30-82-2-6. Muskeg area completely burned.

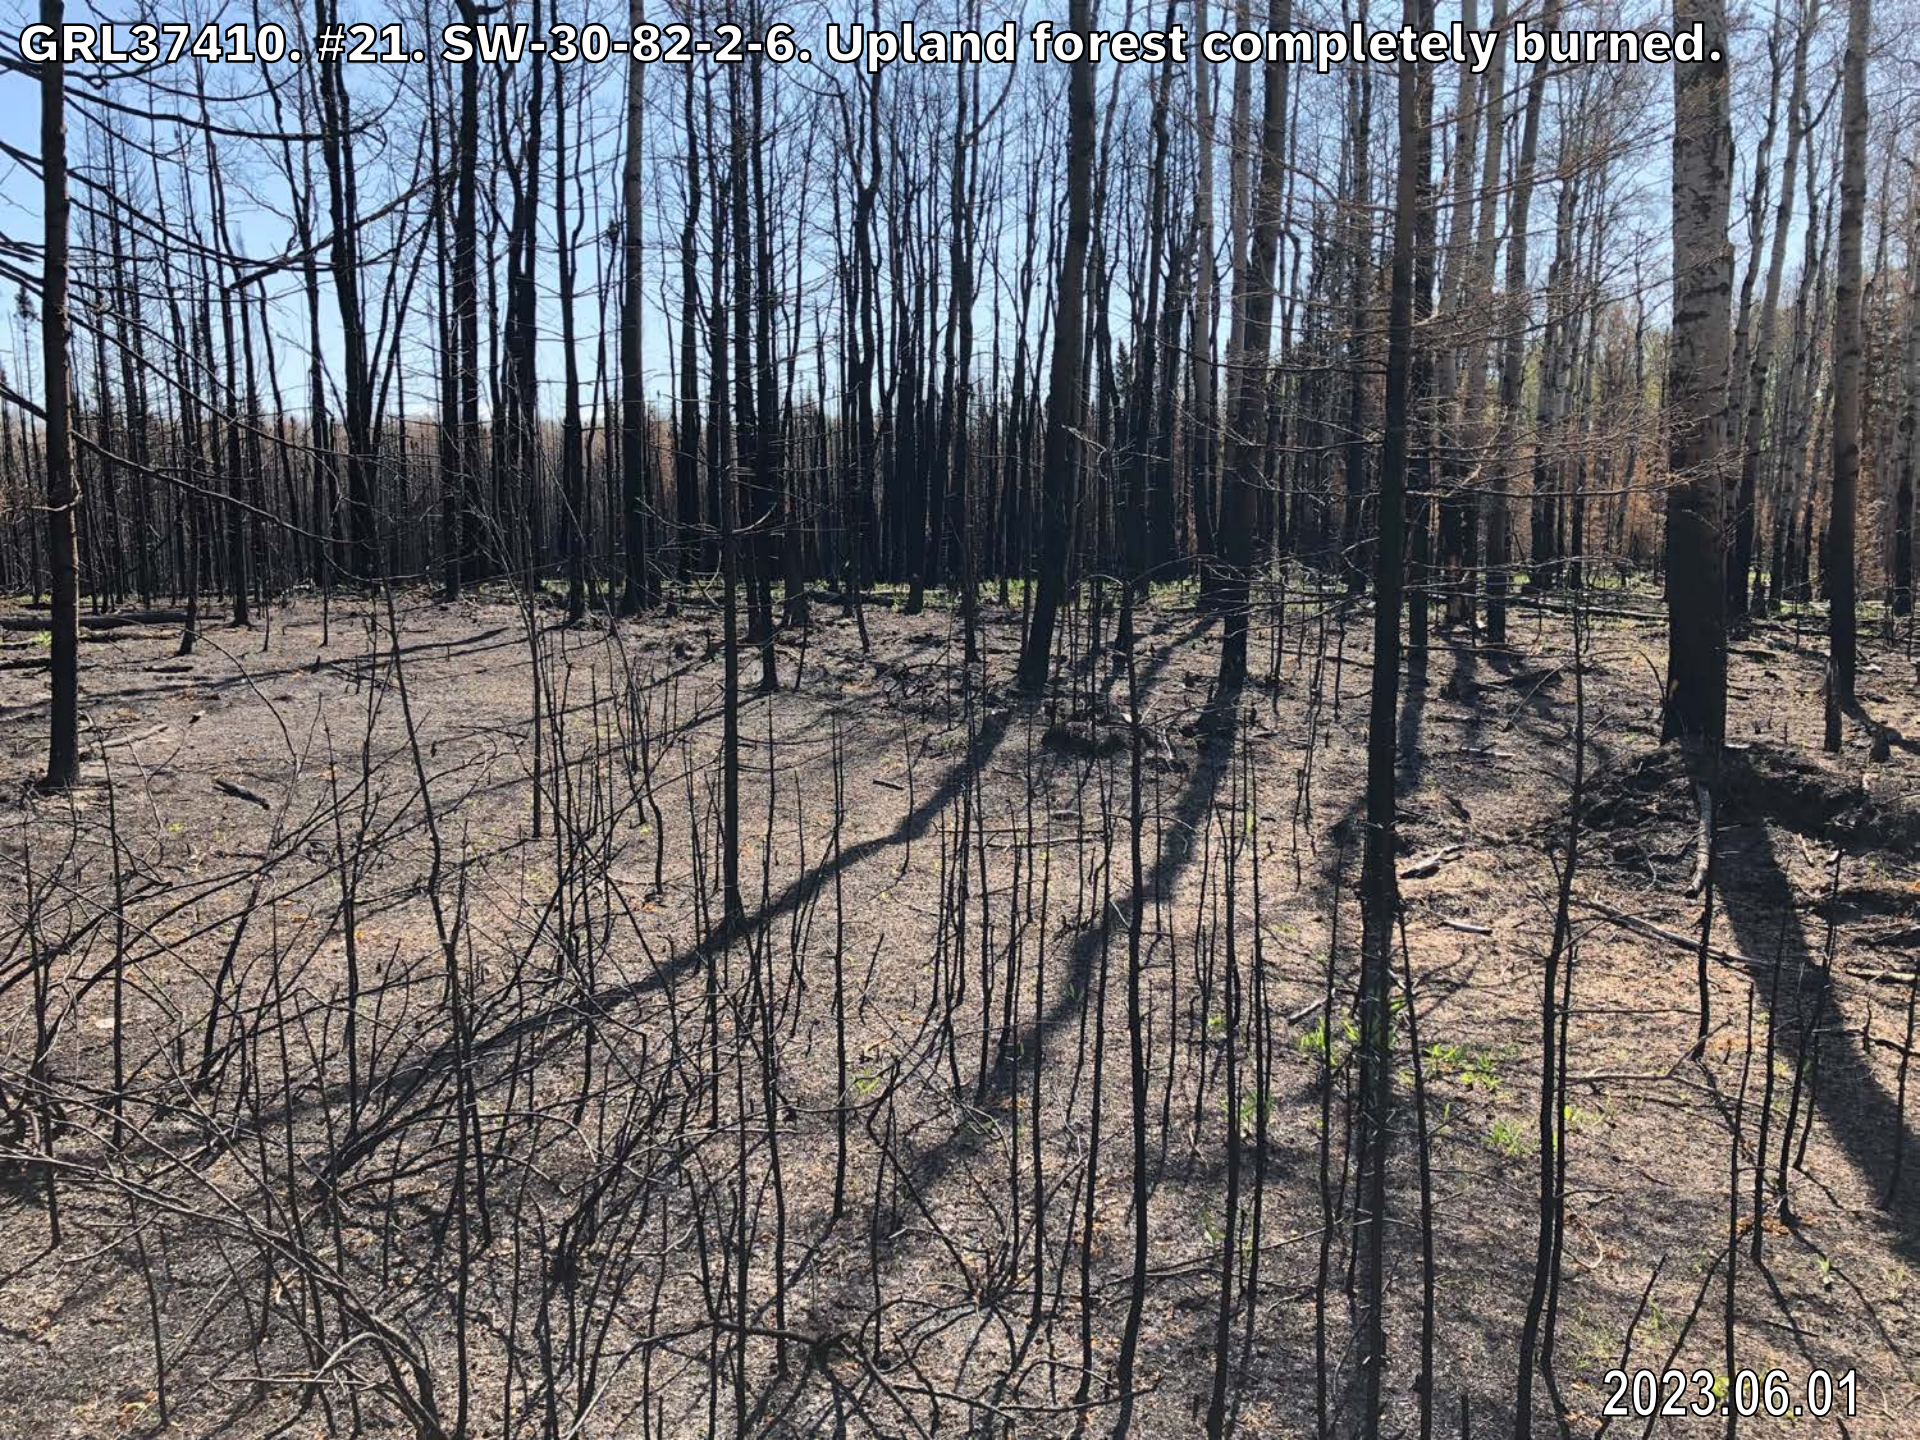
**GRL37410. #21. SW-30-82-2-6. Upland forest completely burned.**

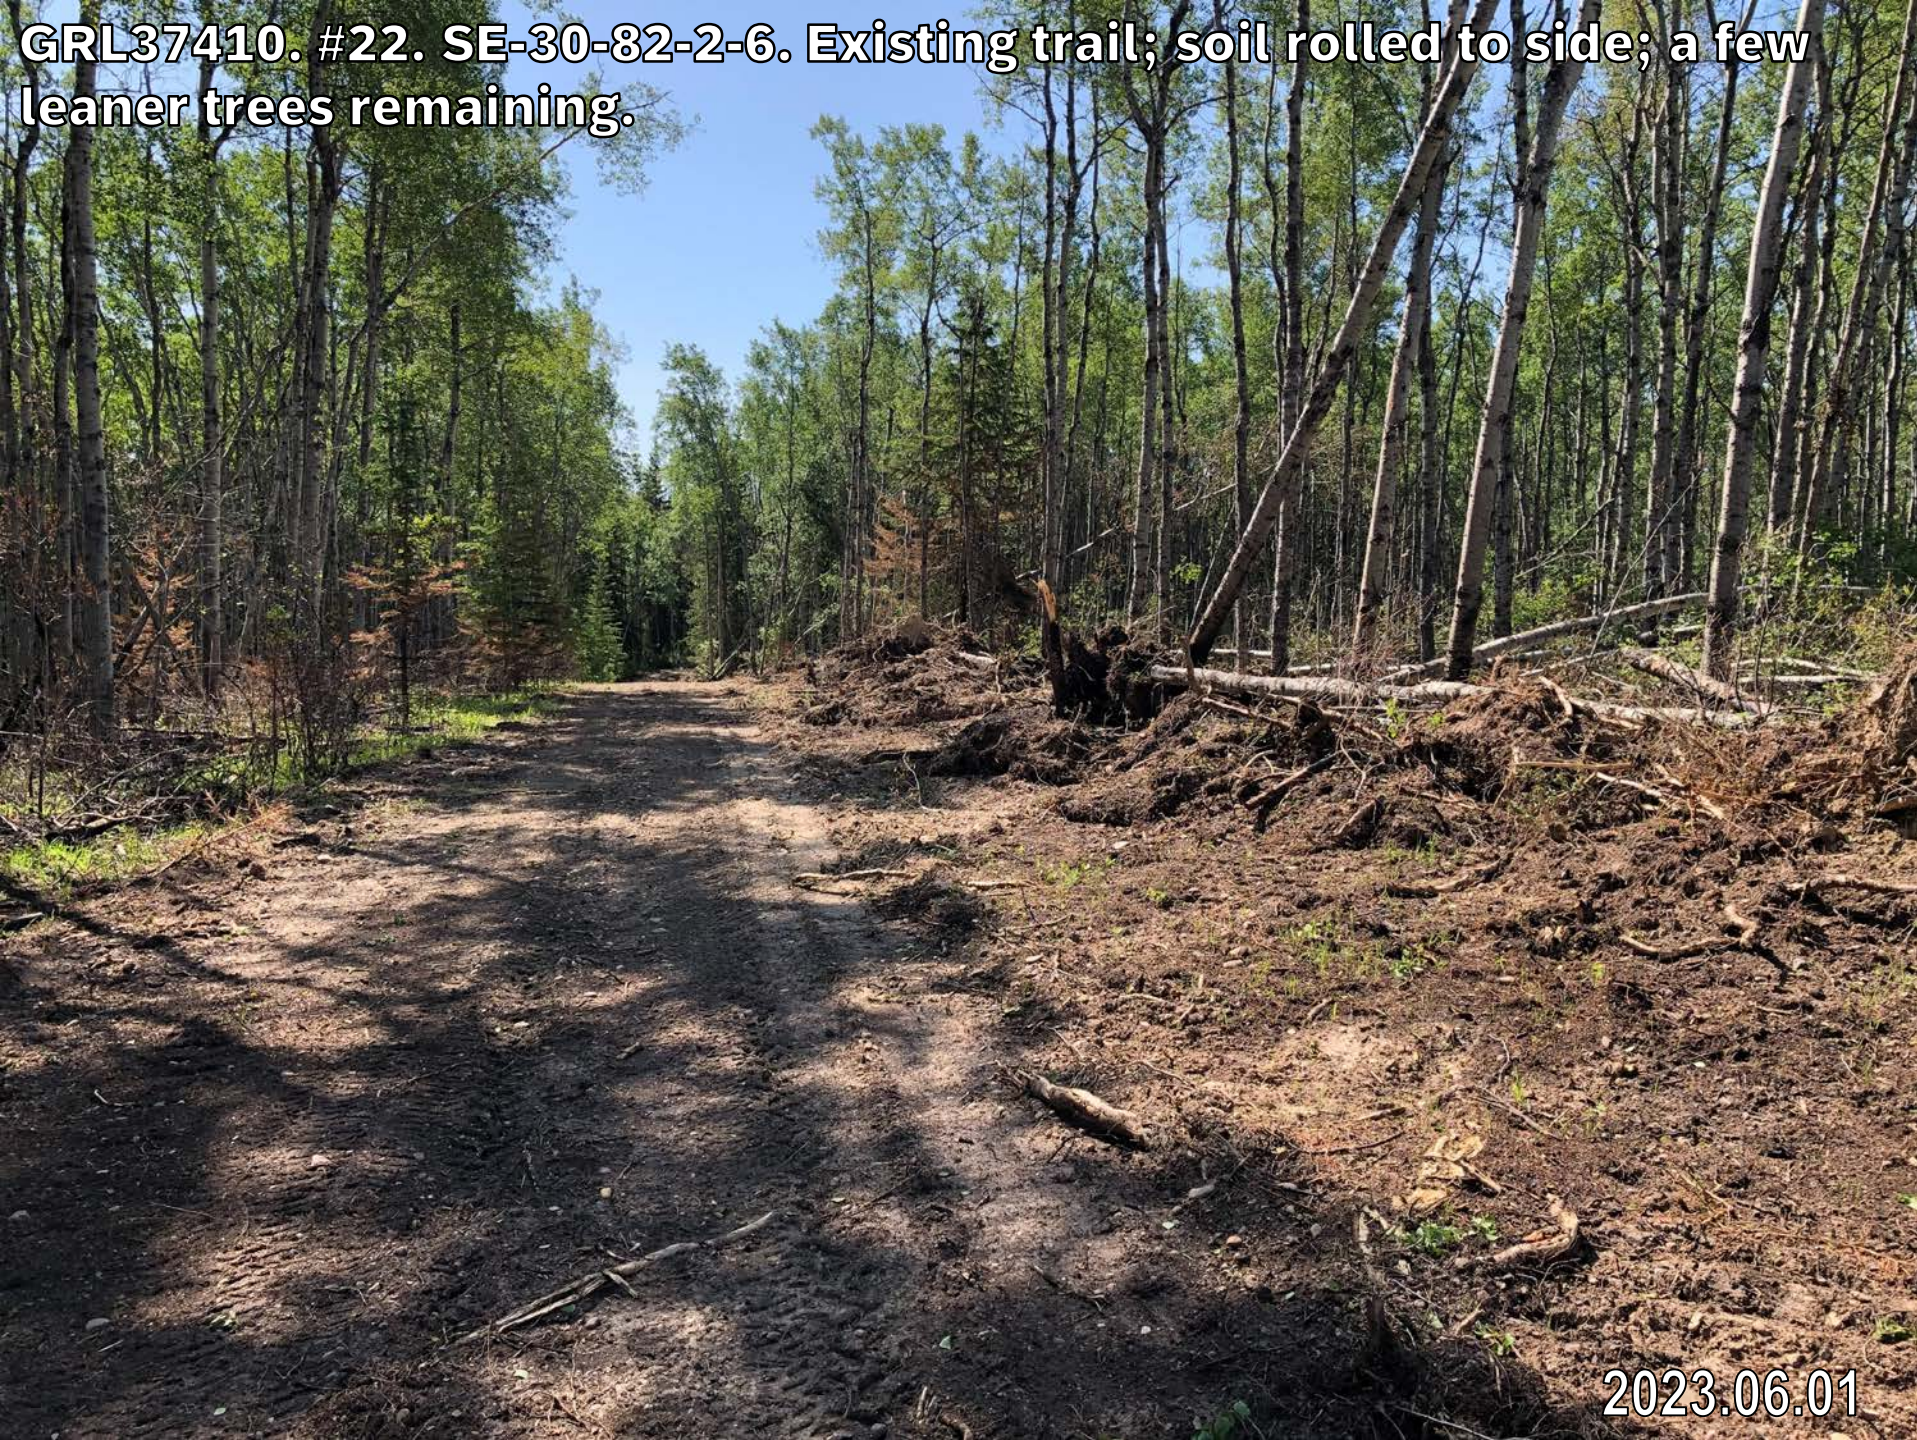
**GRL37410. #22. SE-30-82-2-6. Existing trail; soil rolled to side; a few leaner trees remaining.**

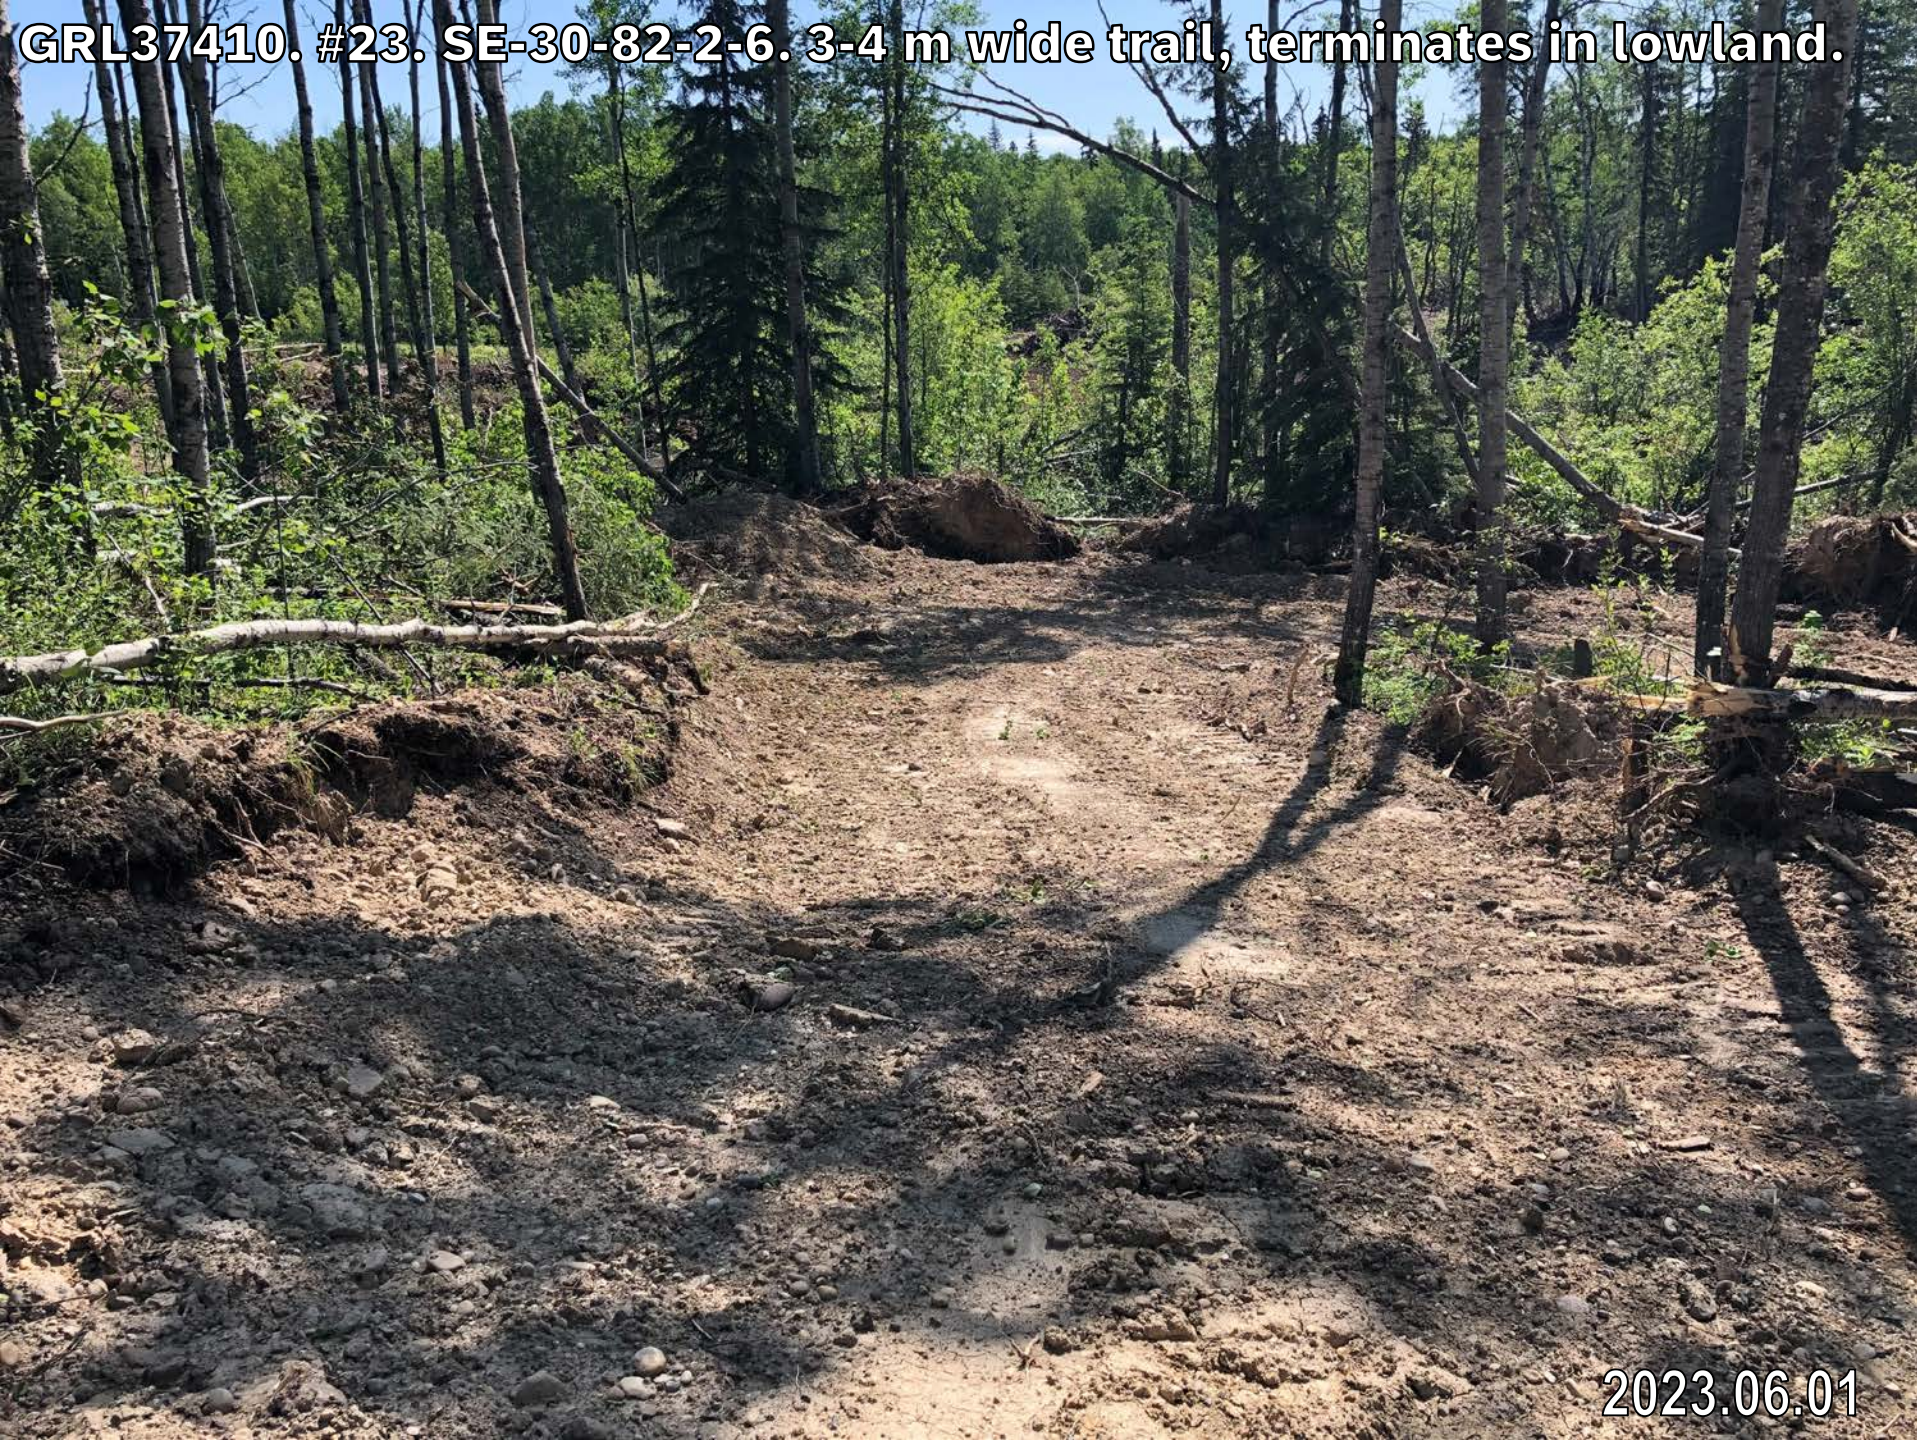
GRL37410. #23. SE-30-82-2-6. 3-4 m wide trail, terminates in lowland.

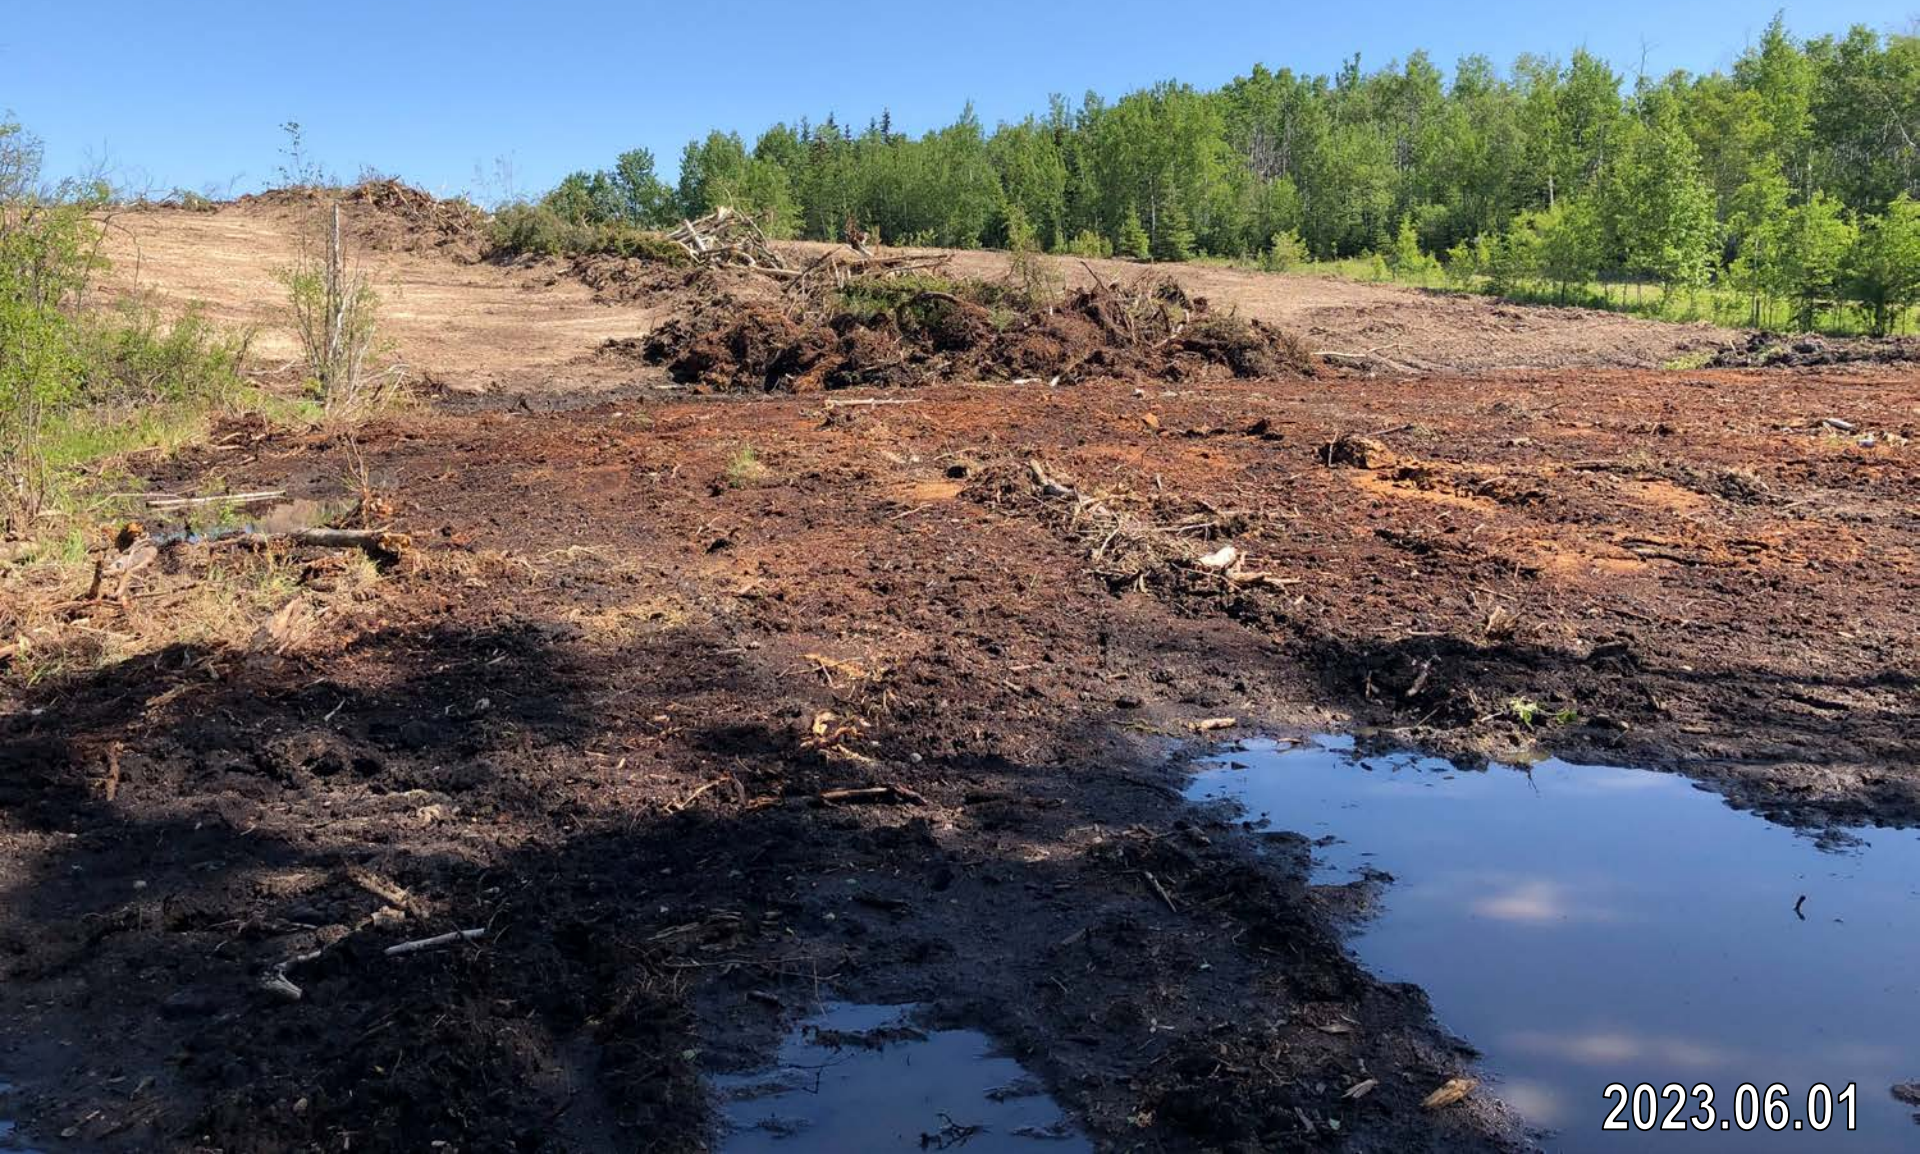
**GRL37410. #24. SE-30-82-2-6. South end of east fireguard (50-60 m wide).**

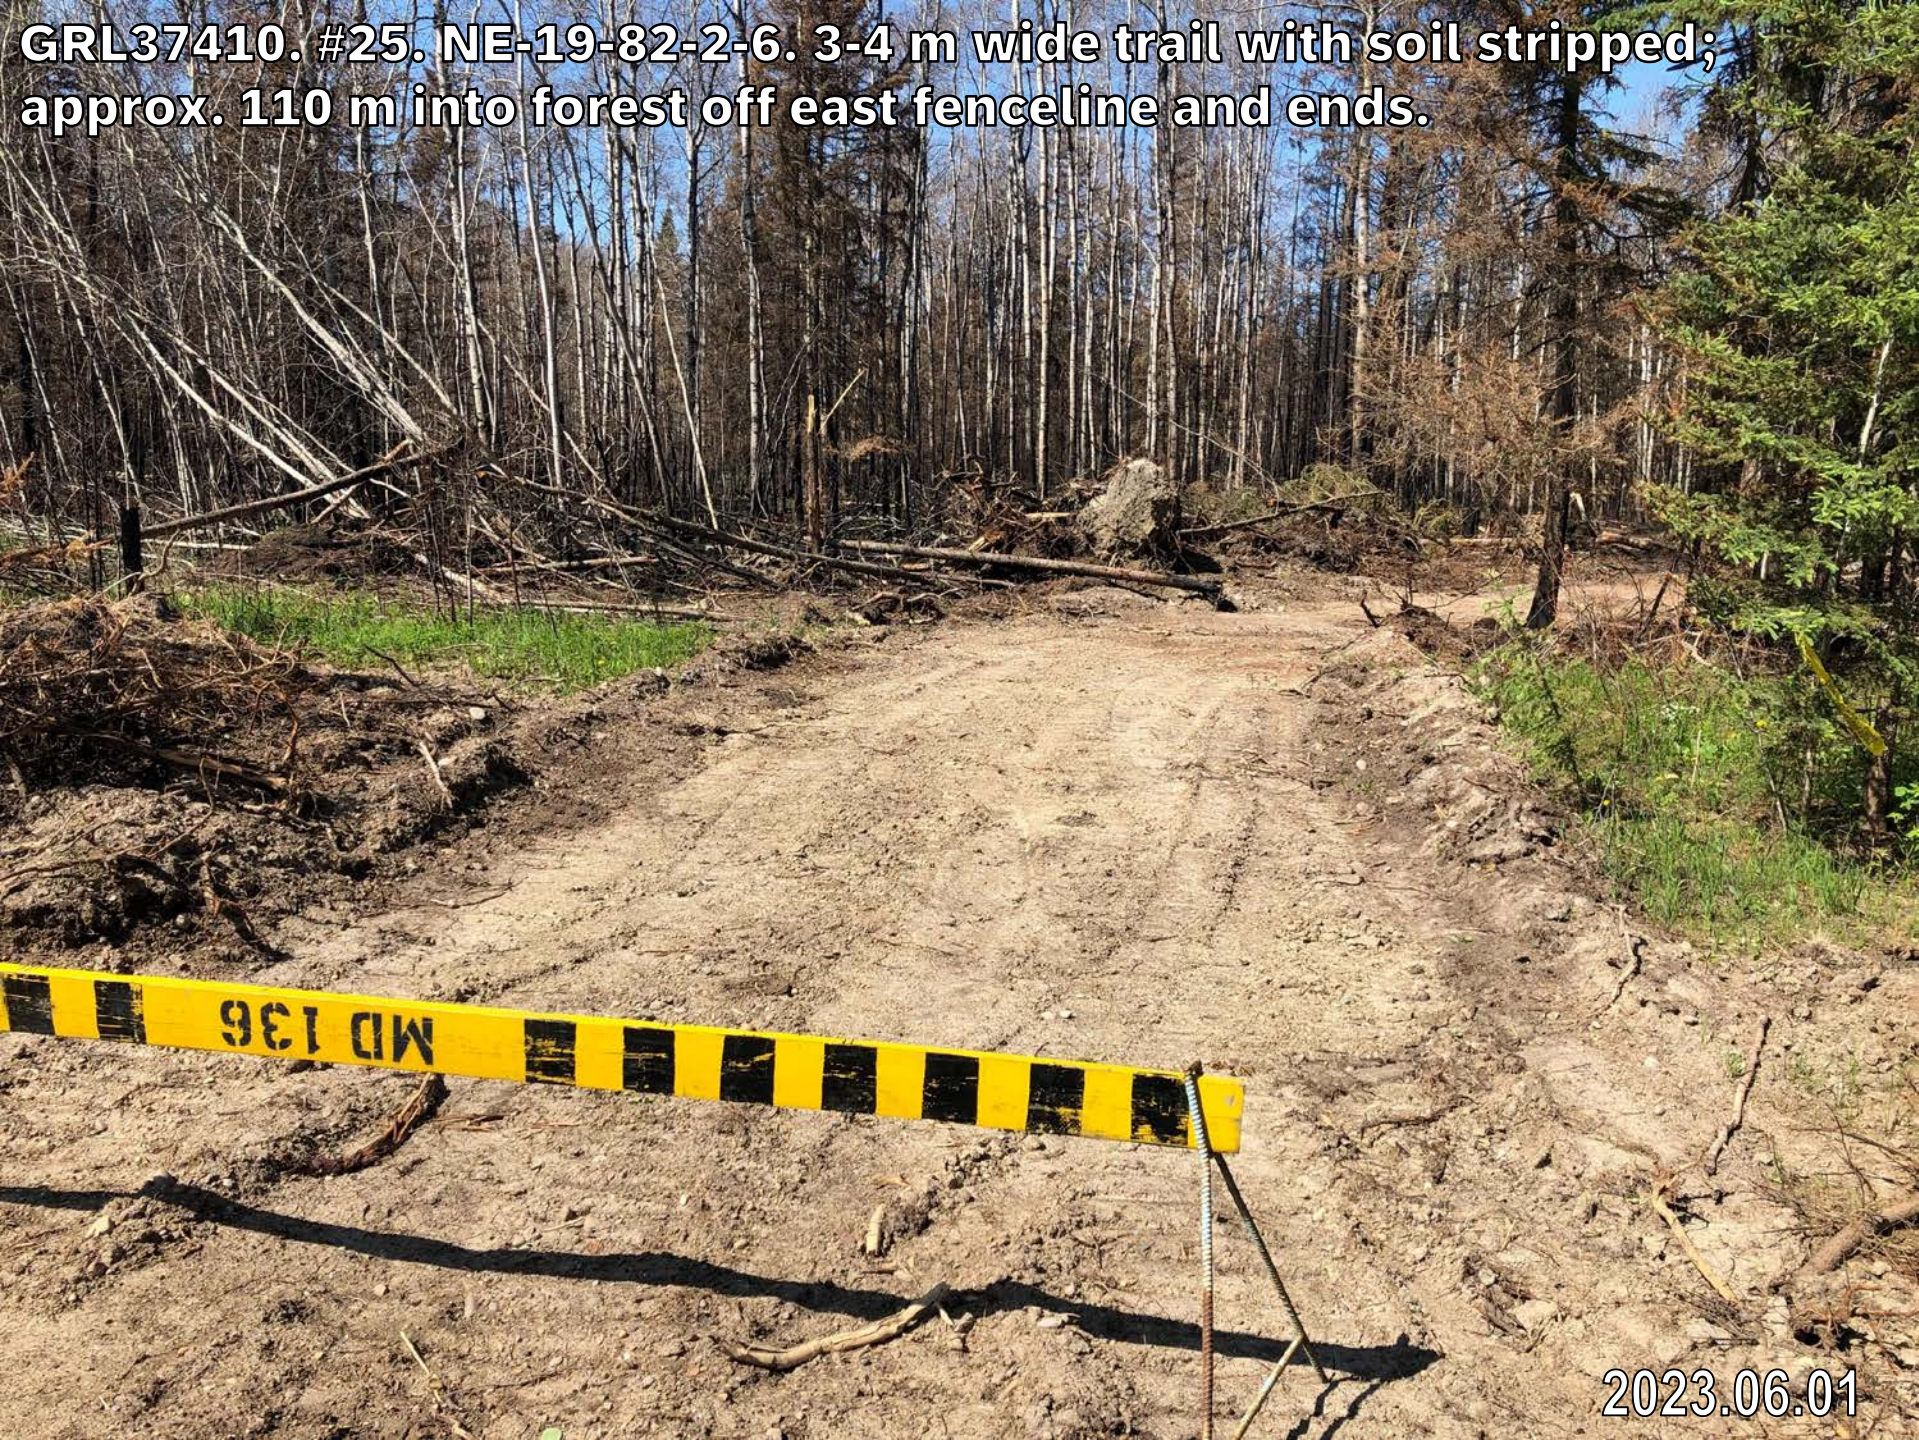
GRL37410. #25. NE-19-82-2-6. 3-4 m wide trail with soil stripped;  
approx. 110 m into forest off east fenceline and ends.
