GRL37410. #1. SE-30-82-2-6. Log fill crossing along access trail.

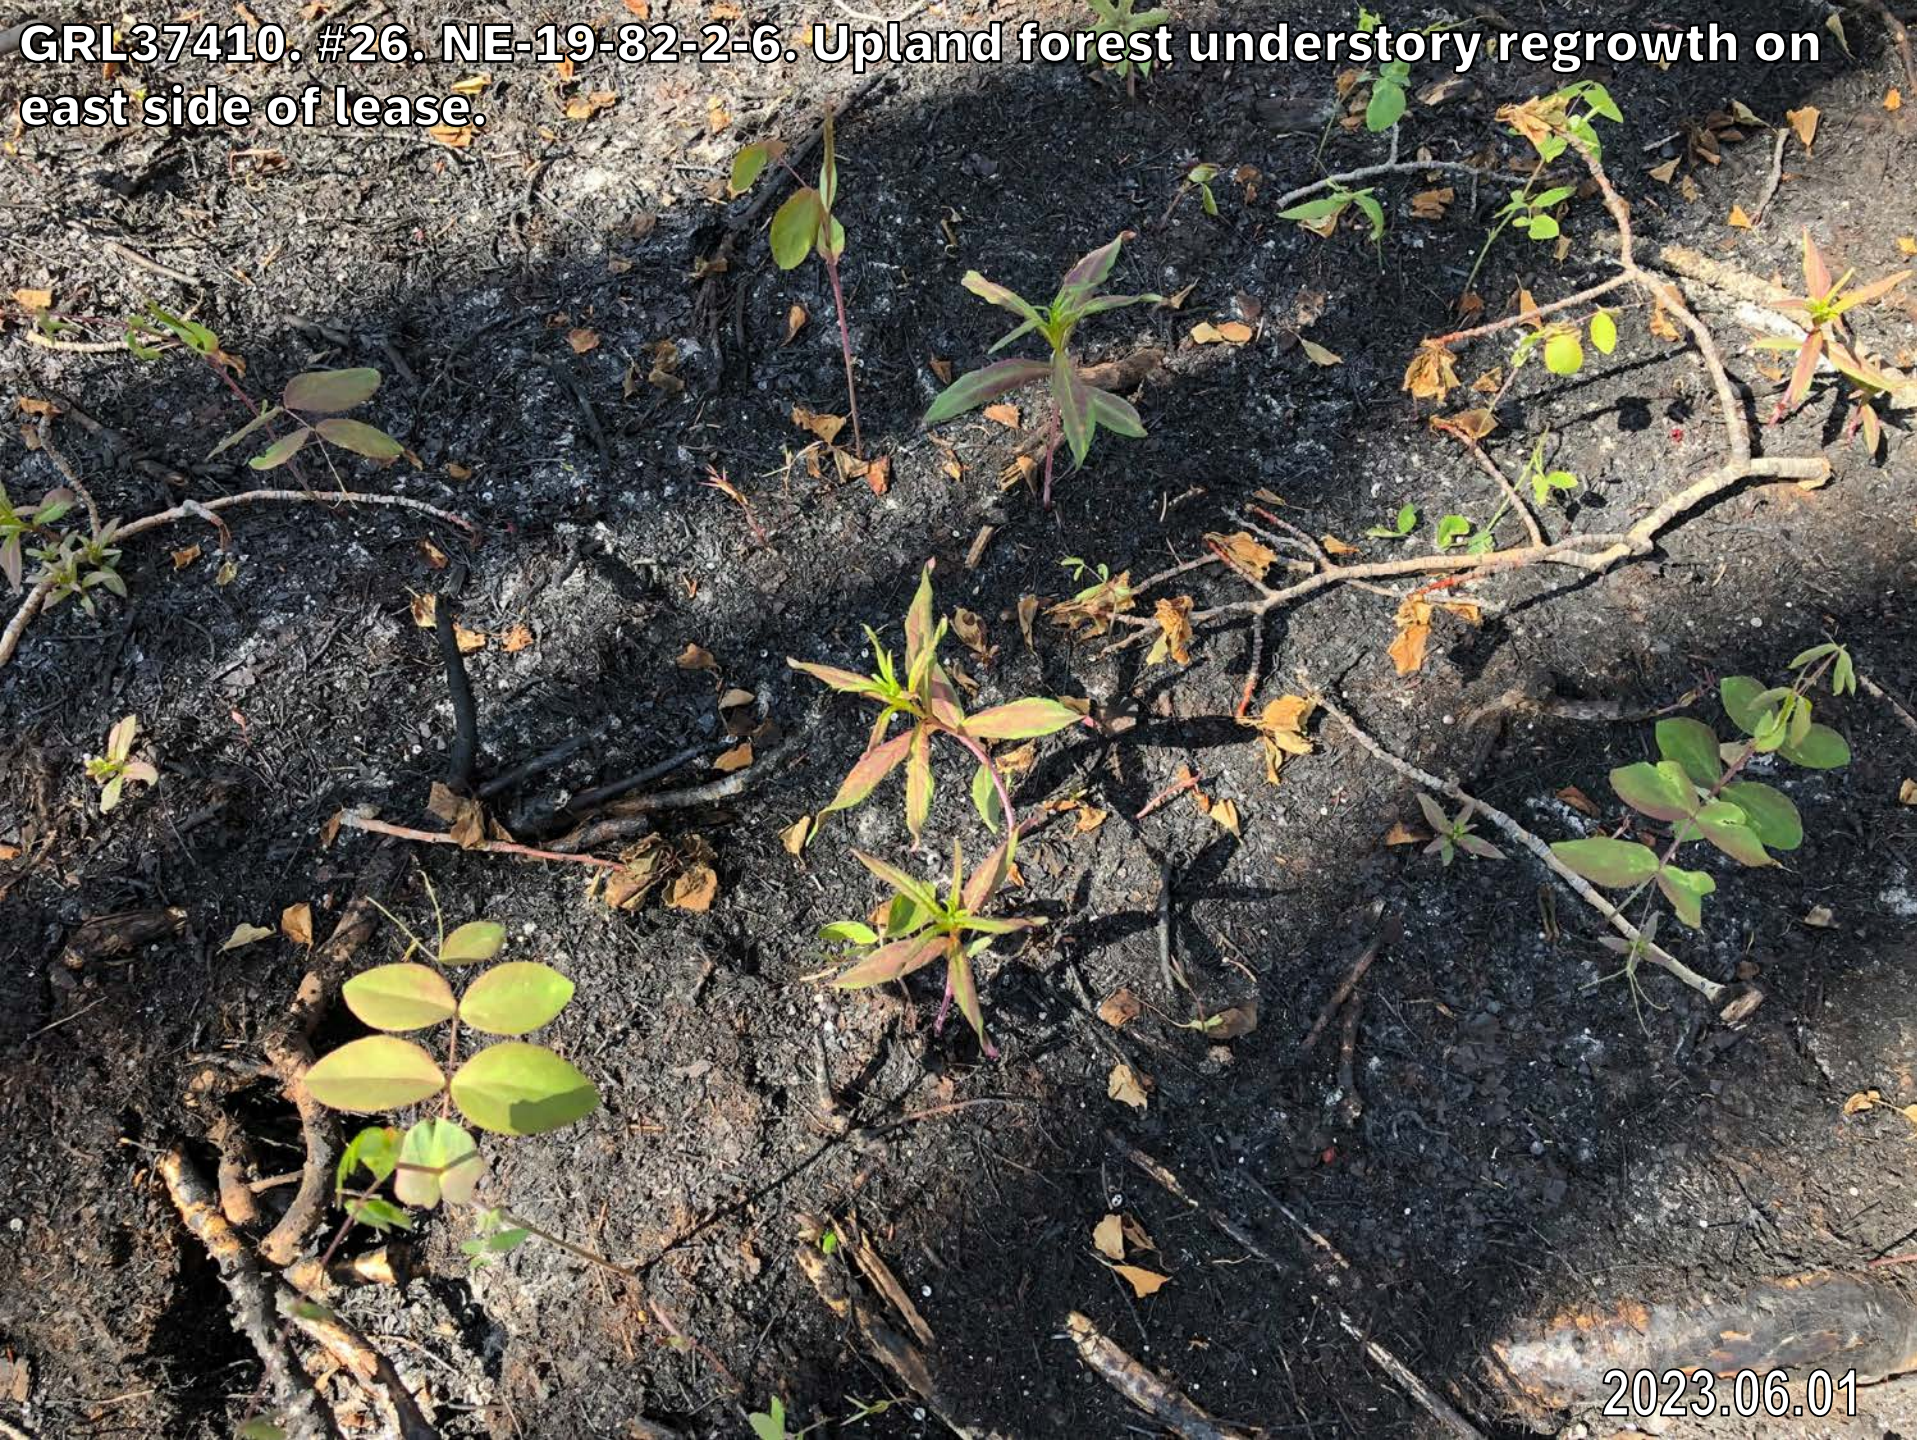
GRL37410. #26. NE-19-82-2-6. Upland forest understory regrowth on east side of lease.

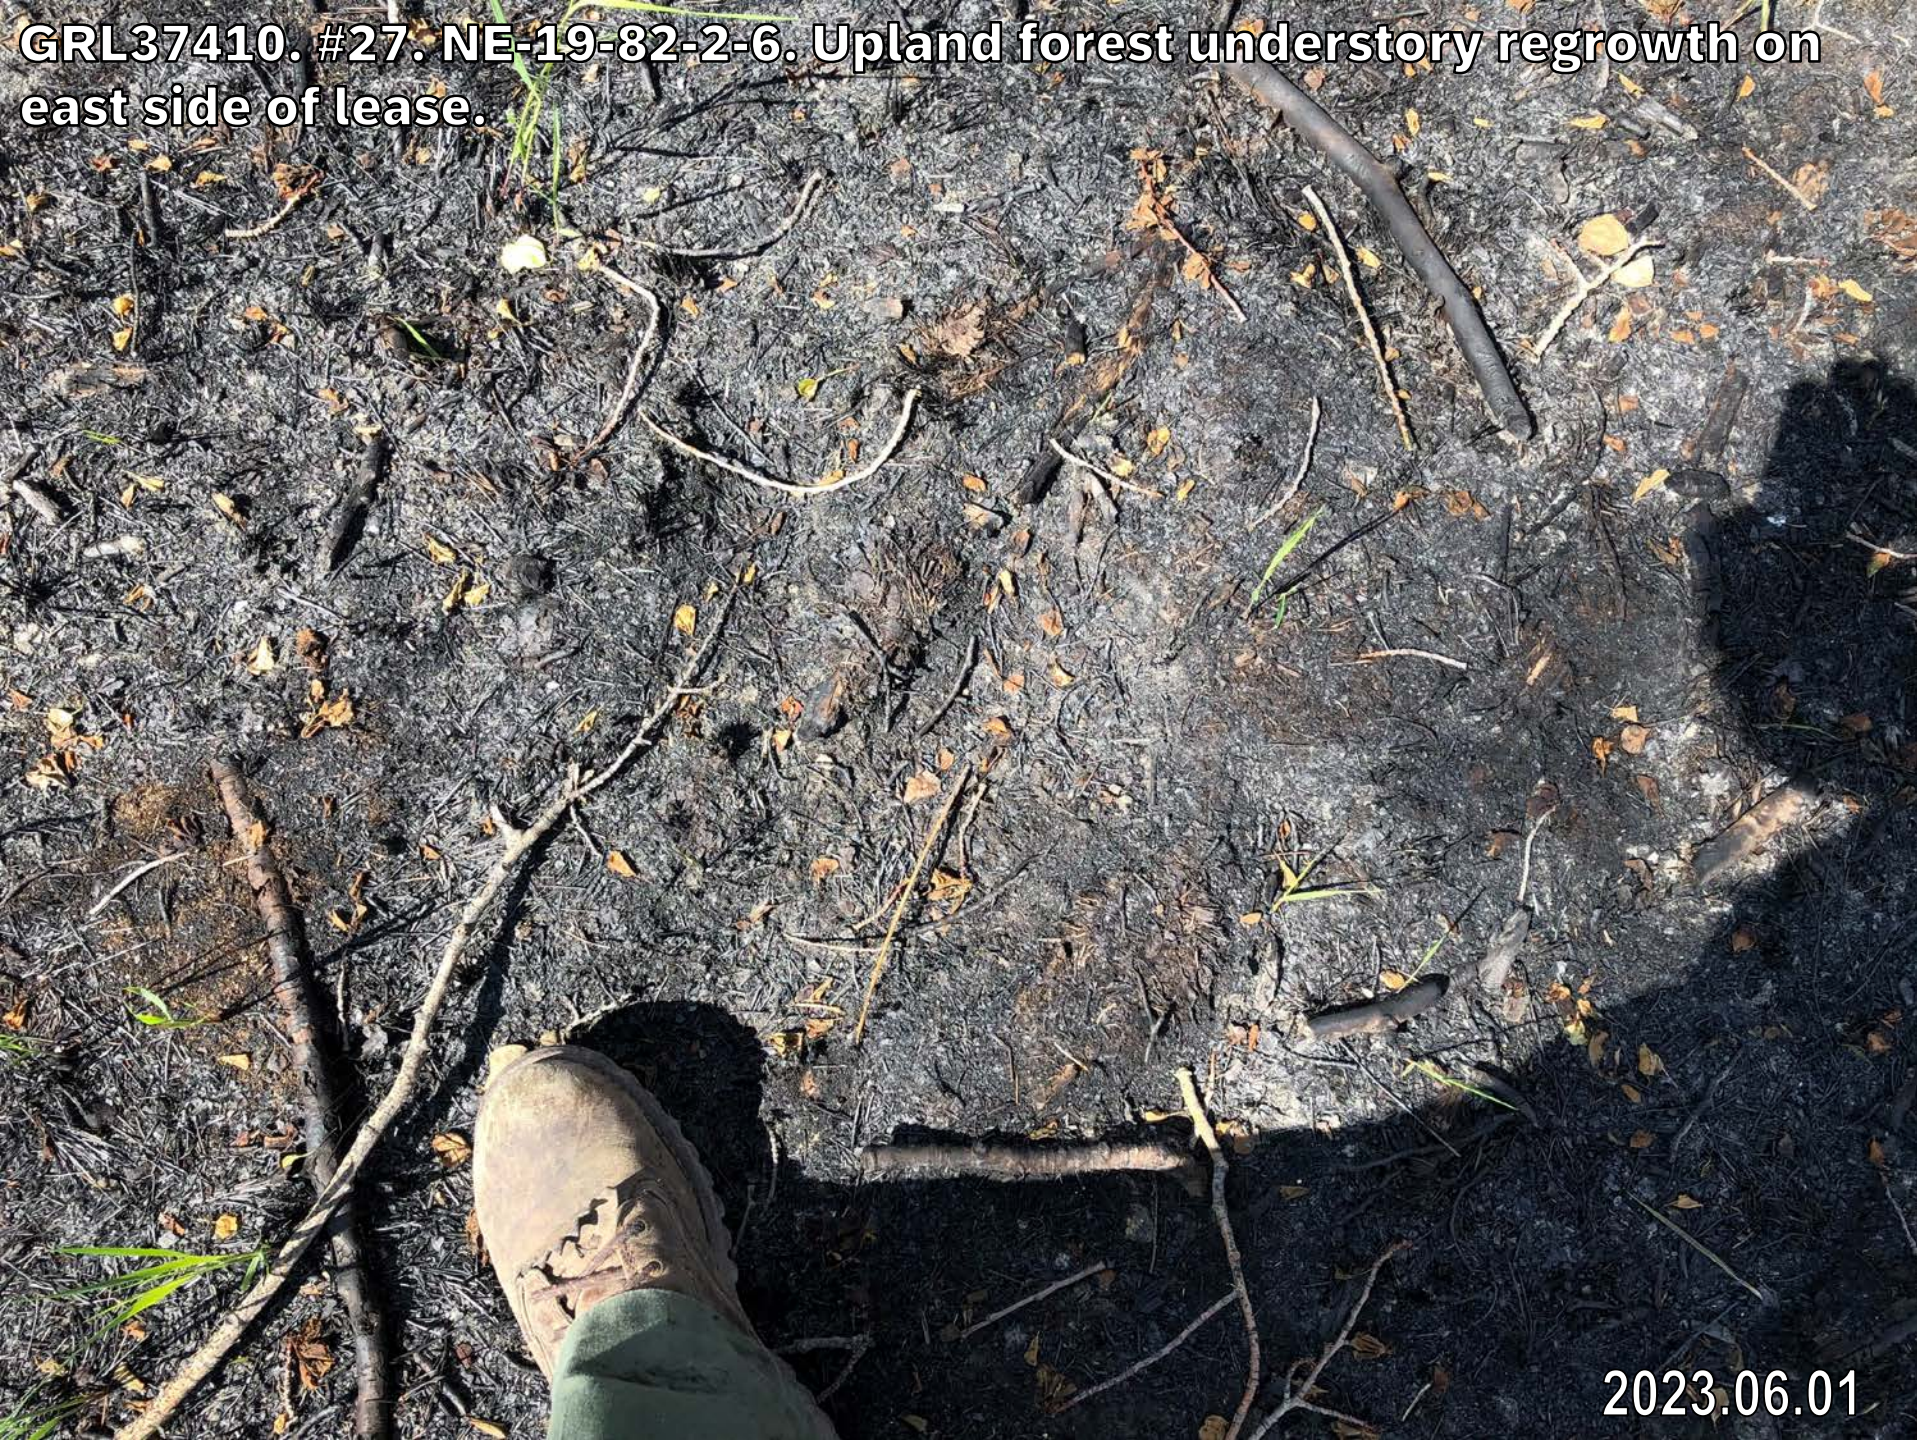
GRL37410. #27. NE-19-82-2-6. Upland forest understory regrowth on east side of lease.

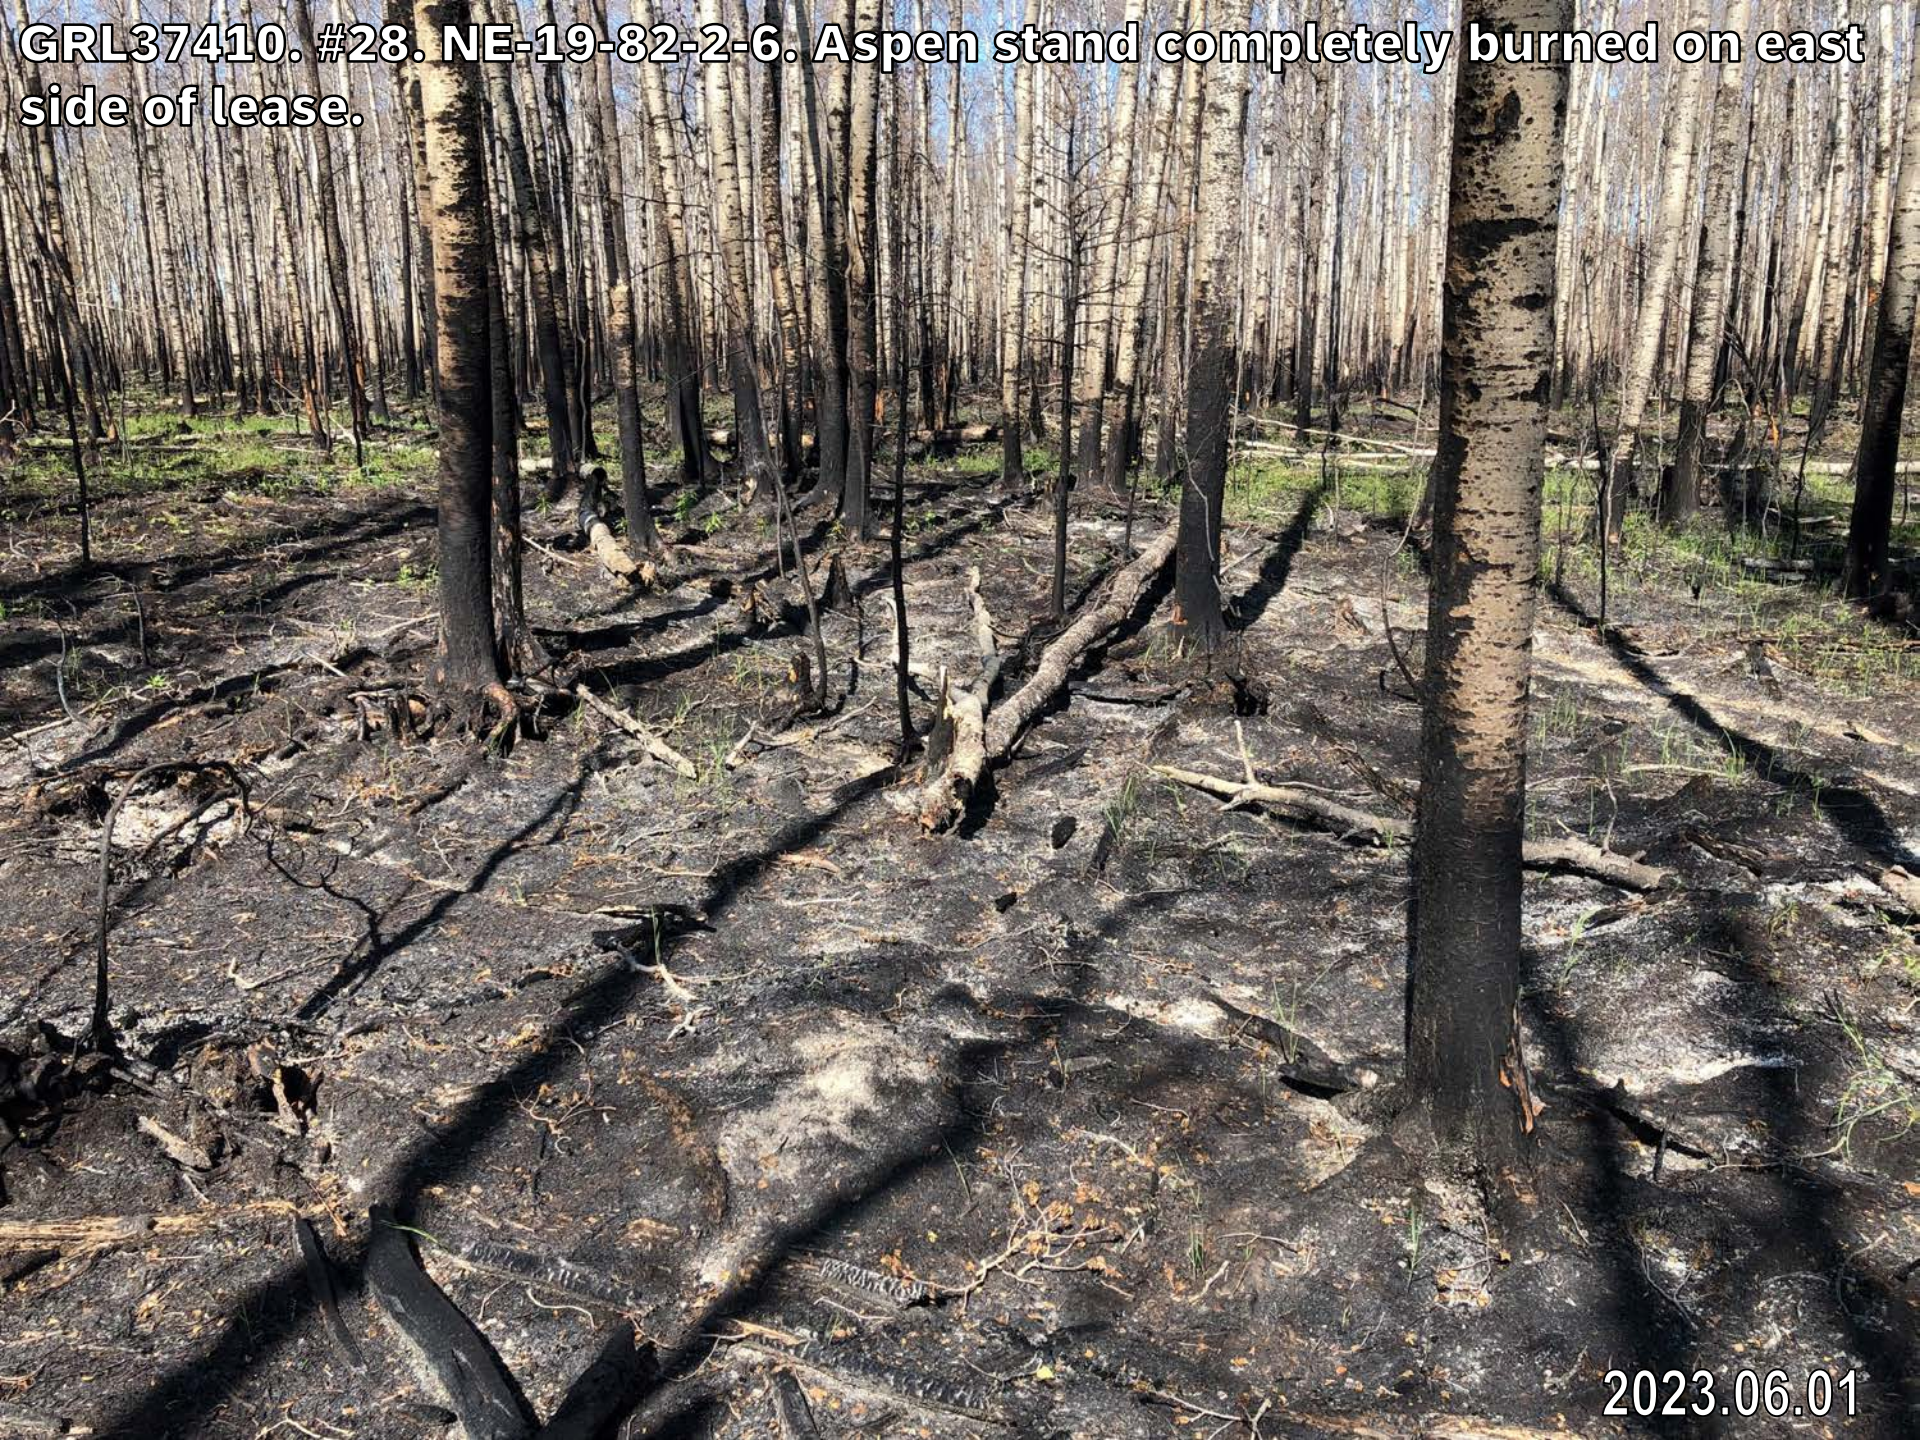
GRL37410. #28. NE-19-82-2-6. Aspen stand completely burned on east side of lease.

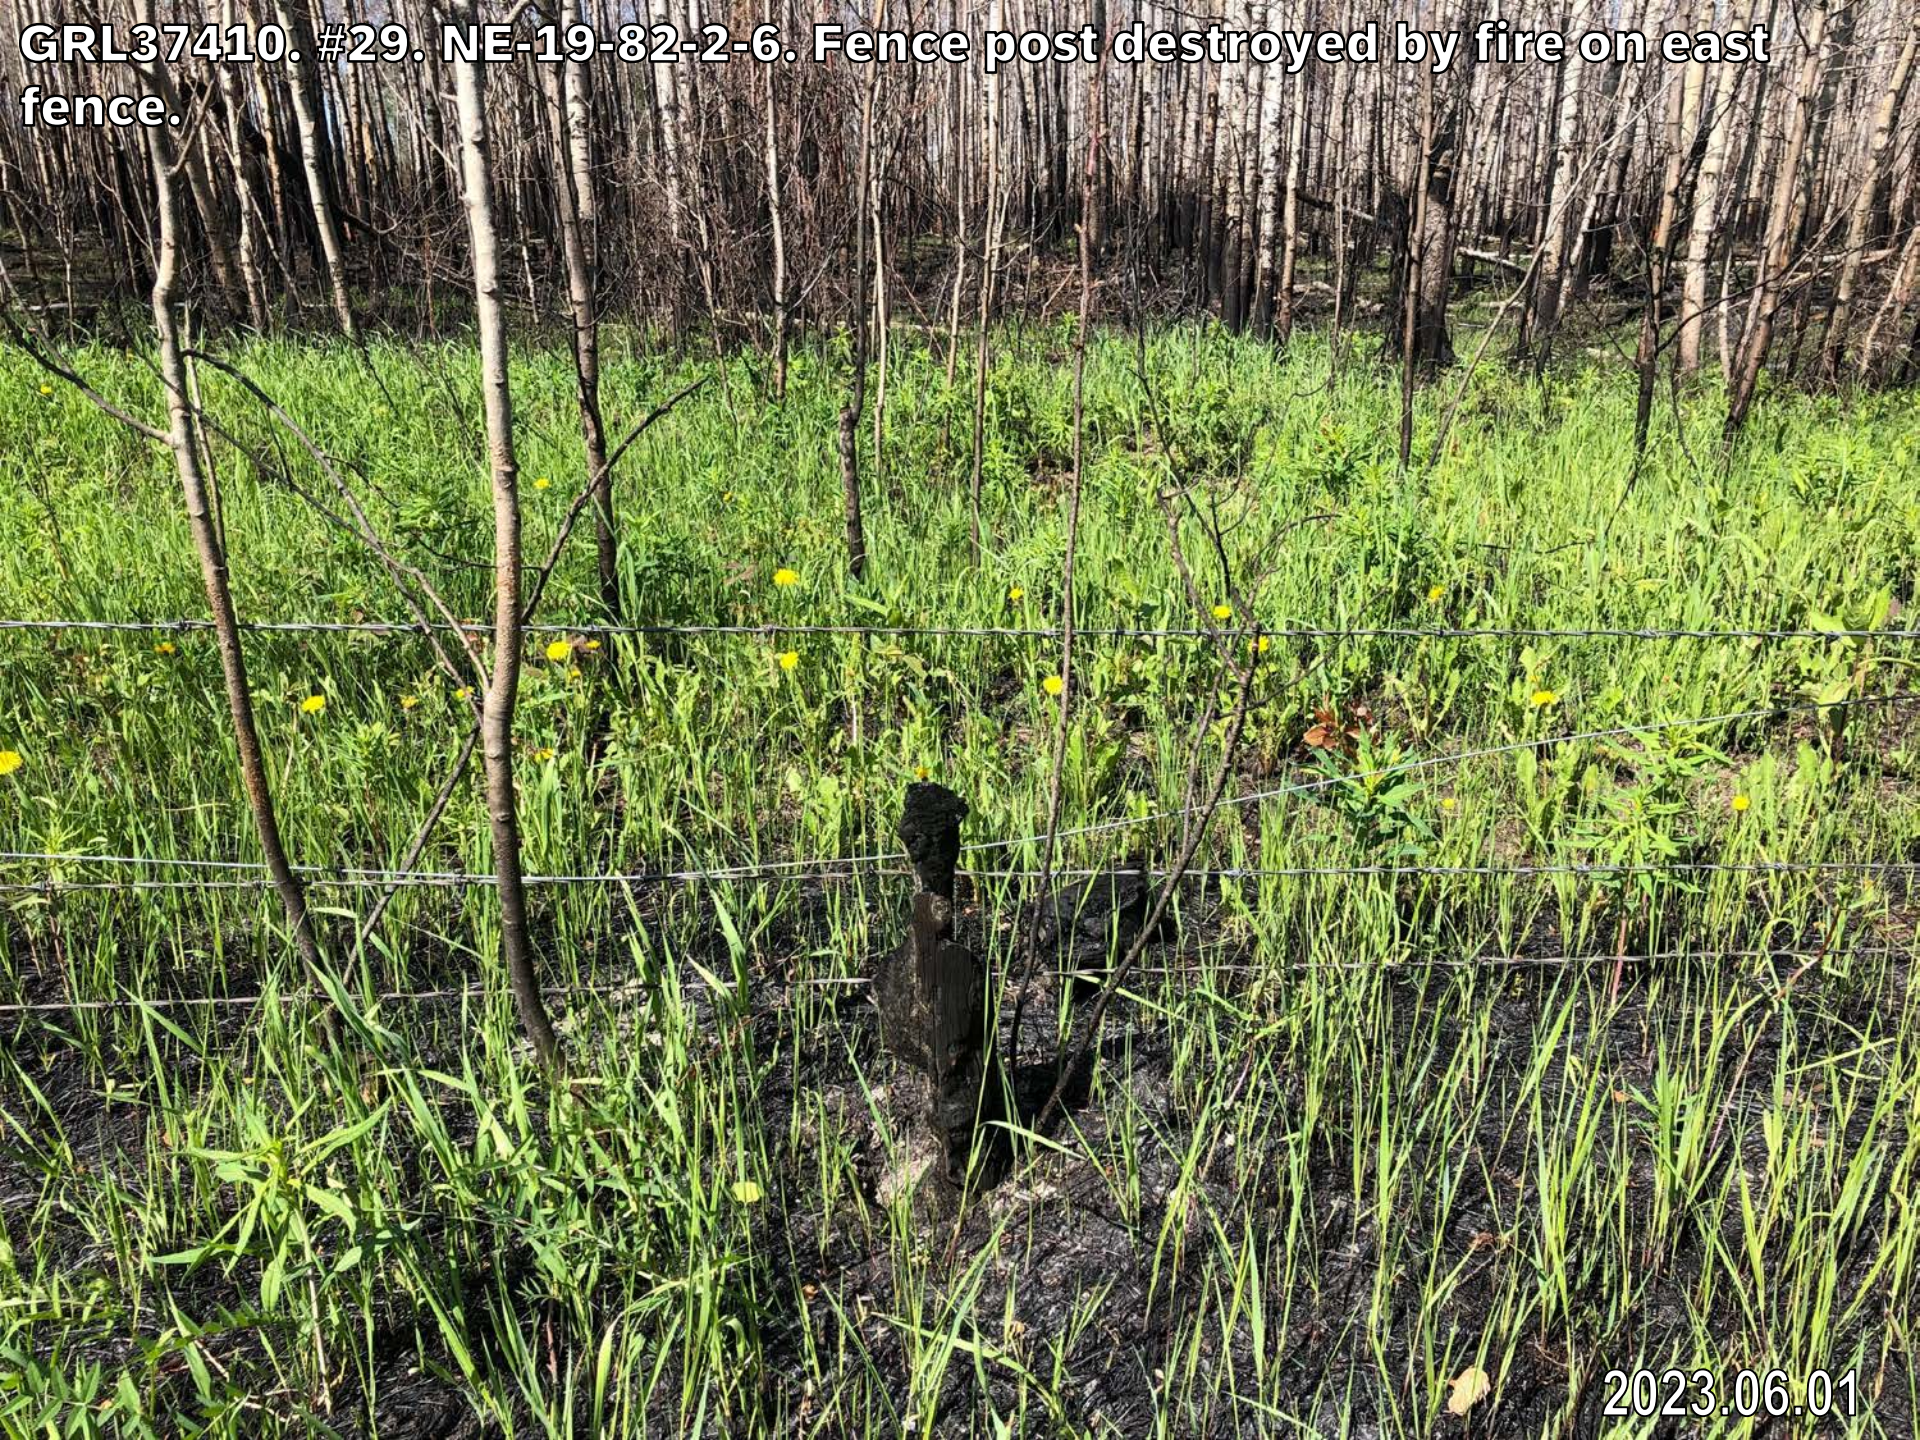
GRL37410. #29. NE-19-82-2-6. Fence post destroyed by fire on east fence.

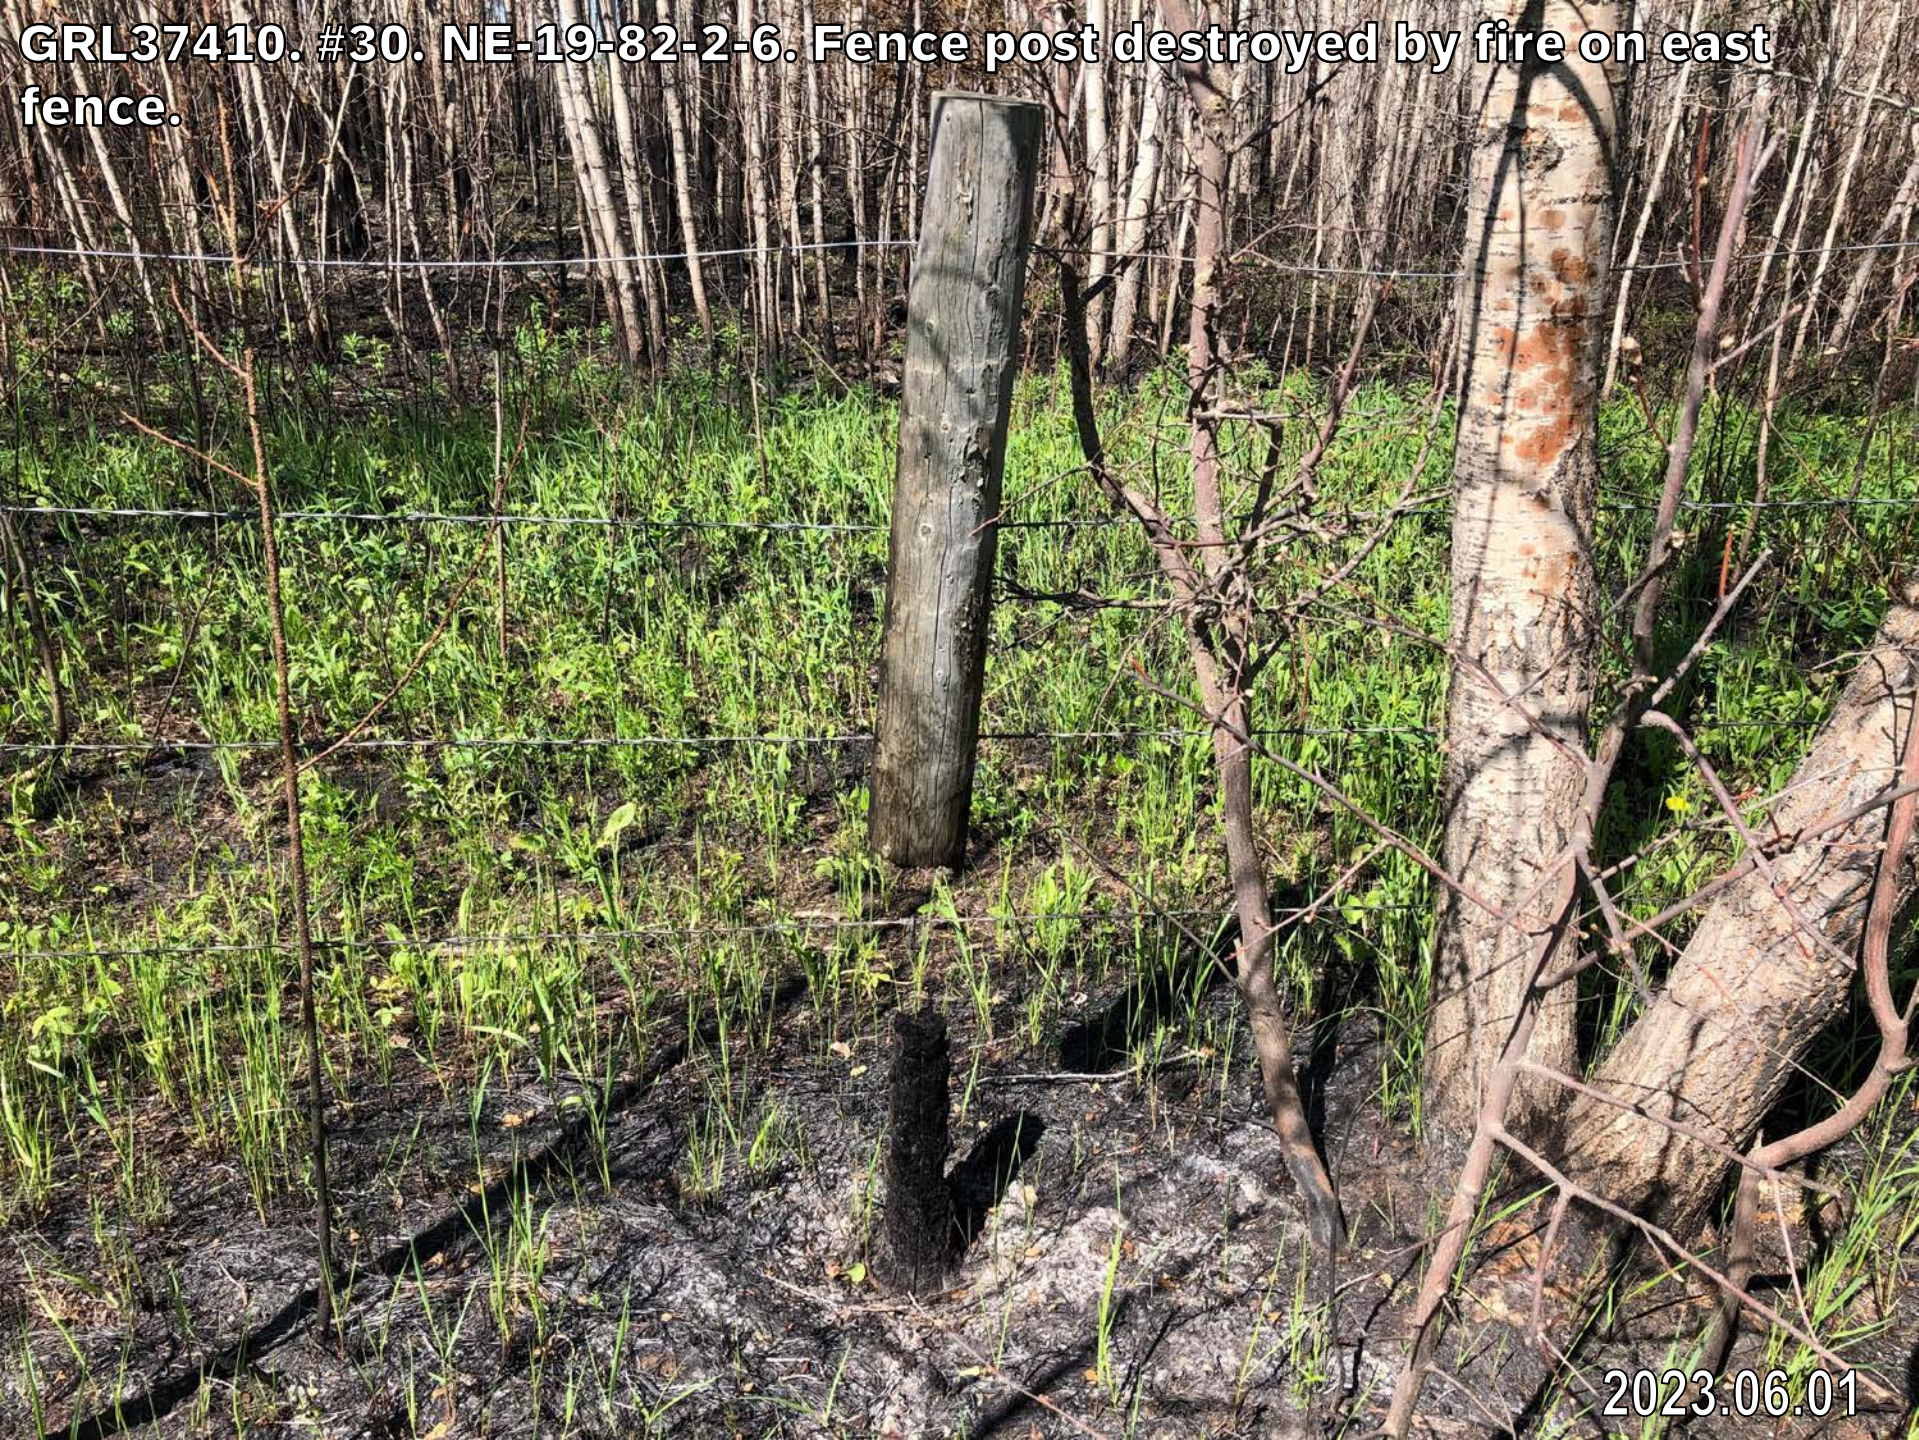
GRL37410. #30. NE-19-82-2-6. Fence post destroyed by fire on east fence.

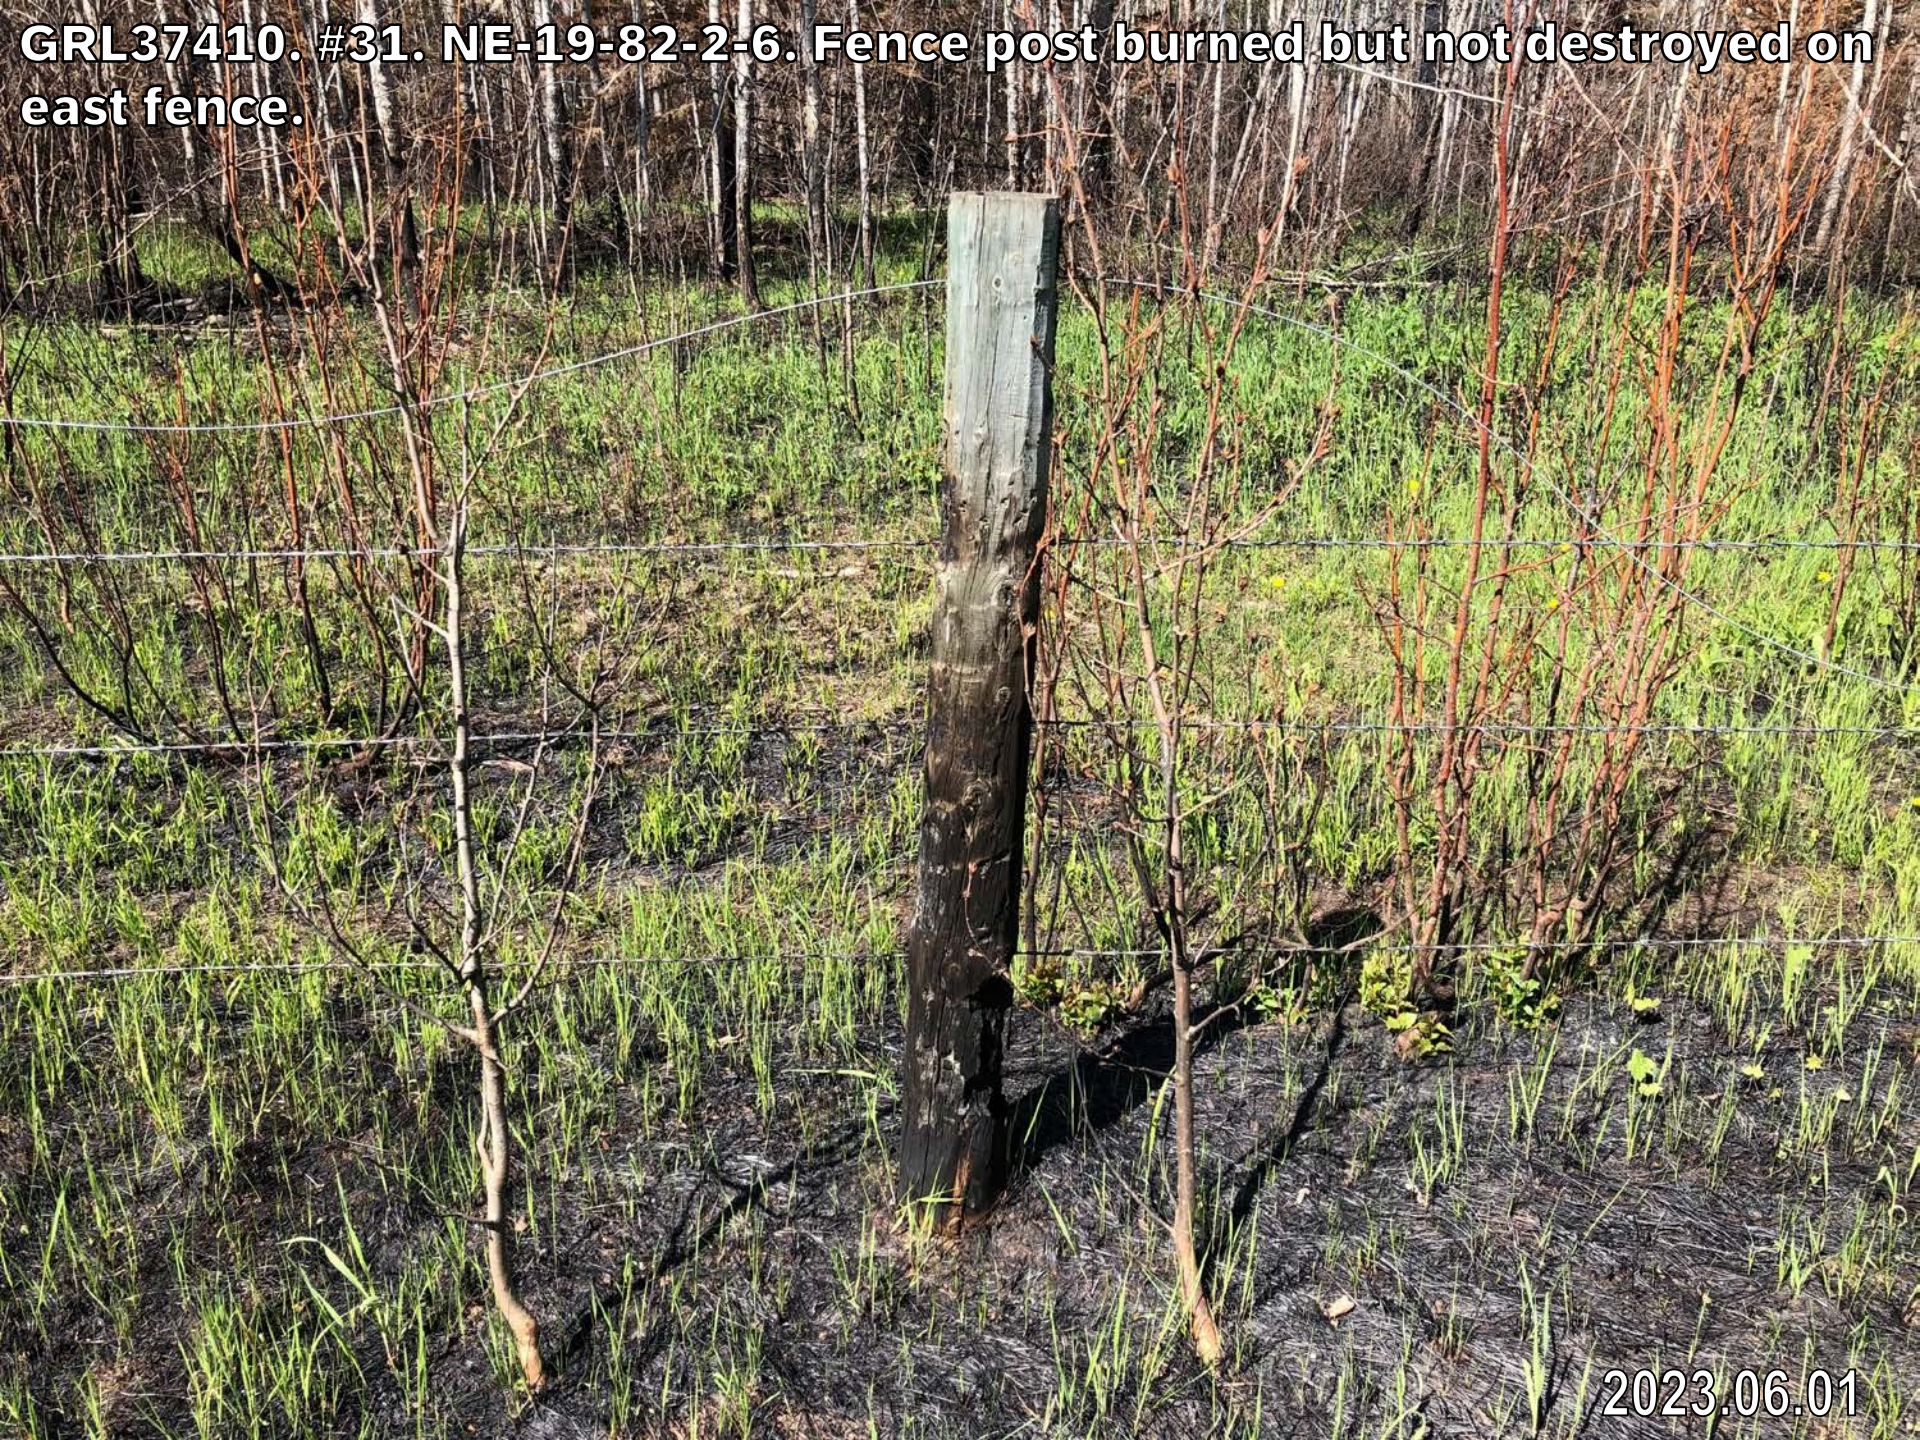
GRL37410. #31. NE-19-82-2-6. Fence post burned but not destroyed on east fence.

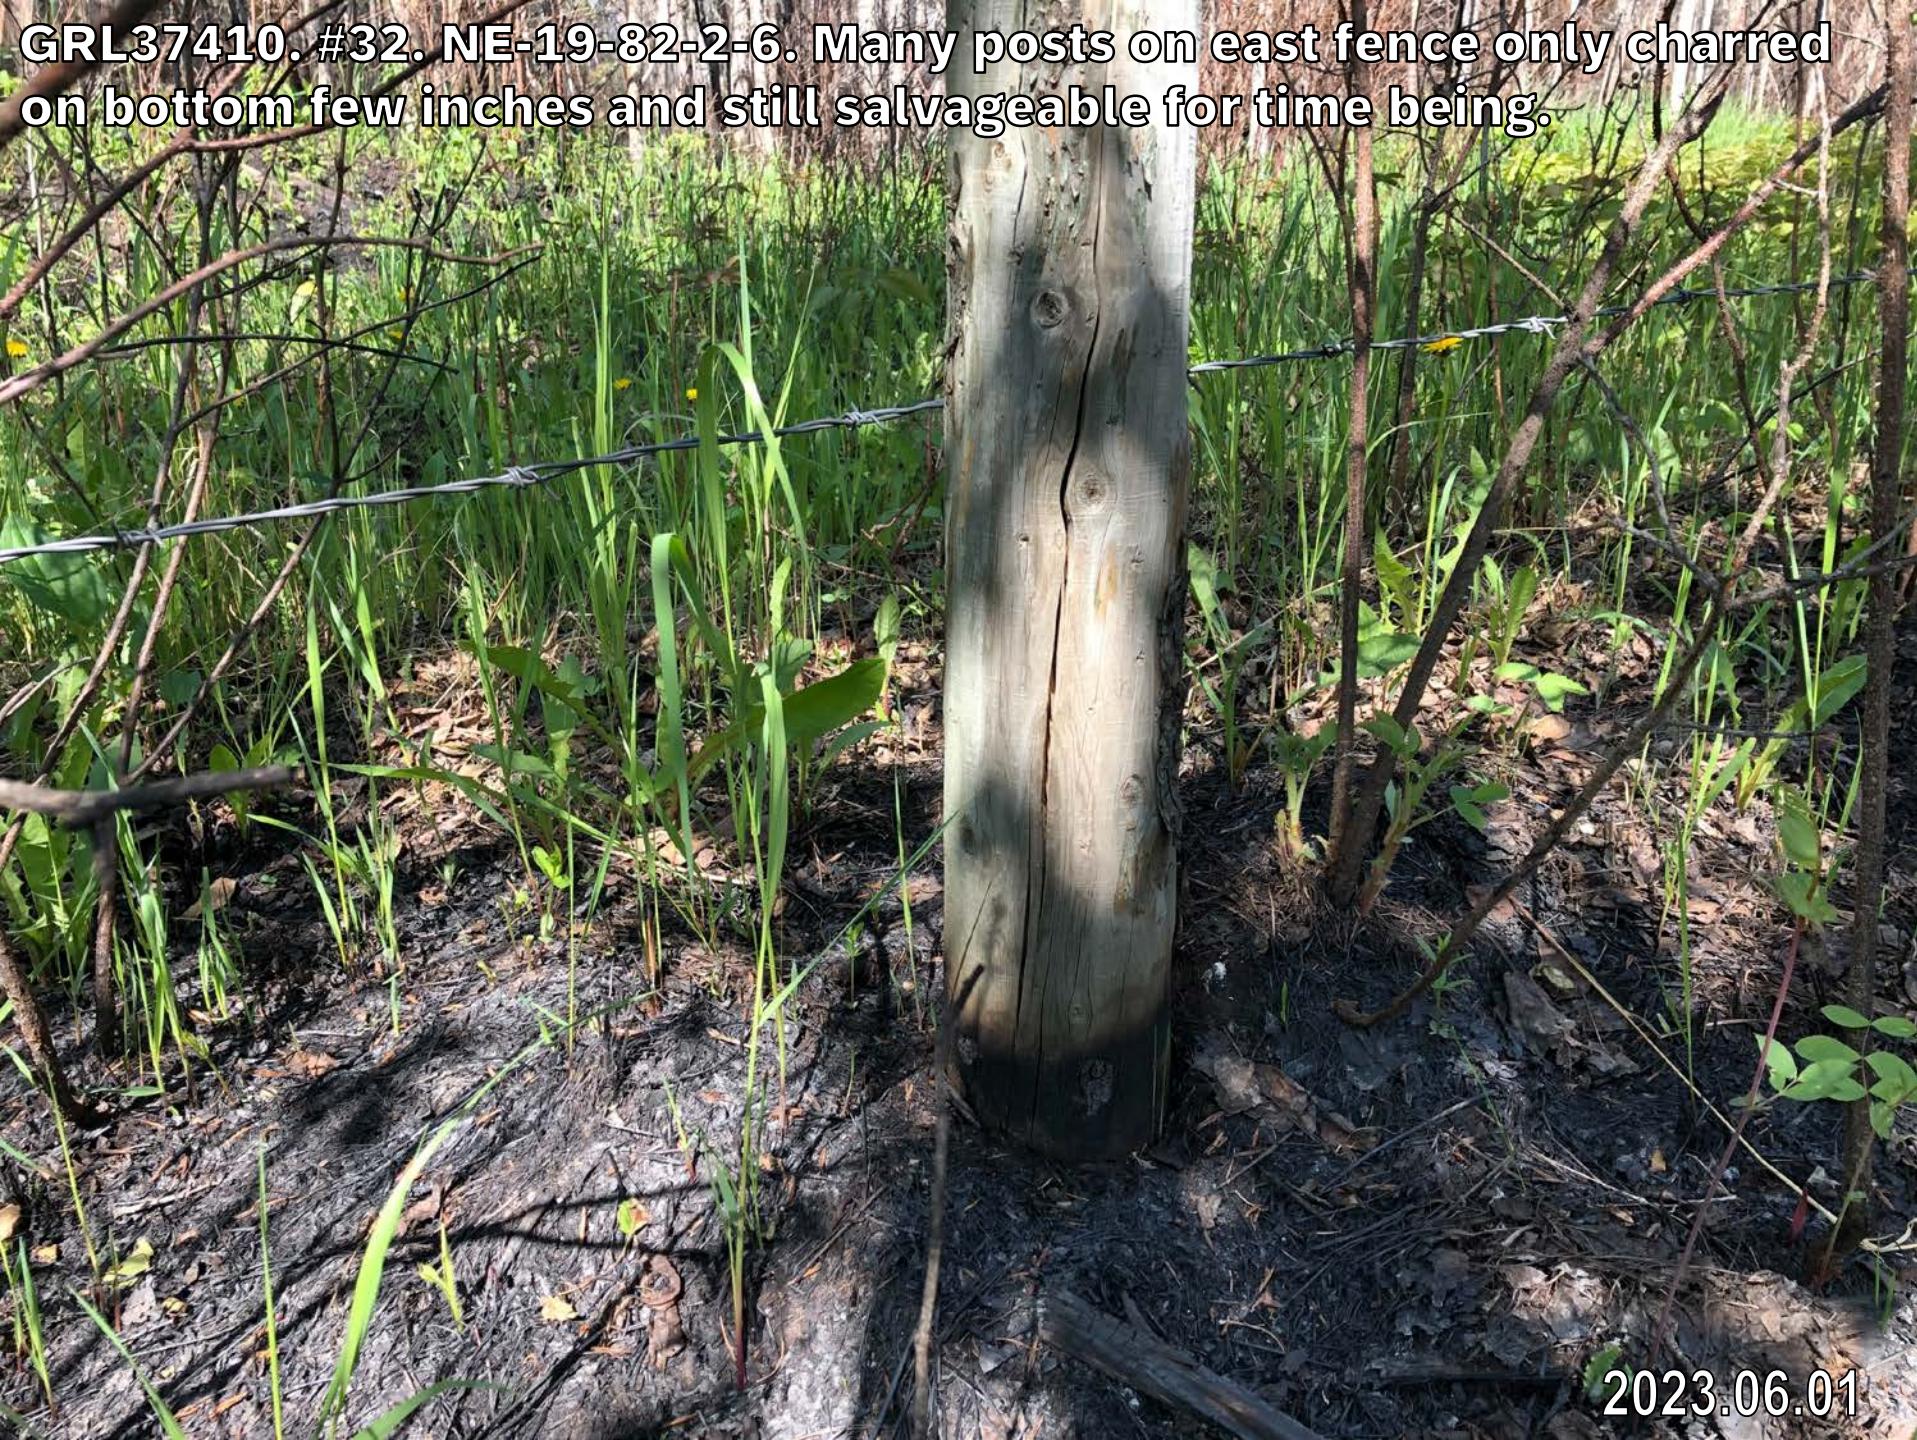
GRL37410. #32. NE-19-82-2-6. Many posts on east fence only charred on bottom few inches and still salvageable for time being.

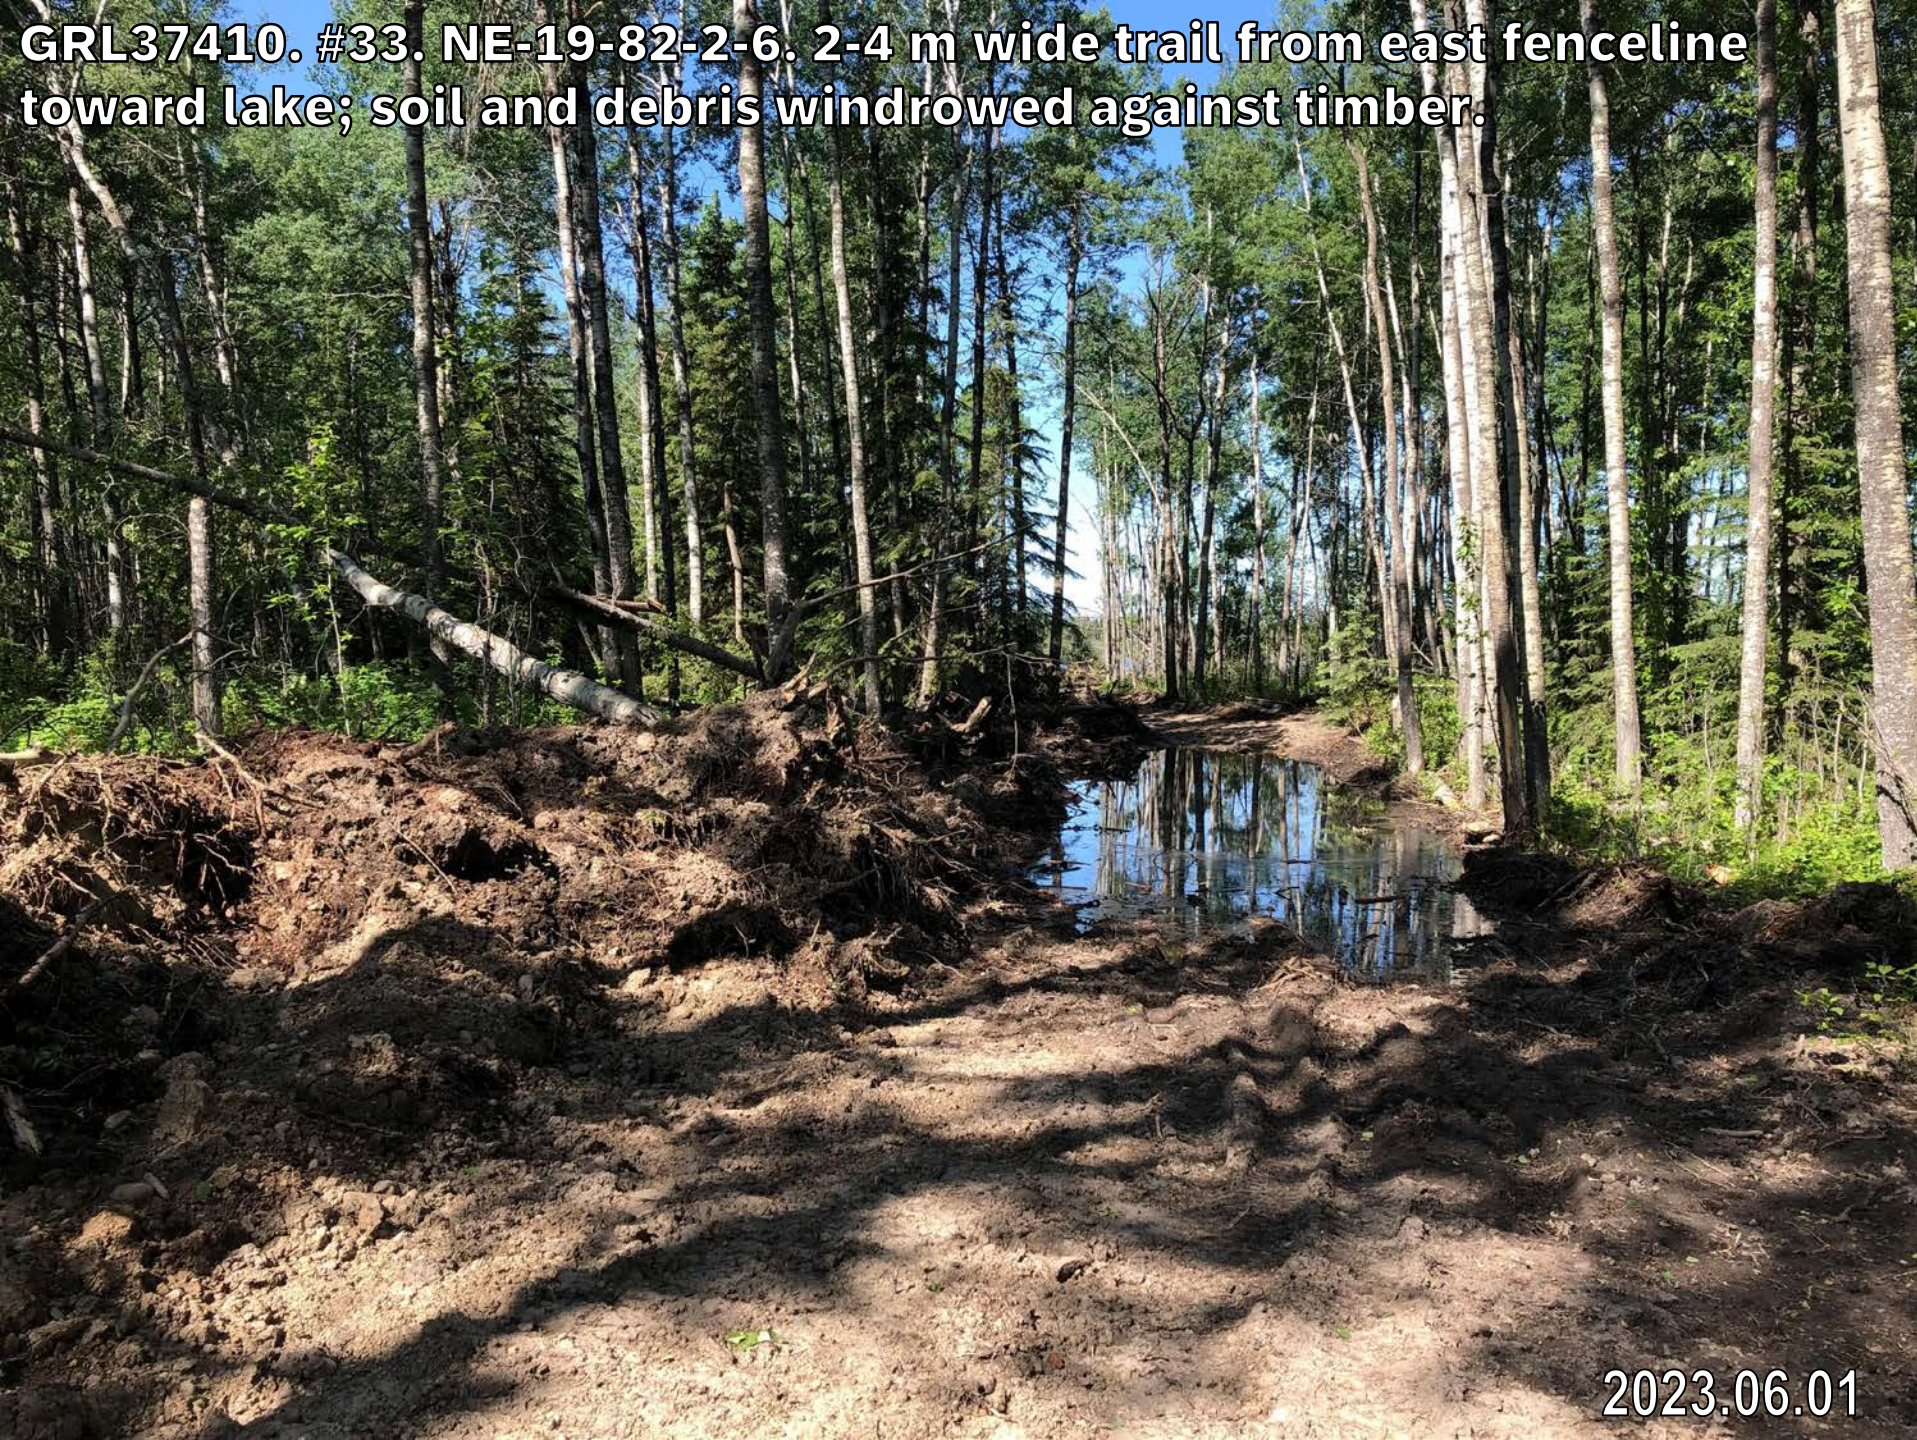
**GRL37410. #33. NE-19-82-2-6. 2-4 m wide trail from east fenceline toward lake; soil and debris windrowed against timber.**
