GRL37410. #1. SE-30-82-2-6. Log fill crossing along access trail.

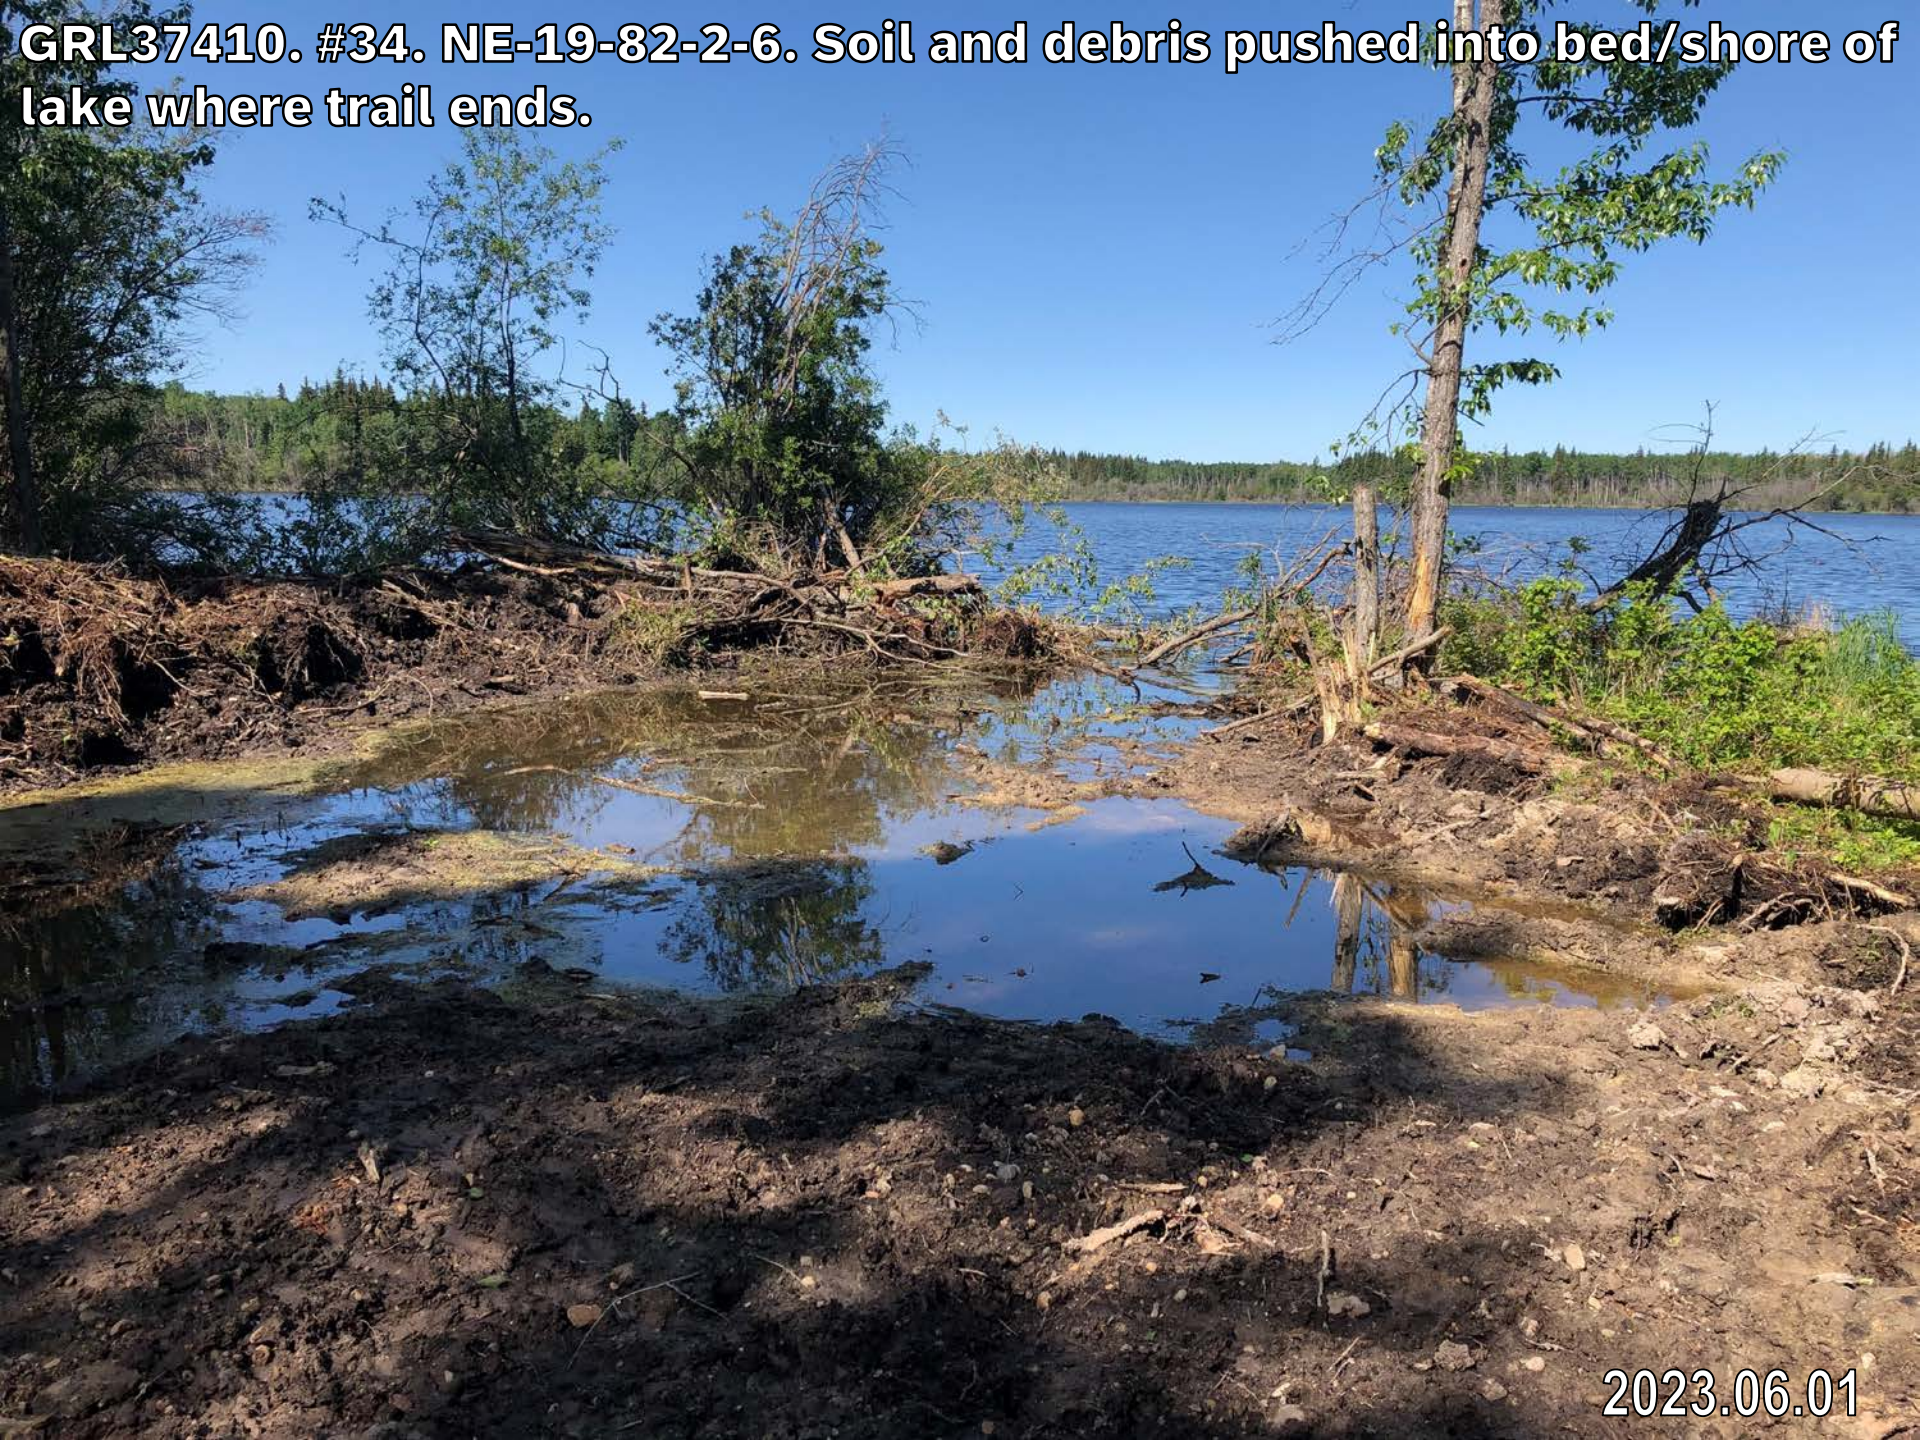
**GRL37410. #34. NE-19-82-2-6. Soil and debris pushed into bed/shore of lake where trail ends.**

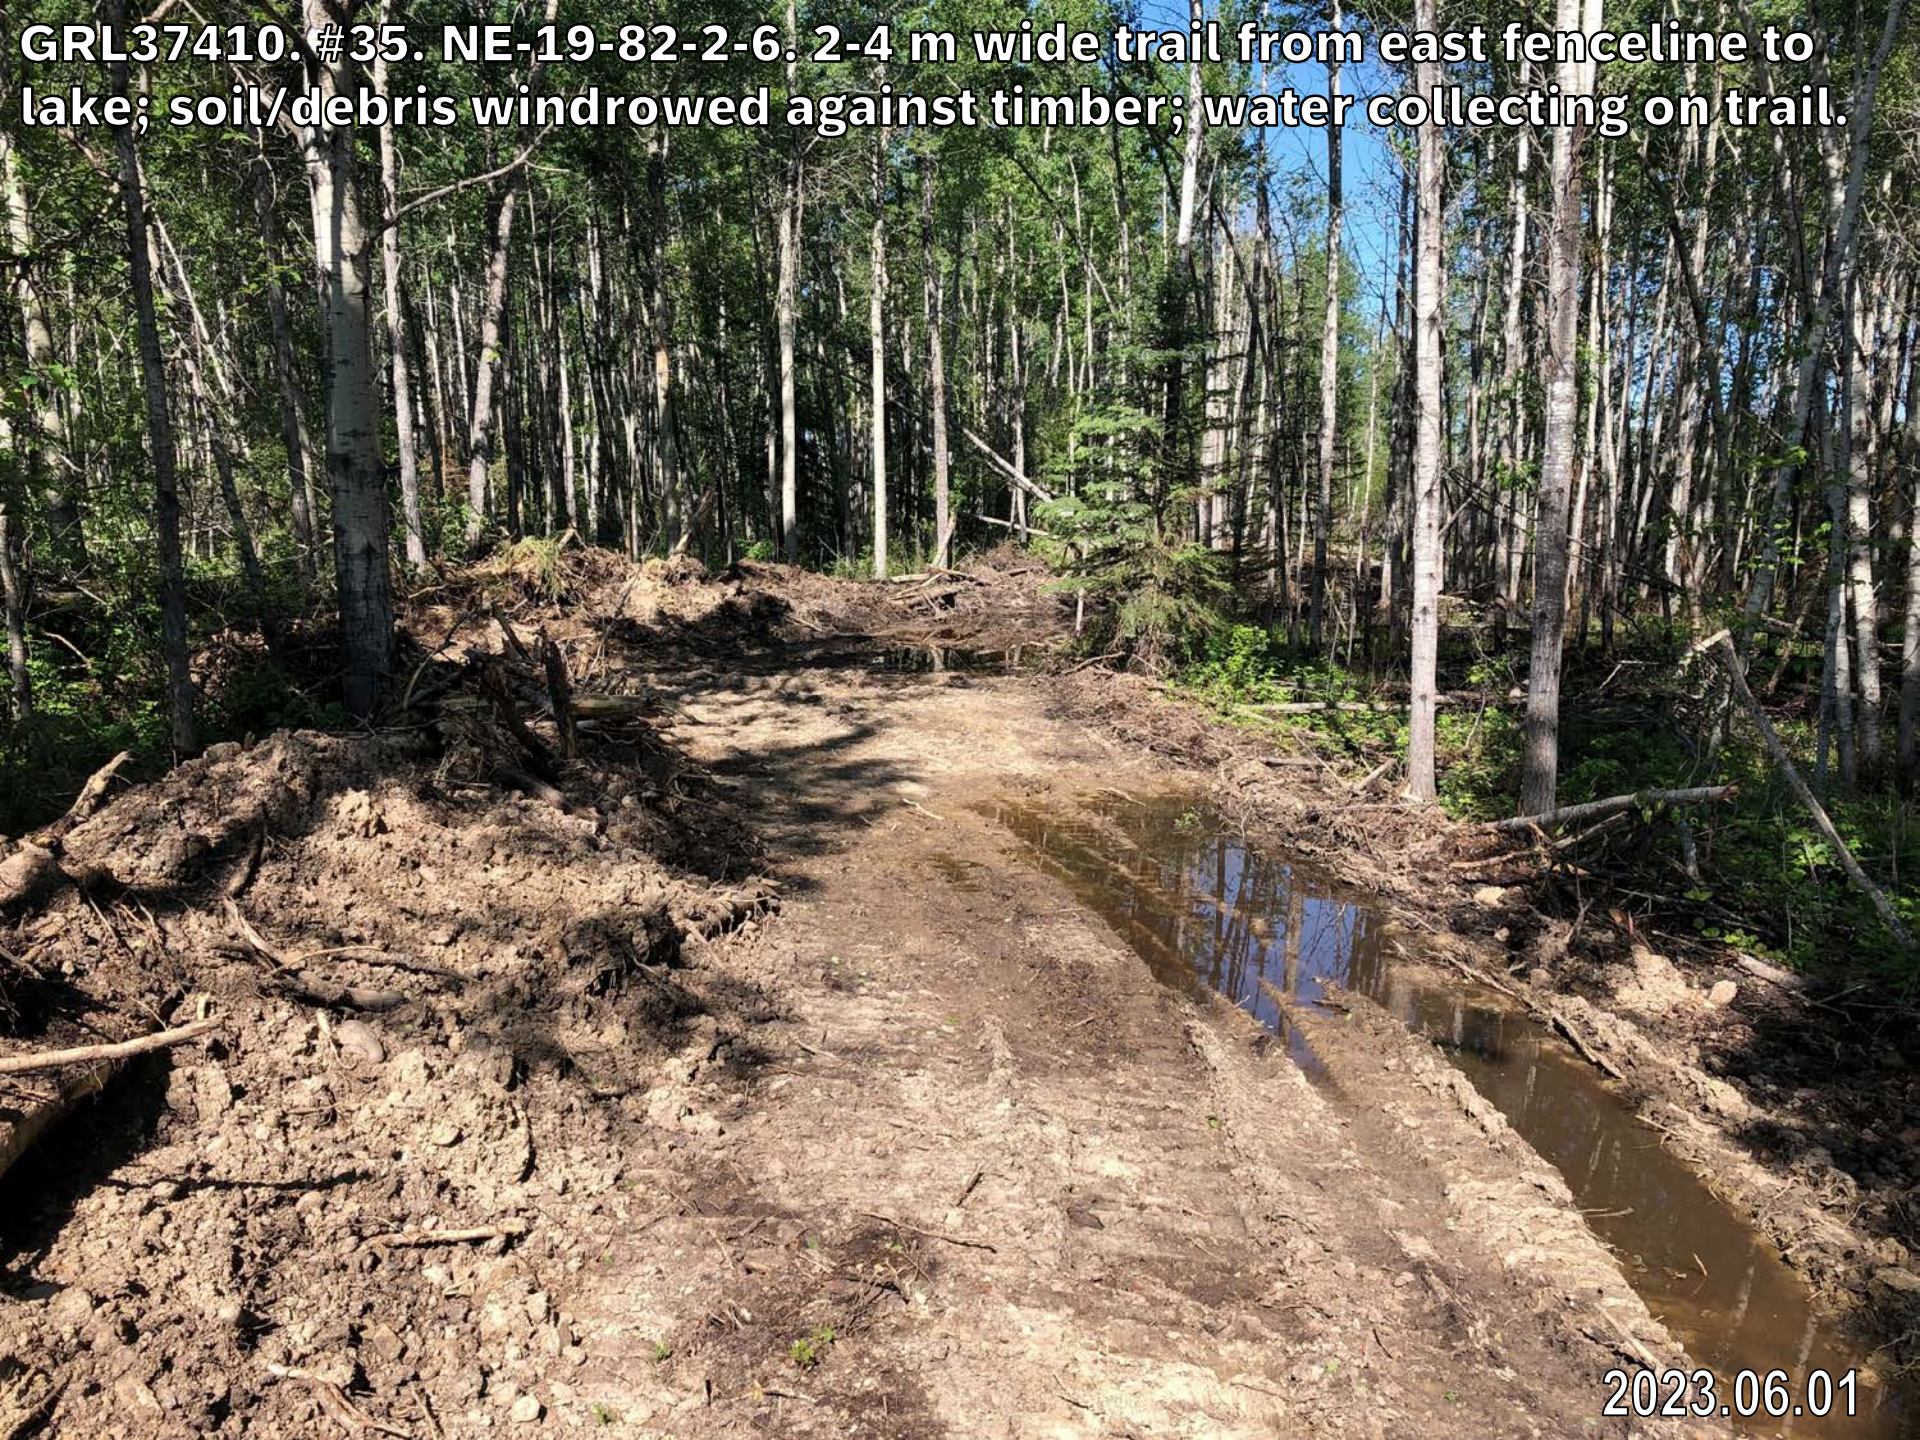
**GRL37410. #35. NE-19-82-2-6. 2-4 m wide trail from east fenceline to lake; soil/debris windrowed against timber; water collecting on trail.**

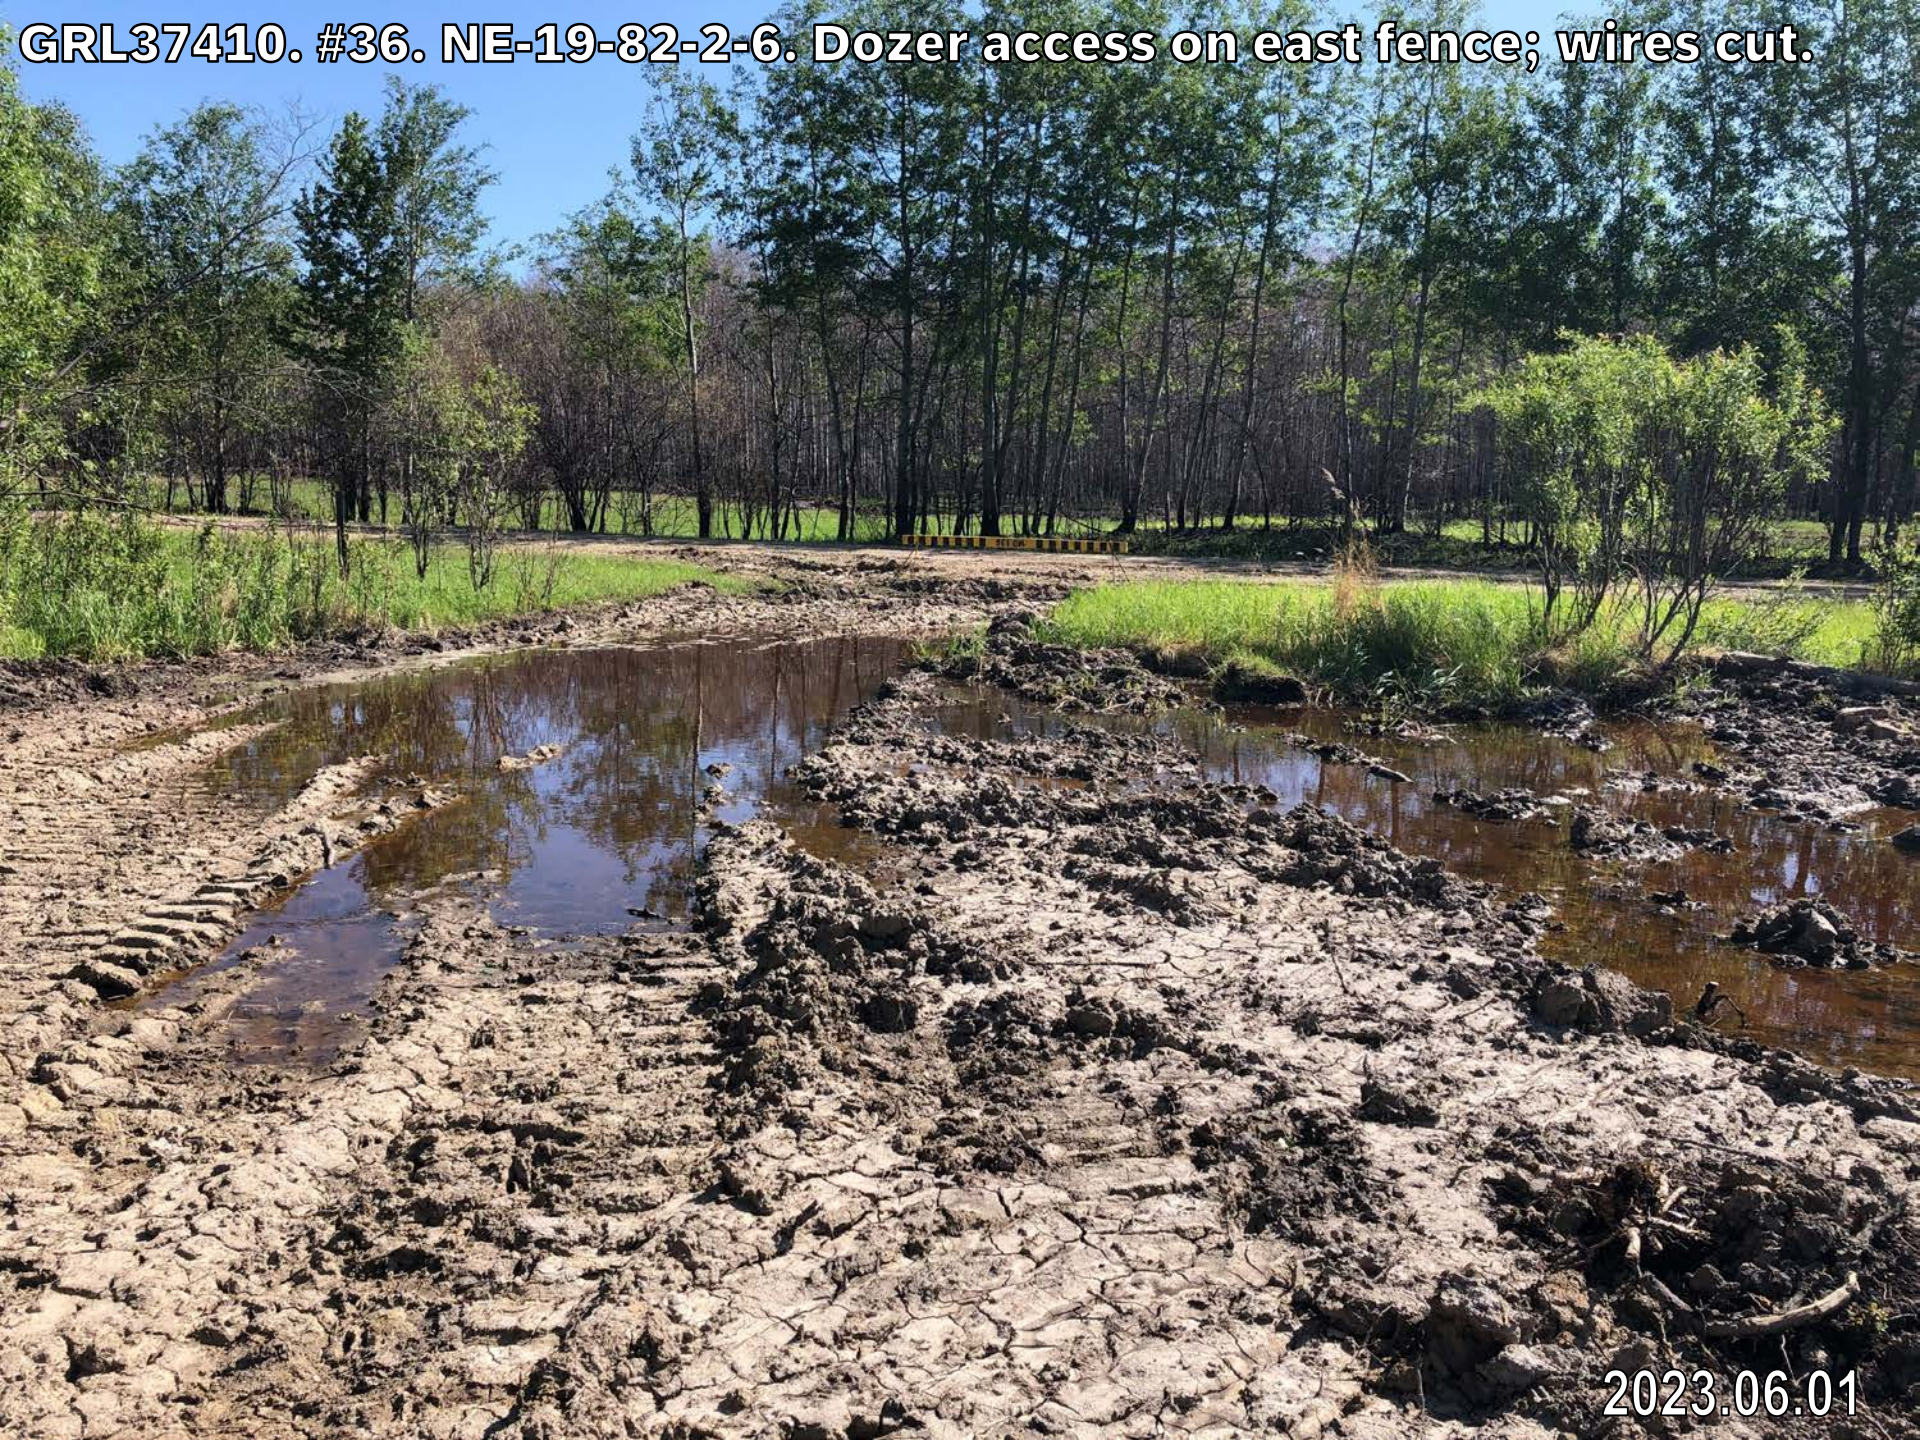
GRL37410. #36. NE-19-82-2-6. Dozer access on east fence; wires cut.

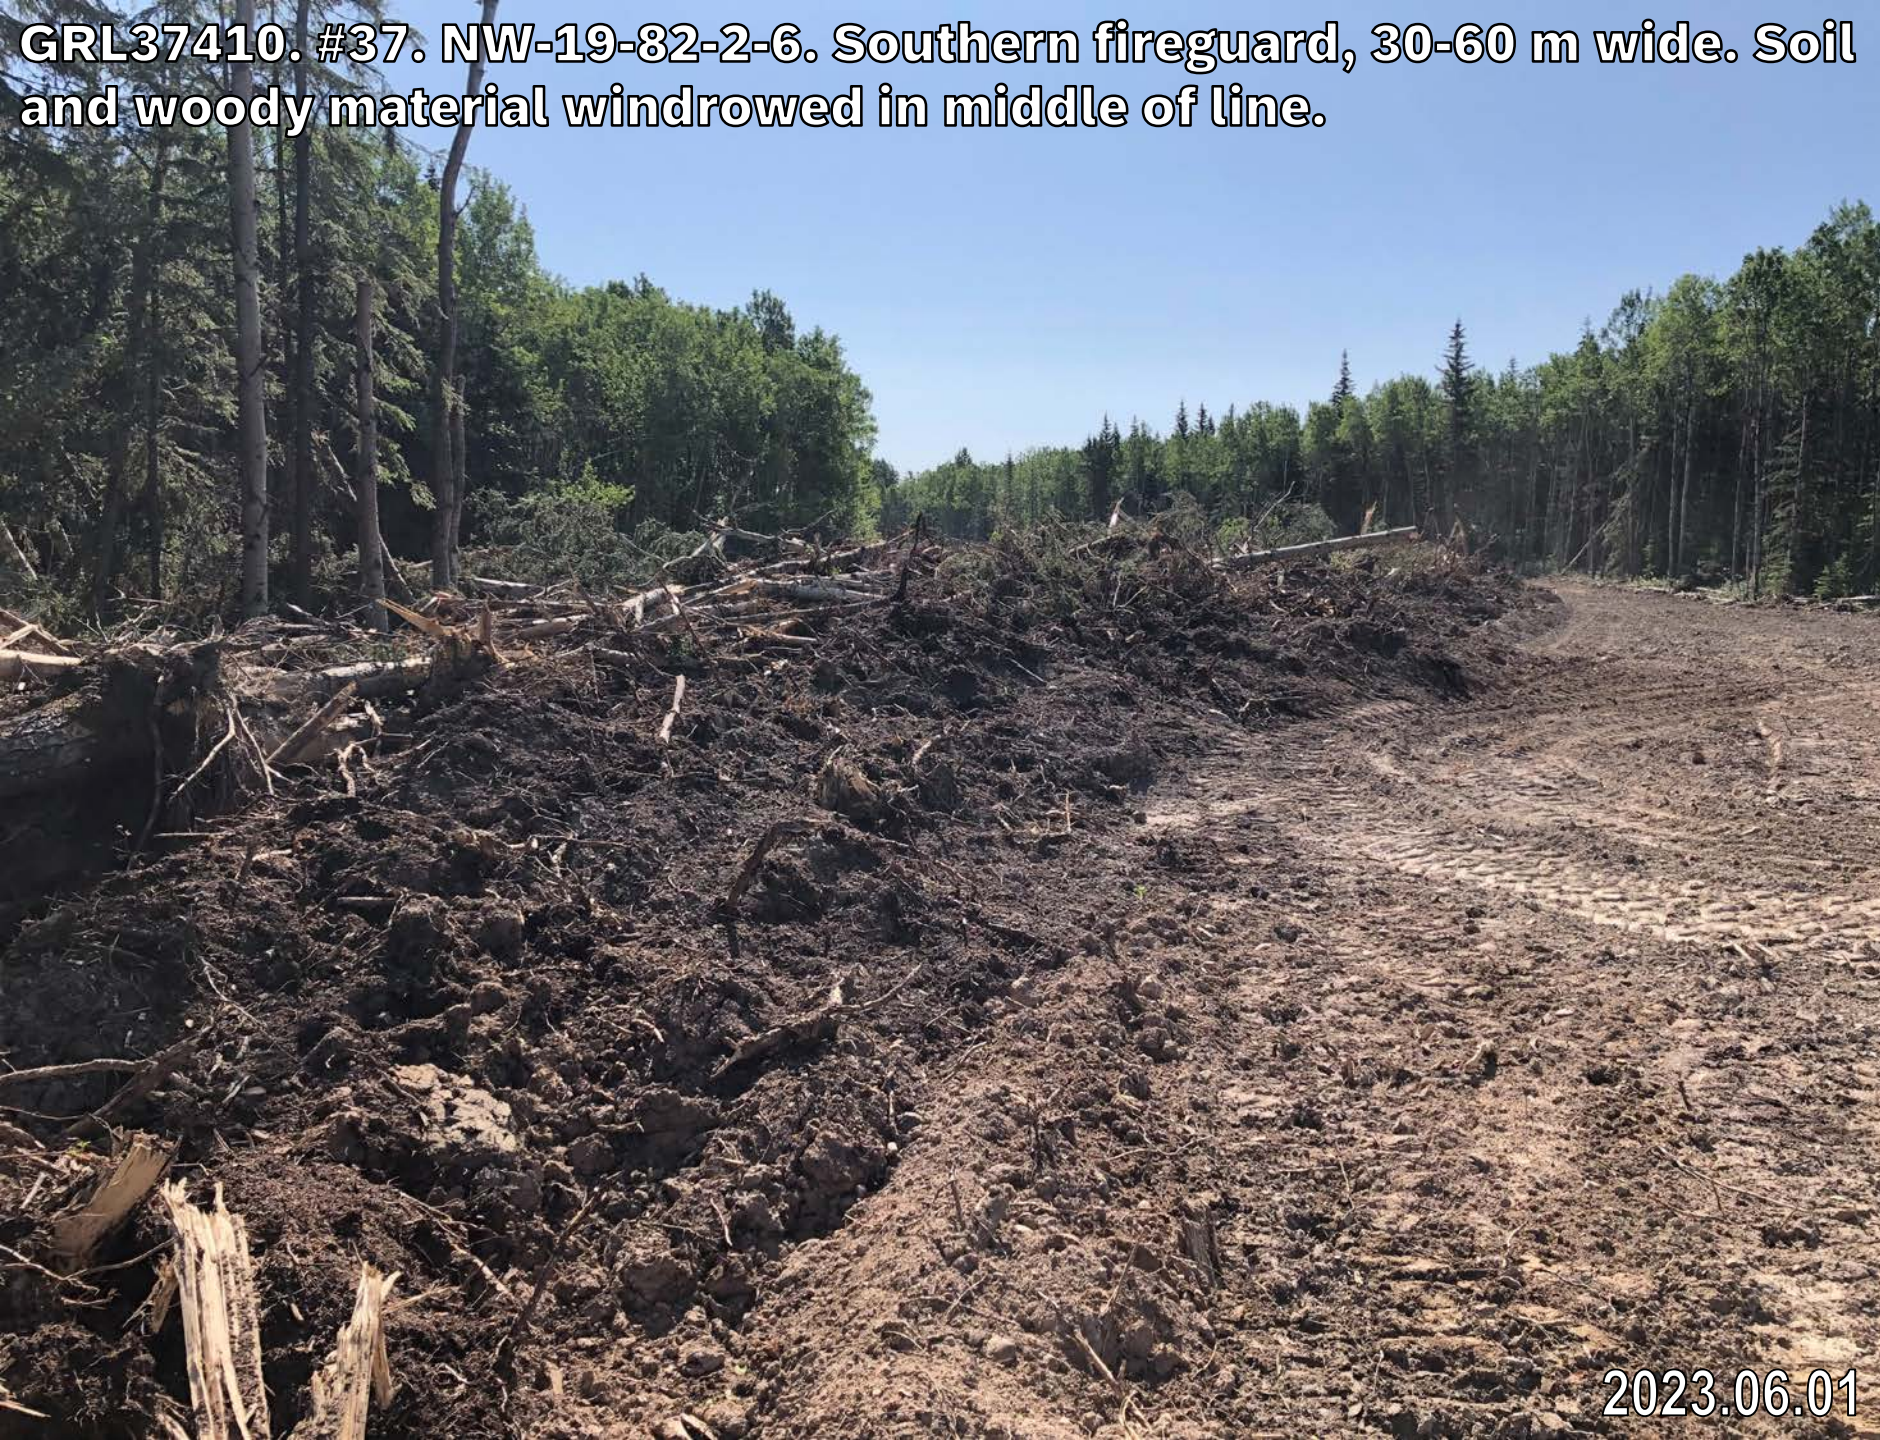
**GRL37410. #37. NW-19-82-2-6. Southern fireguard, 30-60 m wide. Soil and woody material windrowed in middle of line.**

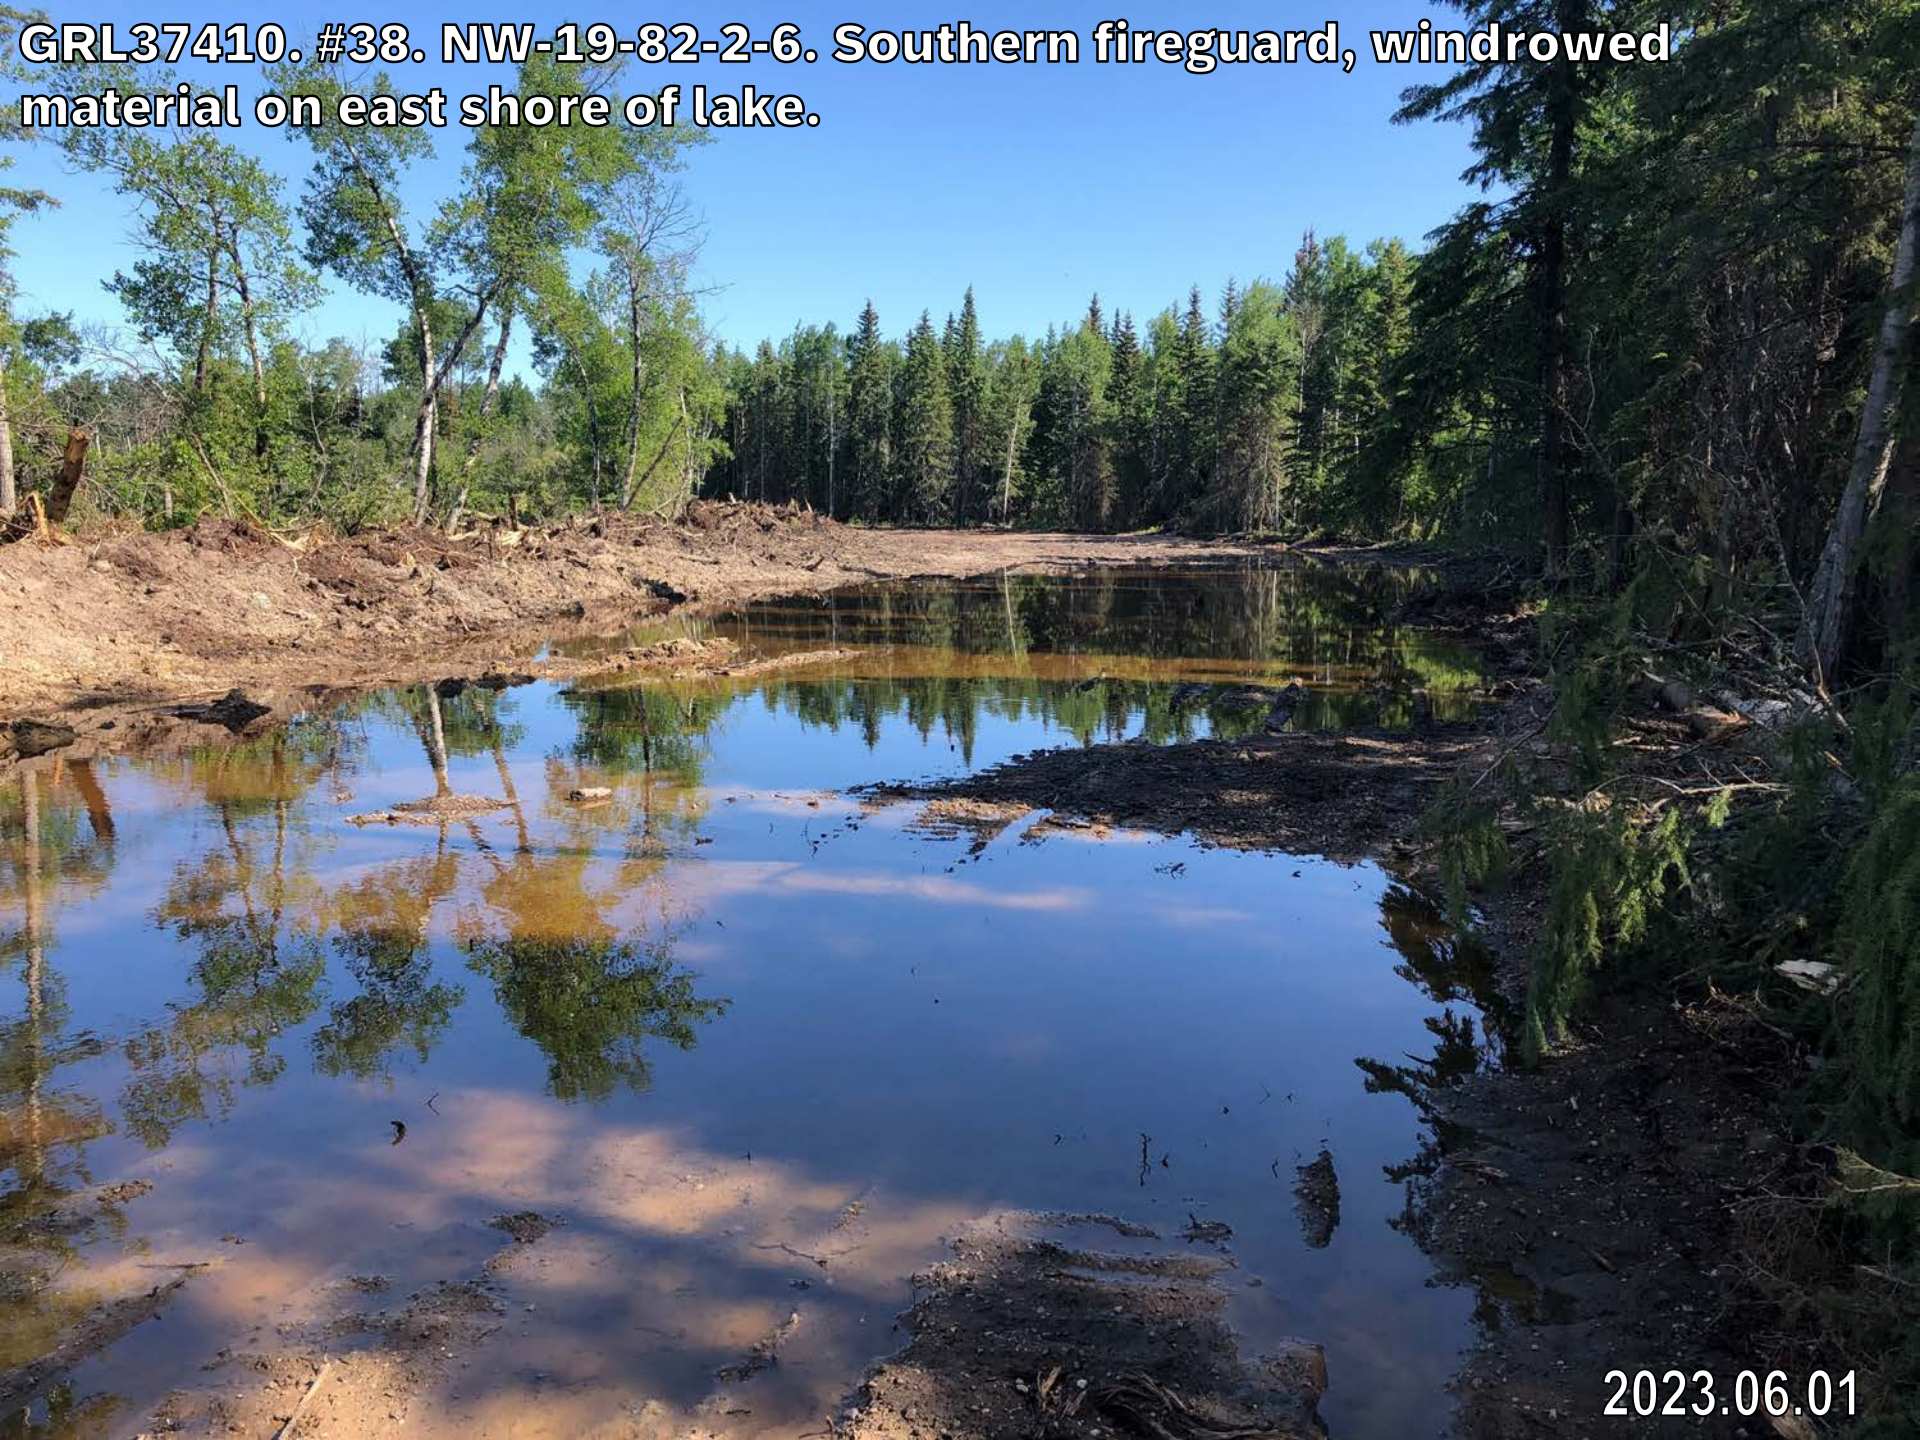
**GRL37410. #38. NW-19-82-2-6. Southern fireguard, windrowed material on east shore of lake.**

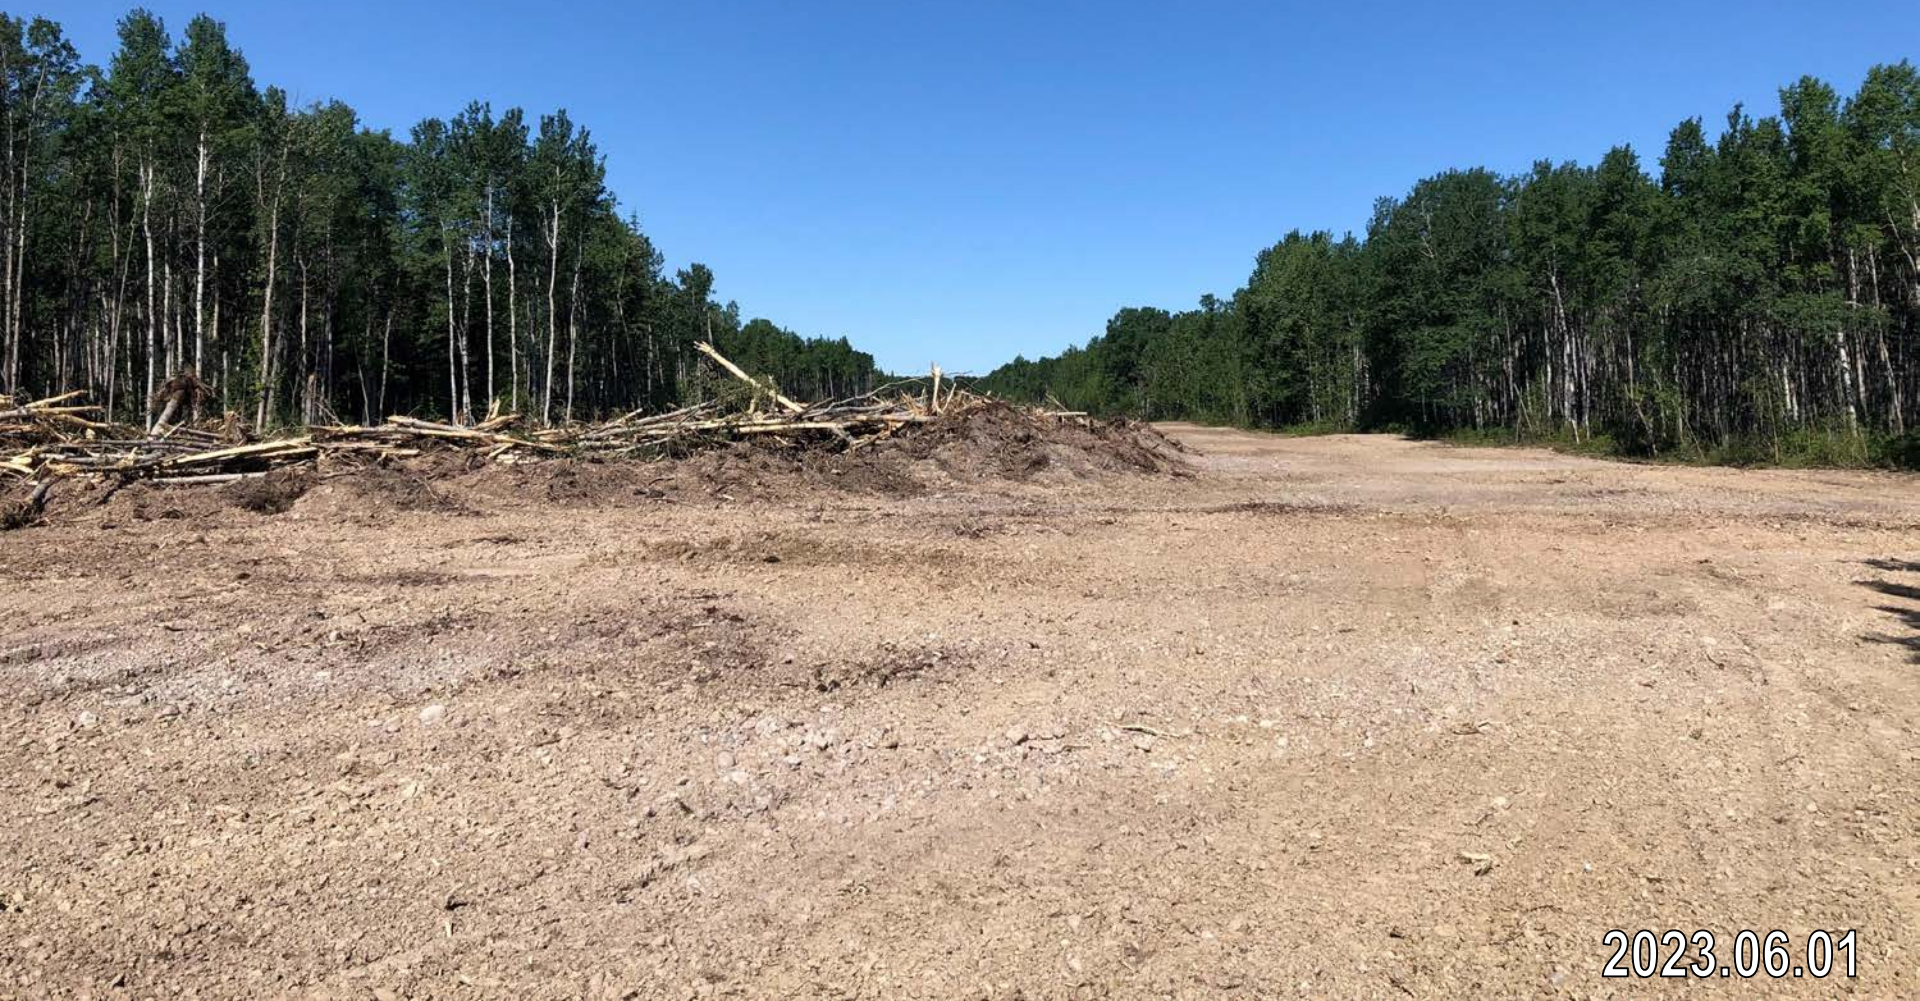
**GRL37410. #39. SE-19-82-2-6. Southern fireguard west from MSL, 50-60 m wide.**

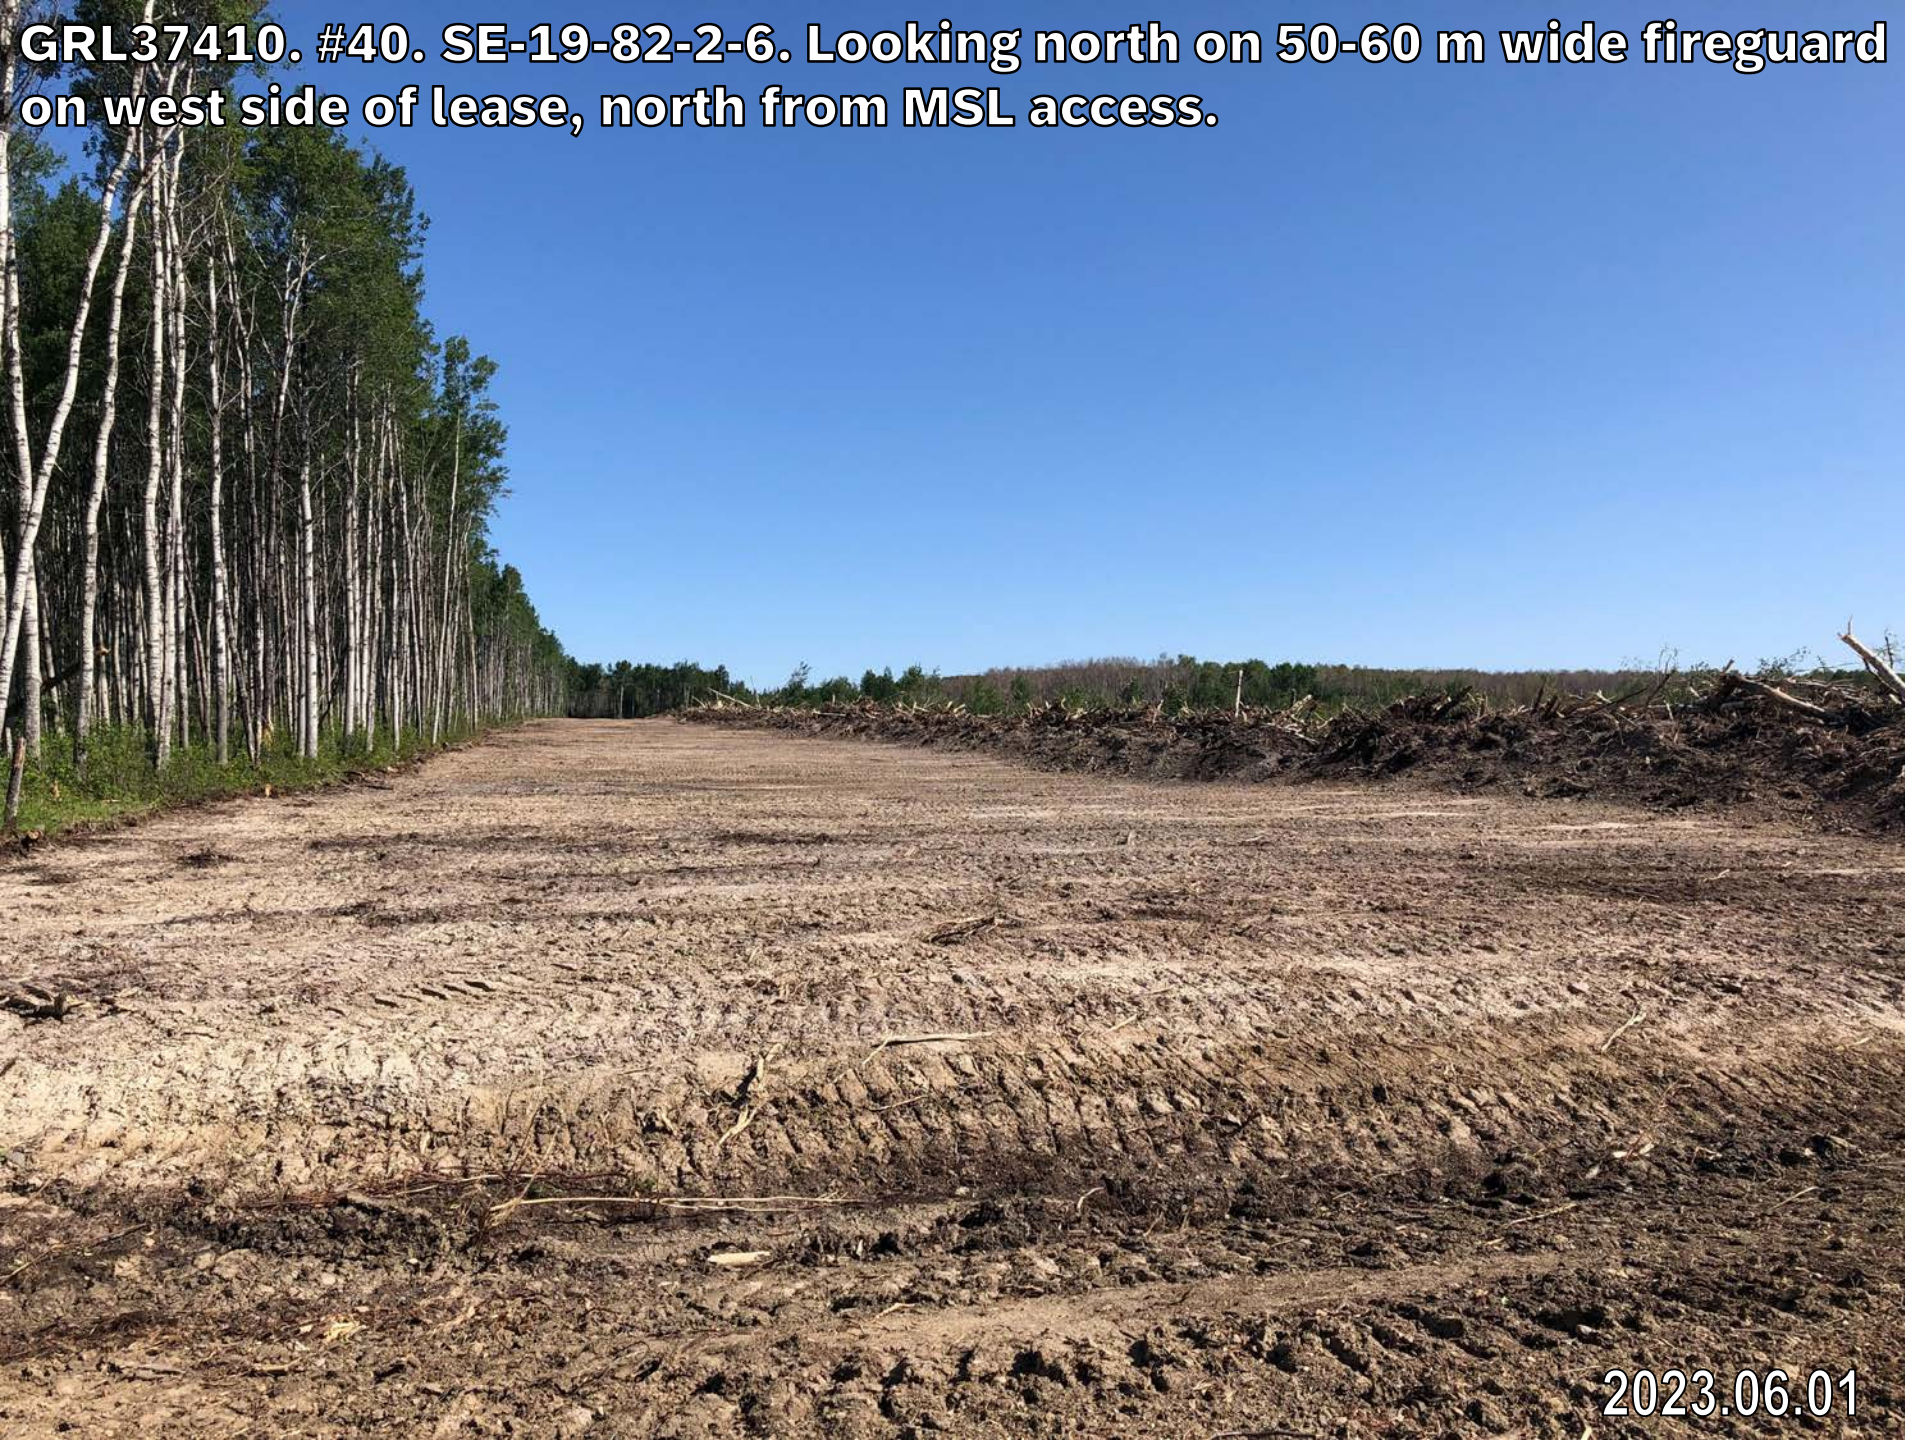
**GRL37410. #40. SE-19-82-2-6. Looking north on 50-60 m wide fireguard on west side of lease, north from MSL access.**

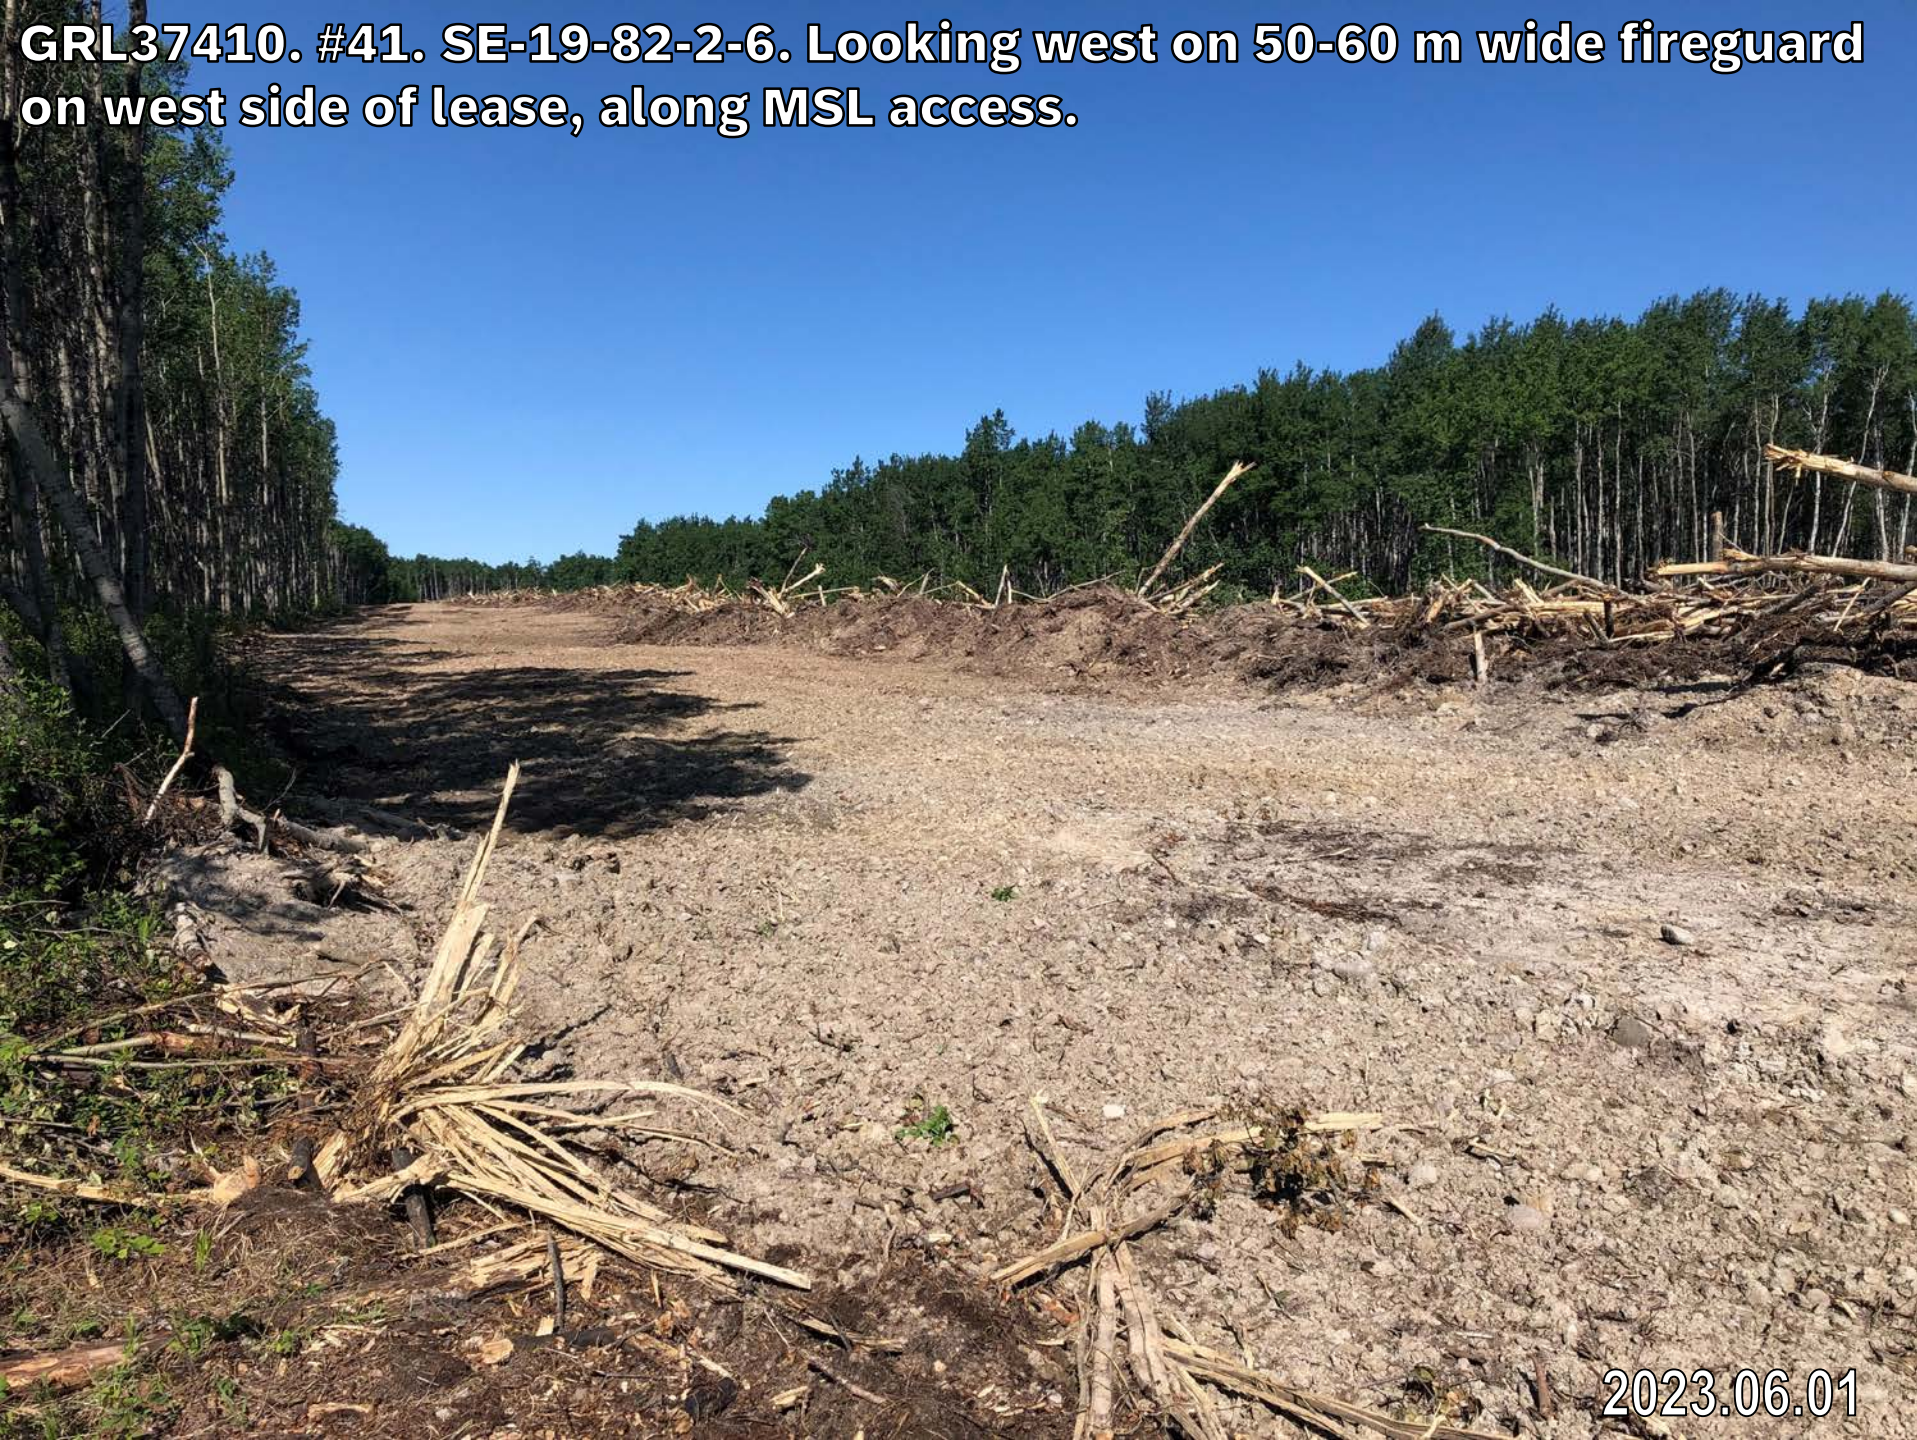
**GRL37410. #41. SE-19-82-2-6. Looking west on 50-60 m wide fireguard on west side of lease, along MSL access.**
