GRL37410. #1. SE-30-82-2-6. Log fill crossing along access trail.

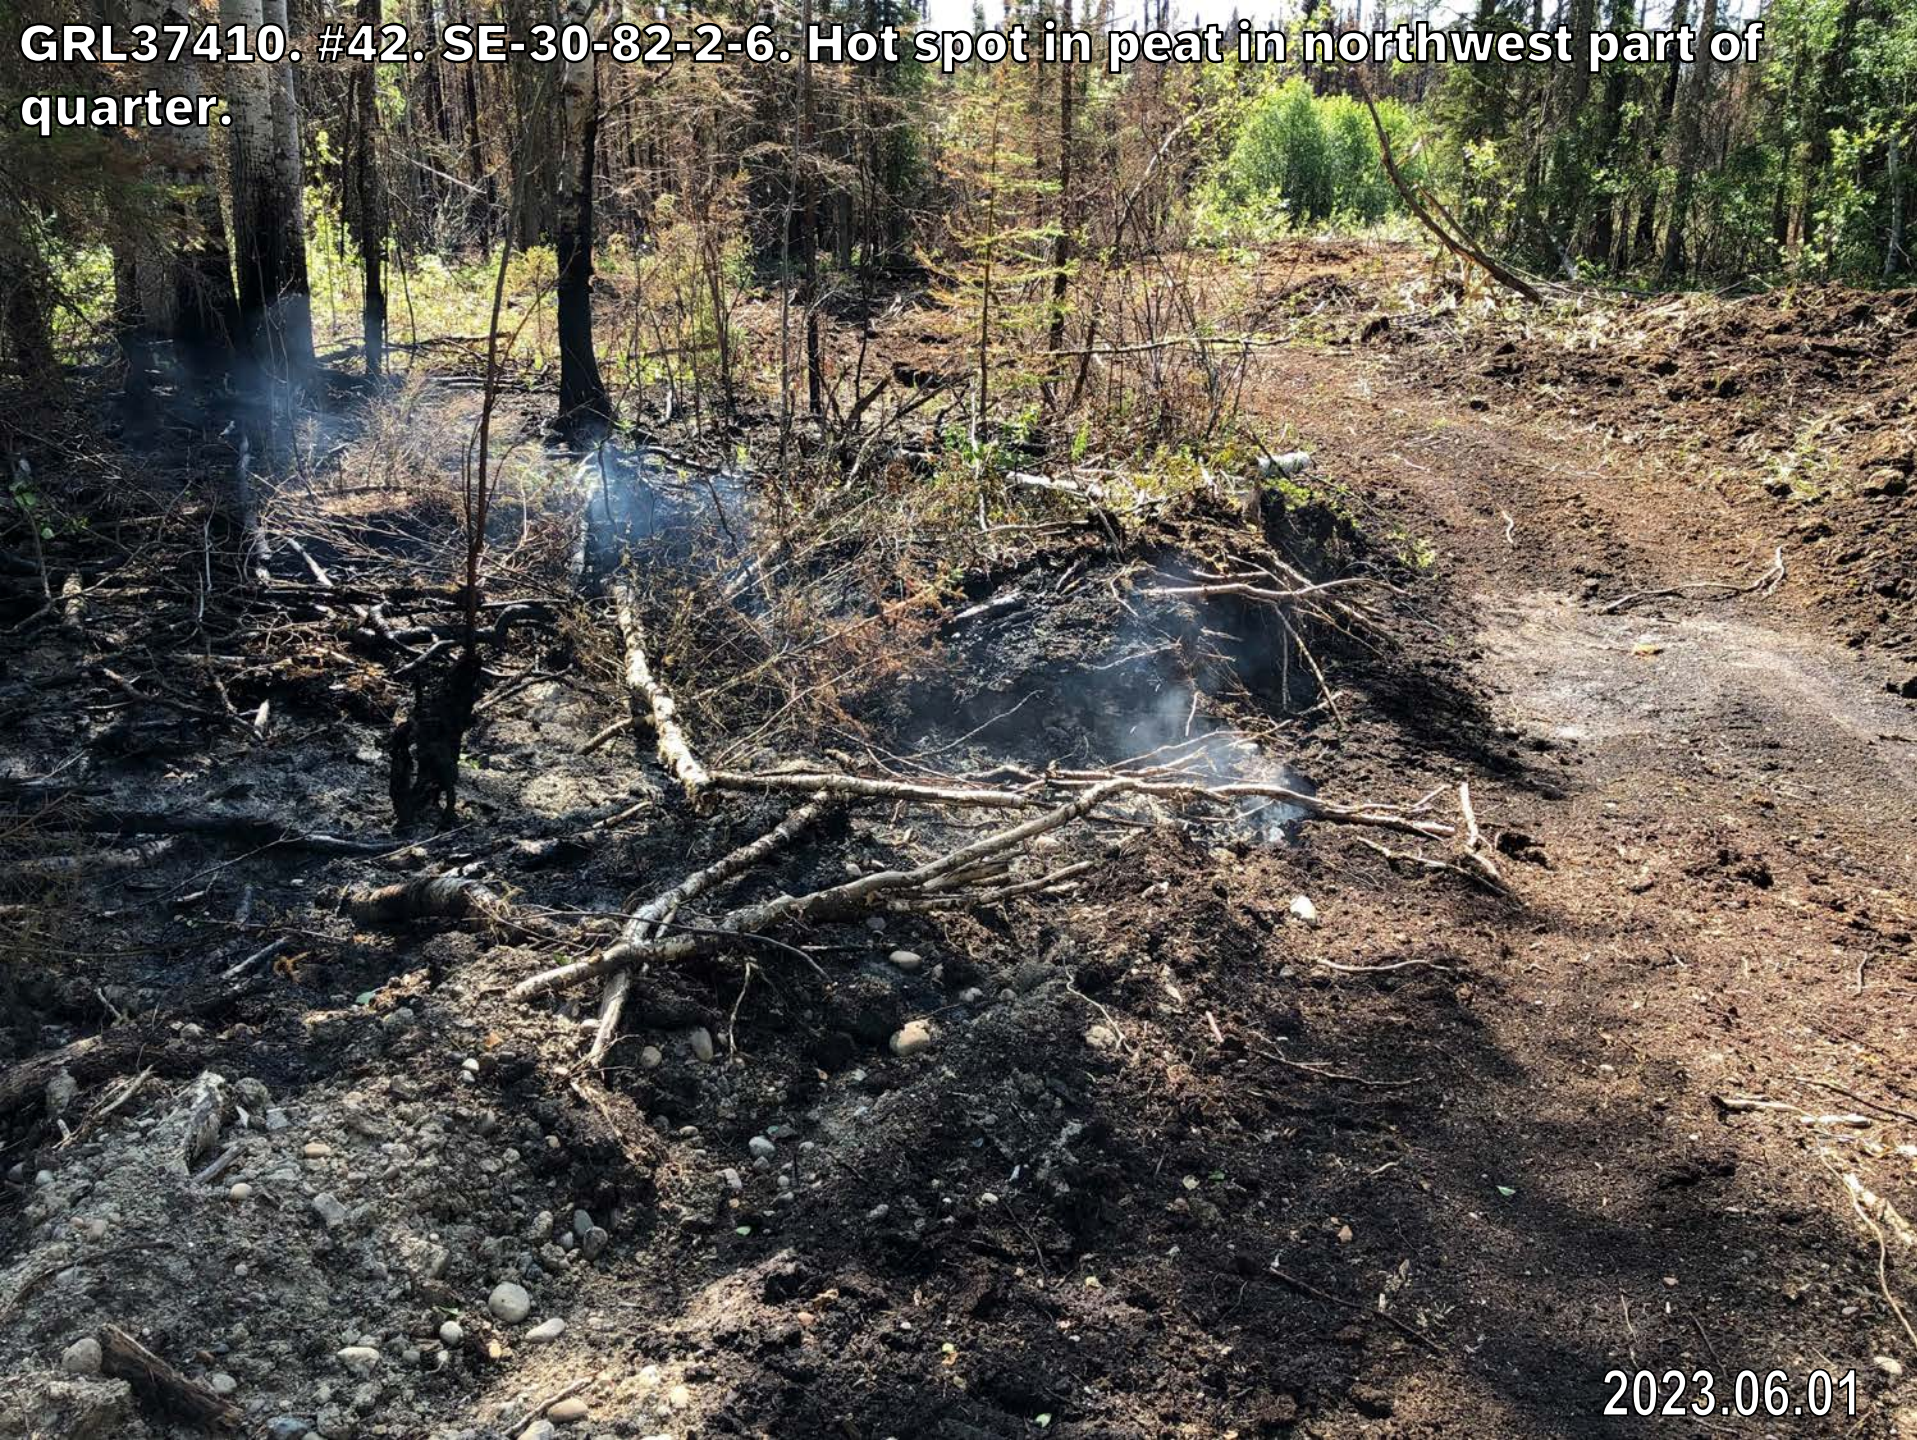
GRL37410. #42. SE-30-82-2-6. Hot spot in peat in northwest part of quarter.

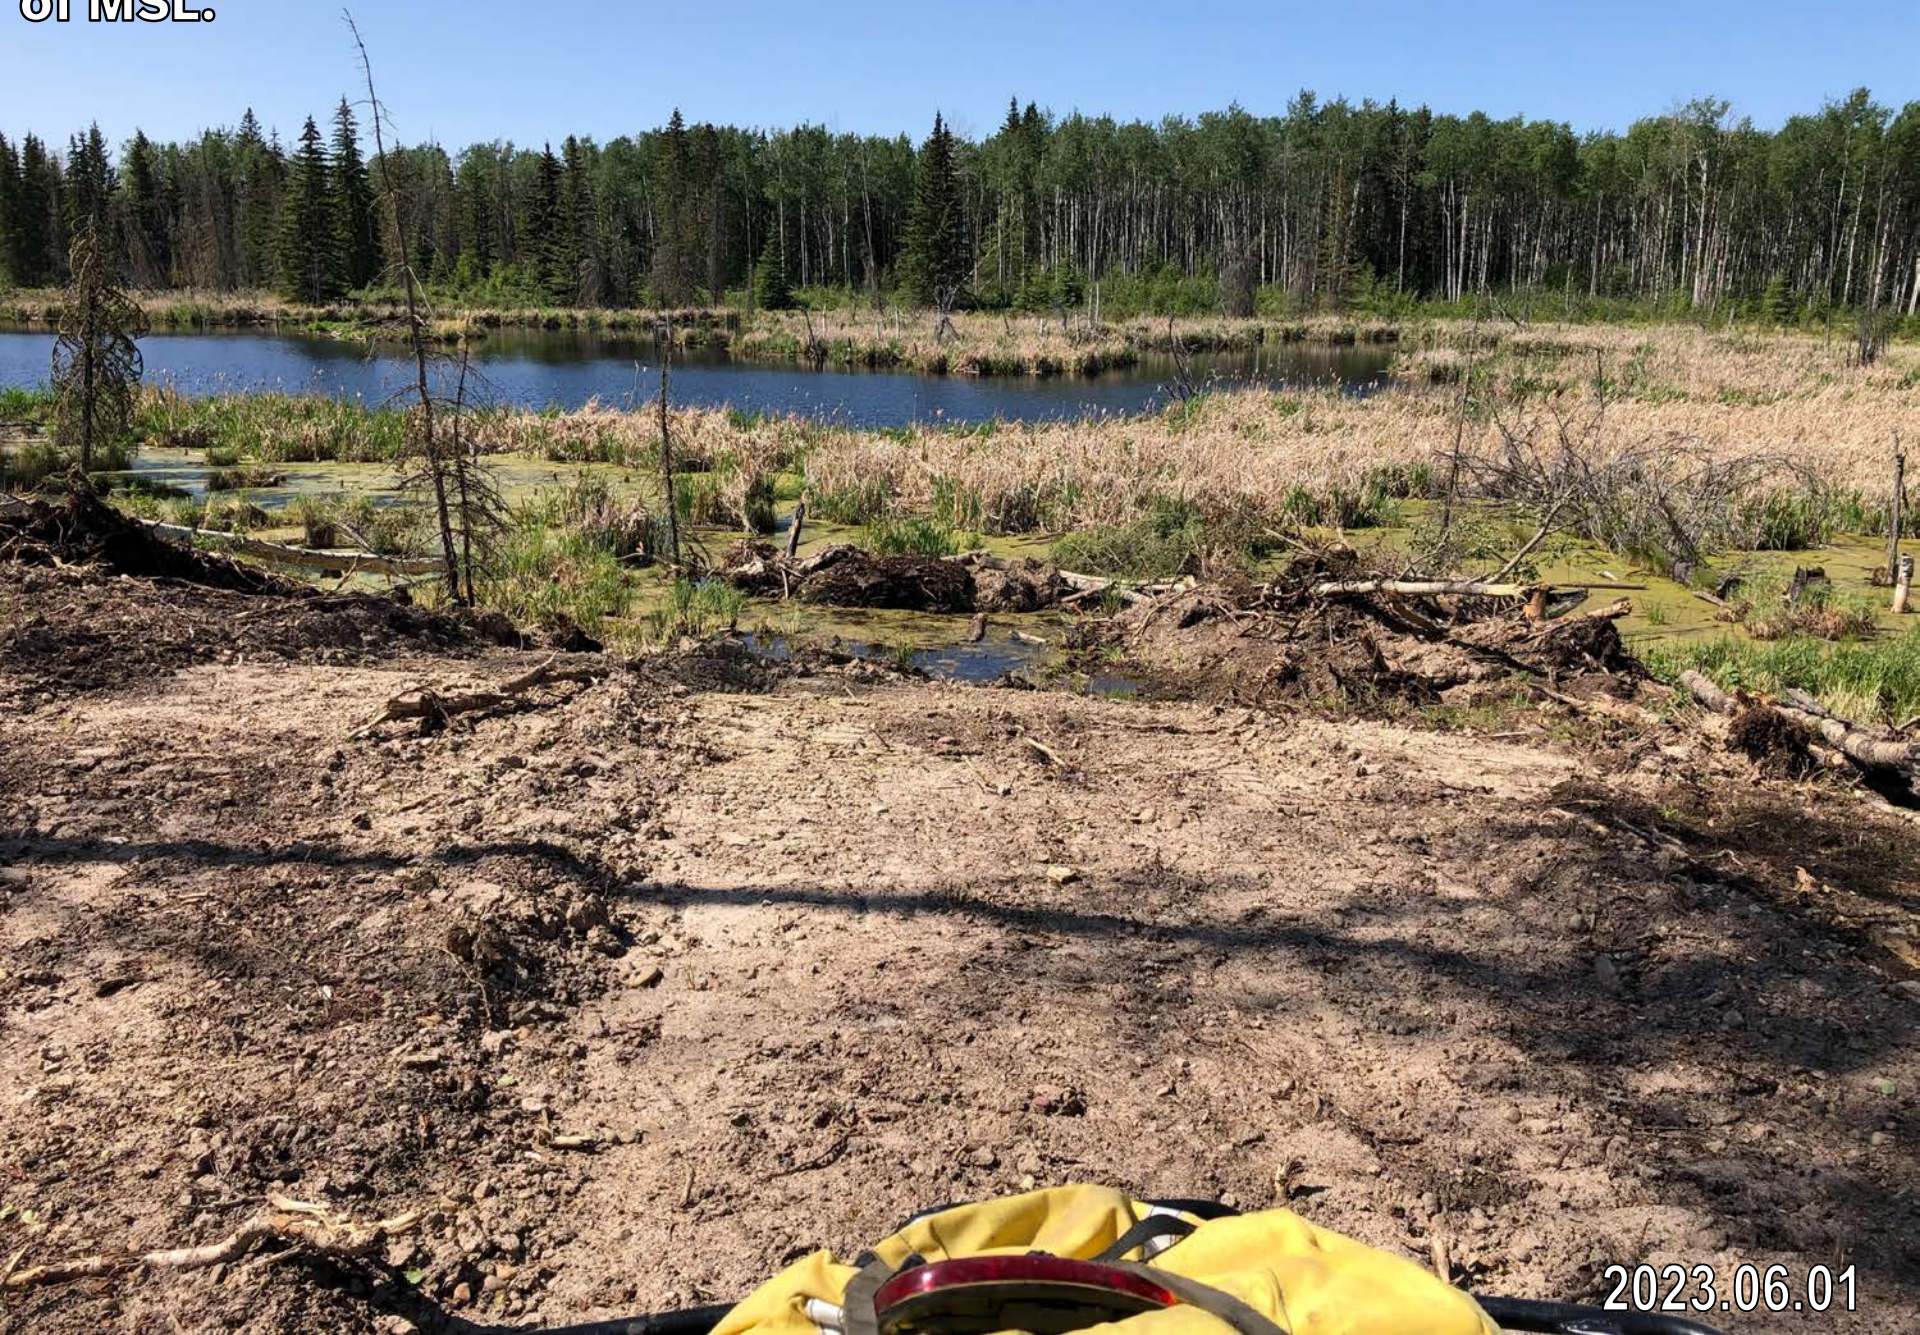
**GRL37410. #43. SE-30-82-2-6. Debris pushed into wetland, northwest of MSL.**
